AVIATION OCCURRENCE REPORT

MID-AIR COLLISION

BETWEEN
BEARSKIN AIRLINES
FAIRCHILD METRO 23 C-GYYB
AND
AIR SANDY INC.
REGISTRATION PA-31 NAVAJO C-GYPZ
SIOUX LOOKOUT, ONTARIO 12 nm NW
01 MAY 1995

REPORT NUMBER A95H0008

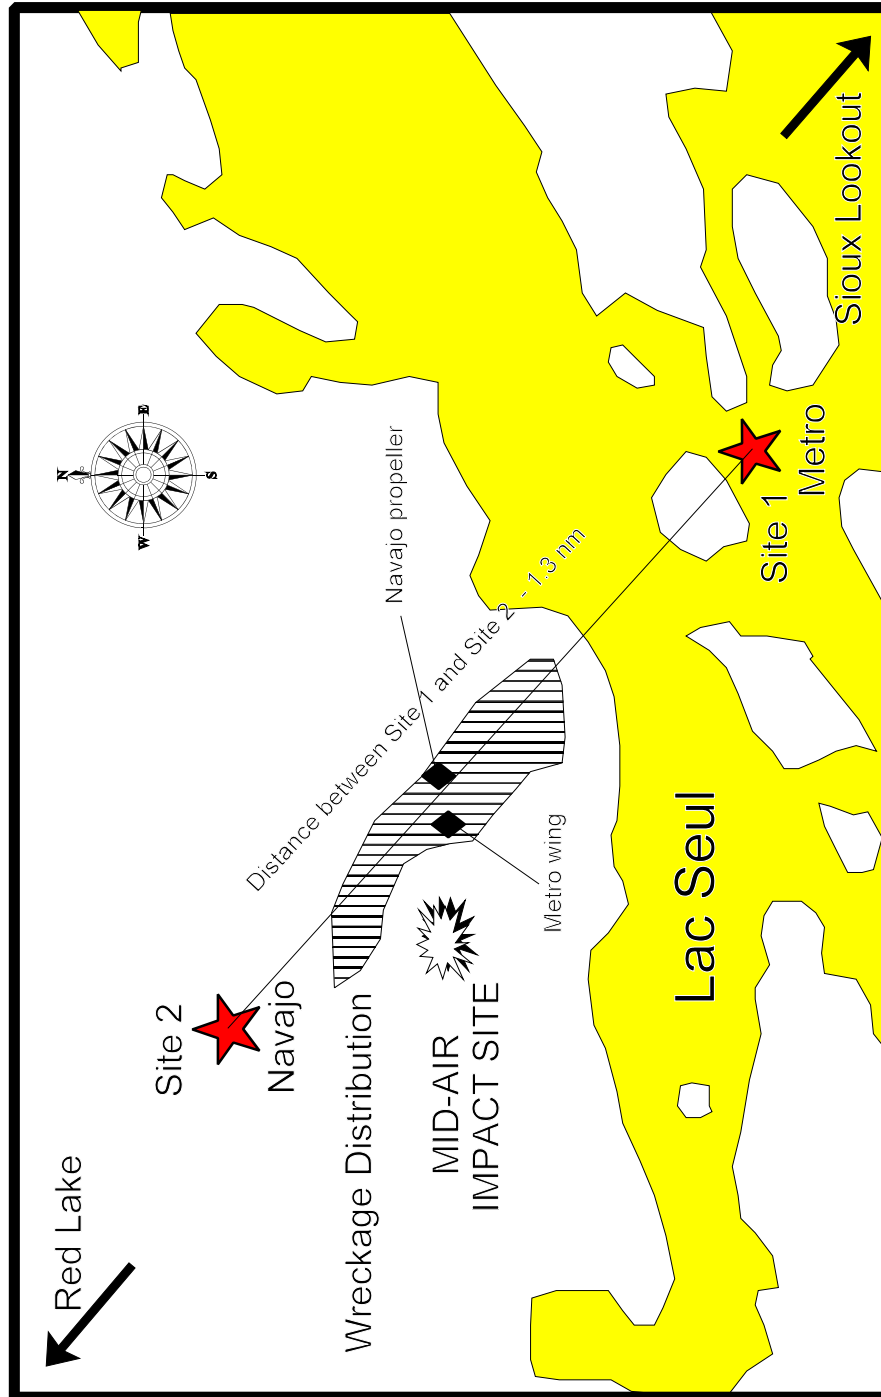
Appendix A - Wreckage Distribution

The wreckage from both aircraft was scattered over an area measuring approximately 1 1/2 by 1/2 miles. The major portions of the Bearskin Metro were located in water (designated Site 1). The high-speed impact with the water resulted in the destruction of the aircraft. Evidence showed that the aircraft was on fire prior to impact with the water. The major portions of the Air Sandy Navajo wreckage were located on land (designated Site 2), where the majority of the aircraft was burned in a post-crash fire.

The right wing of the Bearskin Metro, outboard of the right engine nacelle, and pieces of one of the Metro's propeller spinner and engine exhaust duct housing wrap were located on land in an area approximately midway between the two wreckage sites. The wing was cut through at about a 45-degree angle, consistent with the damage to the wing located at the Metro site. In this same area were numerous pieces of the Navajo's right wing and right aileron.
