AVIATION OCCURRENCE REPORT

CONTROLLED FLIGHT INTO WATER

**CANADA JET CHARTERS LIMITED
LEARJET 35 C-GPUN
MASSET, BRITISH COLUMBIA 8 nm NW
11 JANUARY 1995**

REPORT NUMBER A95P0004

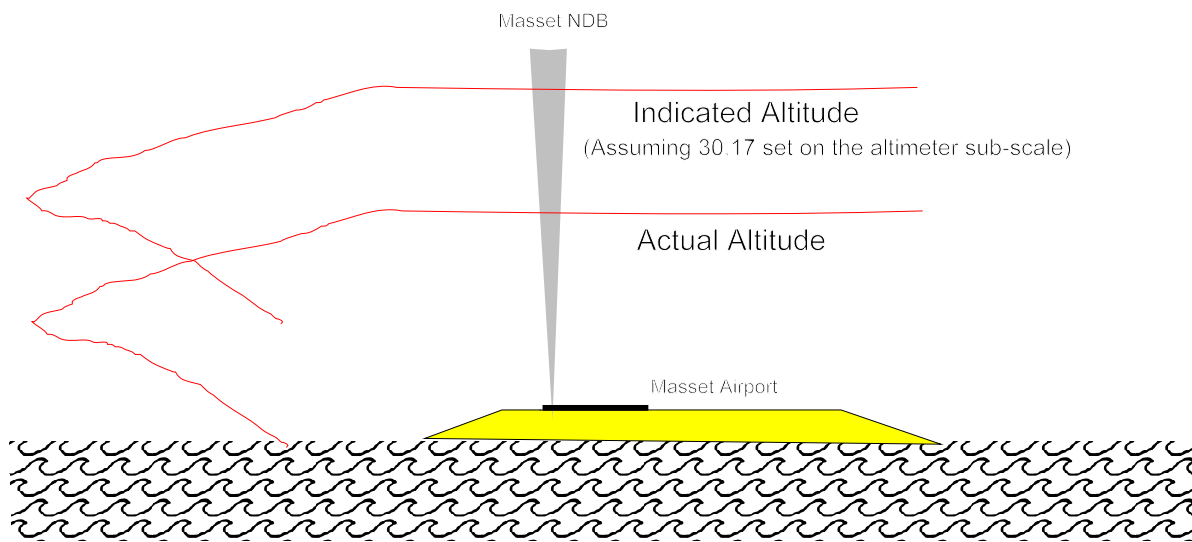
Appendix B - Altitudes Flown

The absence of any pre-impact aircraft deficiencies, the absence of any emergency call from the crew, the conscientiously flown instrument approach, and the aircraft attitude at impact as interpreted from the FDR all indicate that the pilot was in control of the aircraft when it struck the water. There are three possible explanations, none of which can be refuted with certainty, as to why the aircraft flew the whole approach with a consistent altitude error.

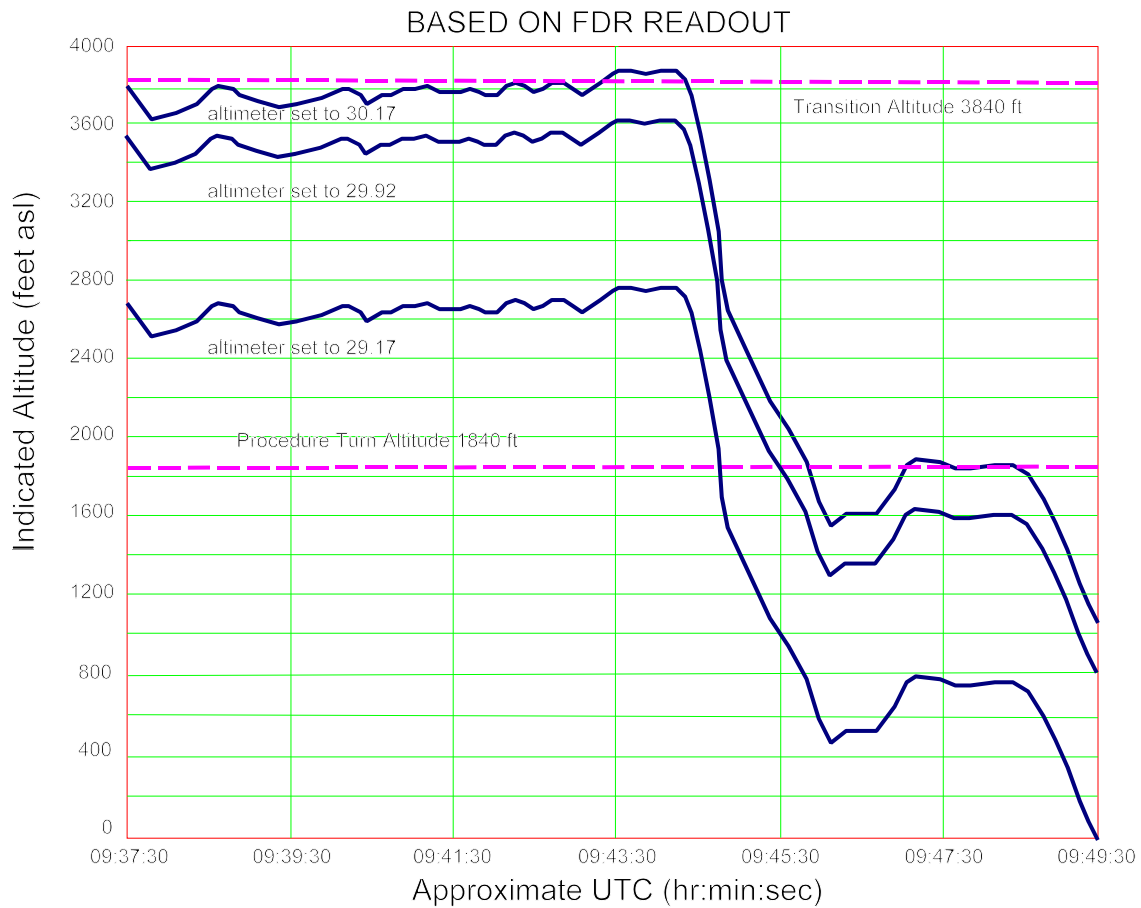
Appendix C - Indicated Altitudes

This is a representation of the last 12 minutes of the primary altitude trace from the FDR at 29.92 in. Hg, with the same altitude trace duplicated for two other pressure settings: 29.17 and 30.17 in. Hg. The trace marked "29.17" represents the true altitude of the aircraft above the water; the trace marked "30.17" represents what altitude the pilot would have seen on his altimeter had it been set to 30.17.
