AVIATION OCCURRENCE REPORT

A97Q0250

MID-AIR COLLISION

MASCOUCHE AIRPORT, QUEBEC

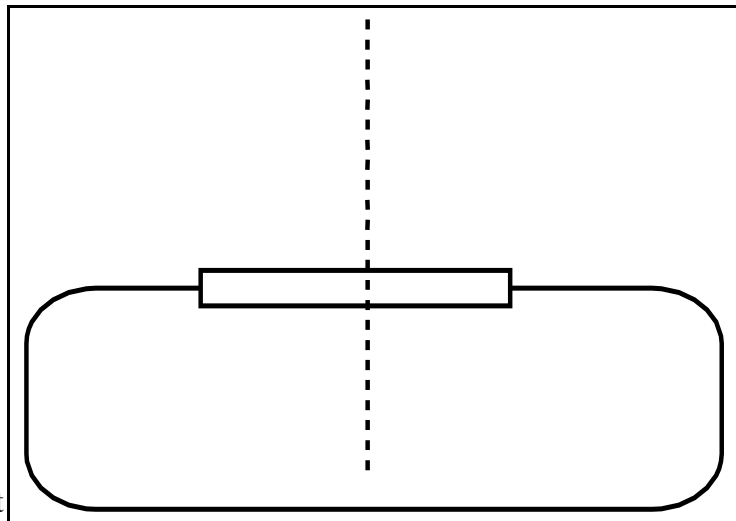
Both aircraft had joined a left-hand circuit for Runway 29 at Mascouche (meaning all turns in the circuit were to the left). Another aircraft, C-GADU, was preceding them, but it was on the ground, clear of the runway, by the time of the accident. The circuit is composed of several parts, as shown in Figure 1. The arrows on the upwind side indicate how aircraft can join this side from different directions before entering the circuit as such.
