AVIATION OCCURRENCE REPORT

UNSTABILIZED APPROACH/HARD LANDING

ALBERTA CITYLINK
BRITISH AEROSPACE JETSTREAM 31 C-FBIE
LLOYDMINSTER, ALBERTA
20 JANUARY 1998

REPORT NUMBER A98W0011

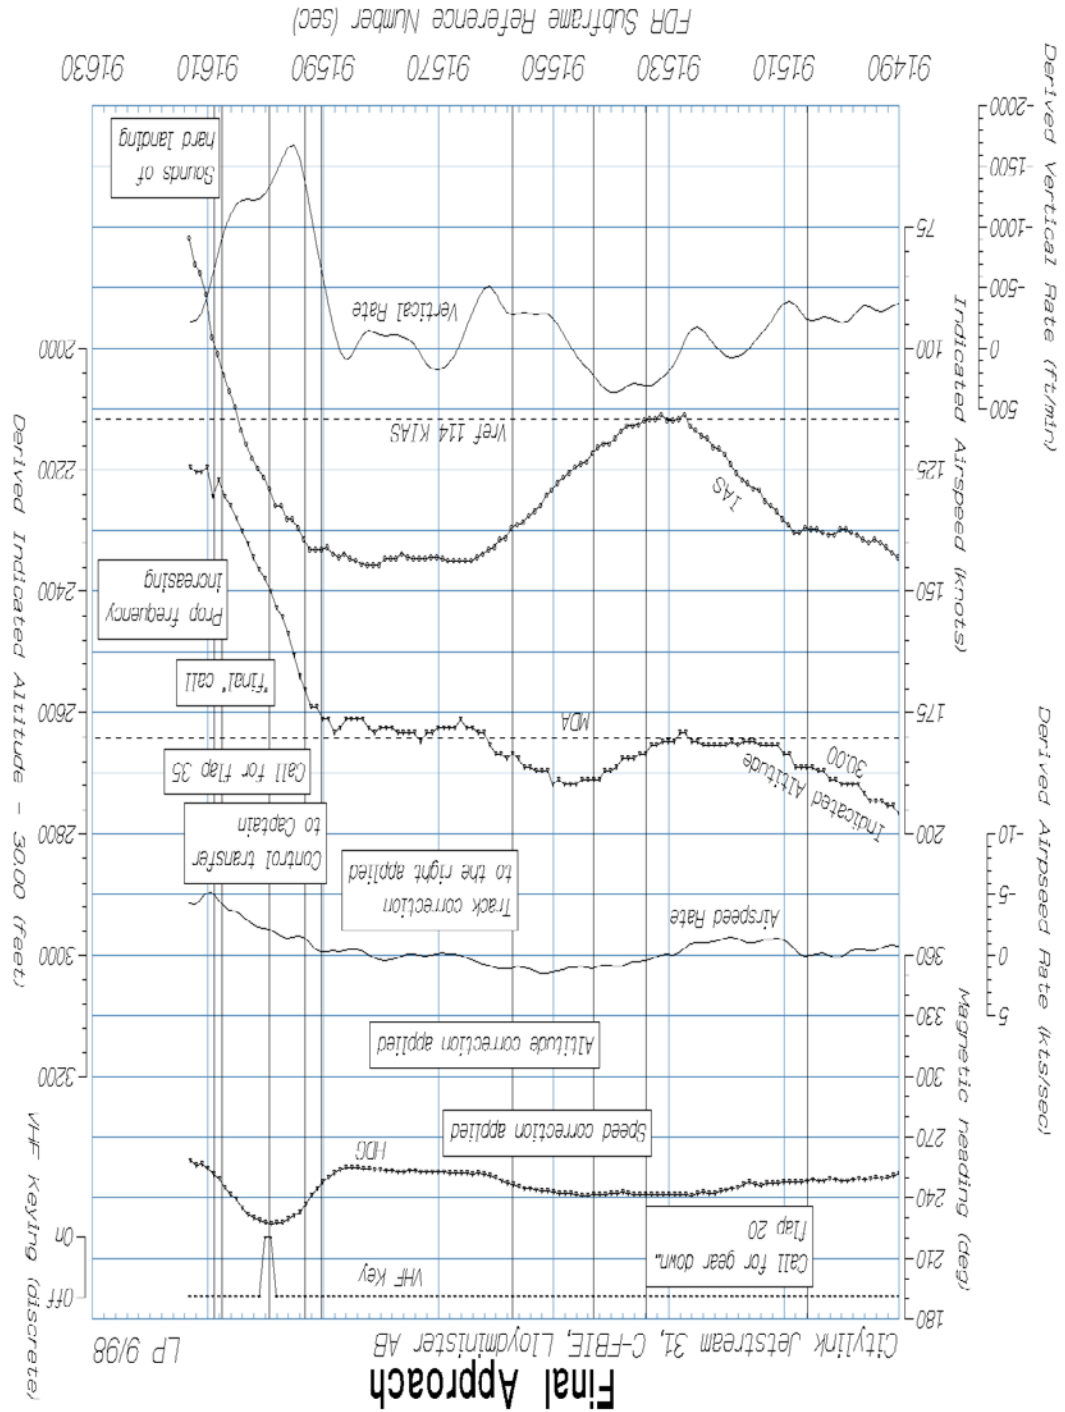
Appendix A - Plot of Approach and Landing

Following the crew's procedure turn inbound call, the FSS reported the latest wind conditions and surface visibility. The landing gear was lowered and the flaps were extended to 20 degrees as the aircraft levelled at the MDA of 2 640 feet asl, or 457 feet agl.

During the gear and flap extension, the speed decreased by 24 knots, from 138 knots indicated airspeed (KIAS) to the V_{ref} speed of 114 KIAS (Appendix A). The crew corrected for the decrease in speed, accelerating to 144 KIAS. During the acceleration, the aircraft briefly climbed approximately 70 feet, then descended back to the MDA.

Approximately three miles back from the runway threshold, and before visual contact was established, the aircraft was left of the inbound track. A track correction to the right followed, as evidenced by a 15-degree increase in heading. When the final descent to the runway commenced, the aircraft began to decelerate from 140 KIAS at an initial rate of 1.5 knots per second. The captain requested flaps 35; a high sink rate subsequently developed, reaching a peak of approximately 1 700 feet per minute (fpm) as the heading briefly reached about 230 degrees magnetic; the runway track is 253 degrees. Meanwhile, the rate of deceleration increased, eventually reaching 5 knots per second at the time of the hard landing. The first officer reported the flight on final when the recorded altitude, speed, and heading were approximately 200 feet agl, 129 KIAS, and 228 degrees, respectively. Following the FINAL call, the heading began to increase, suggesting a track correction to the right, and the descent rate reduced to approximately 1 200 fpm. Approximately 1 1/2 seconds

prior to the landing, the pitch of the engine/propeller sounds increased, indicating an increase in power. The descent rate was not arrested prior to touchdown, resulting in a hard landing with a high vertical deceleration of approximately 2.25 g, at 99 KIAS, and on the approximate runway heading of 252 degrees. The FDR stopped recording approximately four seconds after initial runway contact. The CVR continued to record until the power was shut off.
