AVIATION INVESTIGATION REPORT
A99H0005

OPERATING IRREGULARITY

de HAVILLAND AIRCRAFT DHC-8-100 C-GONN

AVIONS DE TRANSPORT RÉGIONAL ATR-42-300 C-FTCP

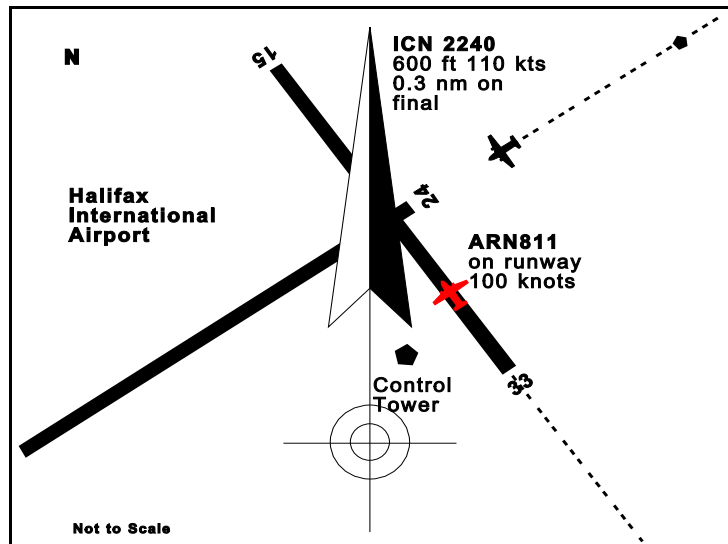
At 0726.56, the airport controller requested ARN 811, now 1.2 nm from the threshold of runway 33 and 1.8 nm from the intersection with runway 24, to land long if able, in an attempt to ensure that the aircraft would be clear of the intersection of runway 24 prior to ICN 2240 crossing the threshold for runway 24. The airport controller then advised ARN 811 that the other traffic was faster than expected and asked if the pilot could still hold short of the intersection of runway 24, but the pilot was unable to do so. ARN 811 landed and the pilot allowed the aircraft to slow without using reverse thrust or braking. The last radar target for ARN 811 prior to the intersection shows the aircraft on runway 33, 0.3 nm from runway 24 and travelling at approximately 90 knots.

Having decided that there was insufficient room to allow ICN 2240 to land, the airport controller instructed ICN 2240 to execute a missed approach. ICN 2240 was approximately 0.3 nm from the threshold of runway 24 (see Figure 1). The pilot acknowledged the instruction and in the same transmission requested permission to land on runway 24 beyond the intersection with runway 33. At 0727.23, the airport controller cleared ICN 2240
