AVIATION INVESTIGATION REPORT

A99P0108

MIDAIR COLLISION

CESSNA 177RG CARDINAL C-GWYY

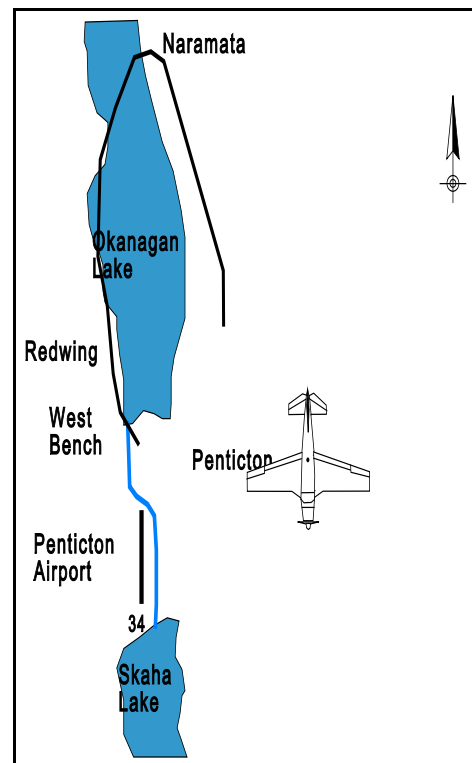
As the aircraft flew south along the west shoreline, witnesses reported that it flew by the Redwing subdivision and the West Bench area at a low altitude, close enough for people on the ground to see the people inside. A witness viewed the aircraft from the east and described the flight profile to be below the level of a landmark on the hillside. The landmark is about 400 feet above the elevation of the airport. Near the southwest corner of Okanagan Lake, abeam the West Bench area, the aircraft entered a left turn. This turn took the aircraft on a southeasterly heading parallel to and north of a section of the canal that passes through the city and connects Okanagan Lake with Skaha Lake on the south side of Penticton. On this heading, the flight path intersected the departure path of runway 34, close to the Penticton non-directional beacon (NDB).

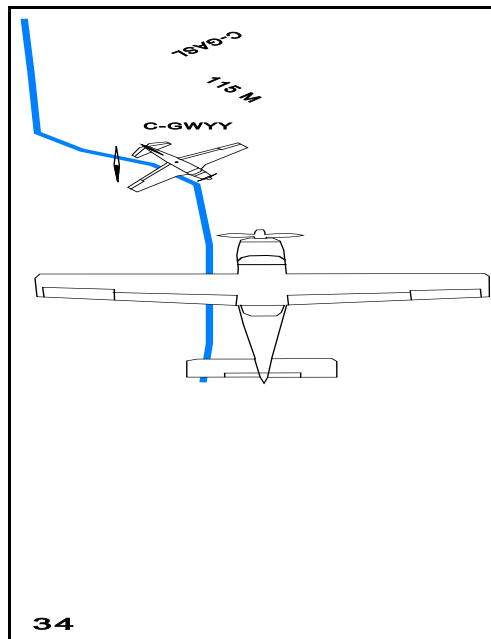
1. The Cessna departed runway 34. The wind was calm. The aircraft maintained the runway heading of 340°M. The recommended climb speed range is 85 to 100 knots. The landing gear was retracted, and the flaps were extended to 9°. The propeller rotates in a clockwise direction when viewed from the pilot's seat.

- The Mooney was flying on a heading of 115°M at the point of collision, based on a heading of 340°M for the Cessna and the initial propeller strike angle of 45° to the leading edge of the right wing of the Mooney. Scratches on the bottom of the severed right wing section form an angle of about 18° clockwise from the longitudinal axis of the aircraft, which forms one side of the angle as viewed from above. This angle indicates the combined collision vector of the two aircraft. A diagram of the same vector, constructed by connecting the two measured propeller strikes in the right wing, forms an angle of 16° .
