MARINE INVESTIGATION REPORT

M00C0019

GROUNDING

CHEMICAL TANKER *SUNNY BLOSSOM*

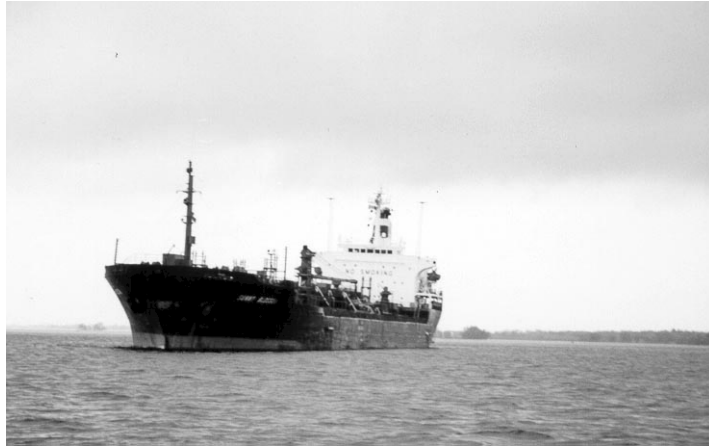
The apprentice pilot observed that the heading markers of both radars were approaching 280° G and advised the pilot accordingly. The pilot went to the radar, commented on the poor radar performance and immediately ordered the OOW to reduce speed from about 7 kn to the dead slow ahead speed of 5 kn. The vessel continued to swing to starboard across the channel. There is conflicting information as to what helm orders were given. One account maintains that there was no time to give helm orders, whereas another account maintains that a series of port helm orders was given. At 0730, the chemical tanker grounded upstream of buoy D36, on the north side of the channel, on a heading of 274° G. The vessel was aground starboard side to the shoal with a list to port of 2.5° (see Appendix A, Photo 1).

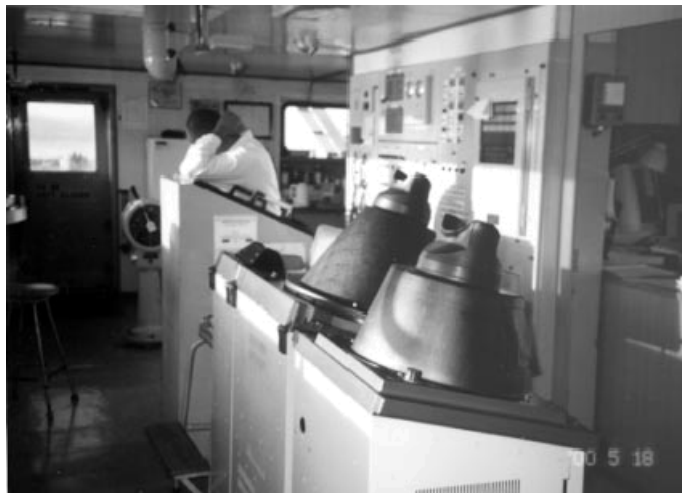
The vessel was fitted with an electronic chart system (ECS). It had been installed on the chart table console, abaft the steering station, the vessel having a traditional bridge layout with chart table in the after part of the wheelhouse (see Appendix A, Photo 2).

The ECS installed on the *Sunny Blossom* was not calibrated with the on-board global positioning system (GPS) and was, therefore, not available for safe navigation. Both the crew and pilot were aware of this, and it was not used during the course of the voyage.

The watch officers had not received training, and did not appear to be proficient in the use of the ECS. They had instituted an informal in-house training routine among themselves. Arrangements had been made to have the system re-calibrated when the vessel arrived at Cornwall. Therefore, the ECS was not being used as a primary source of navigation information.
