MARINE INVESTIGATION REPORT

M00C0026

STRUCTURAL FAILURE

BULK CARRIER *ALGWOOD*

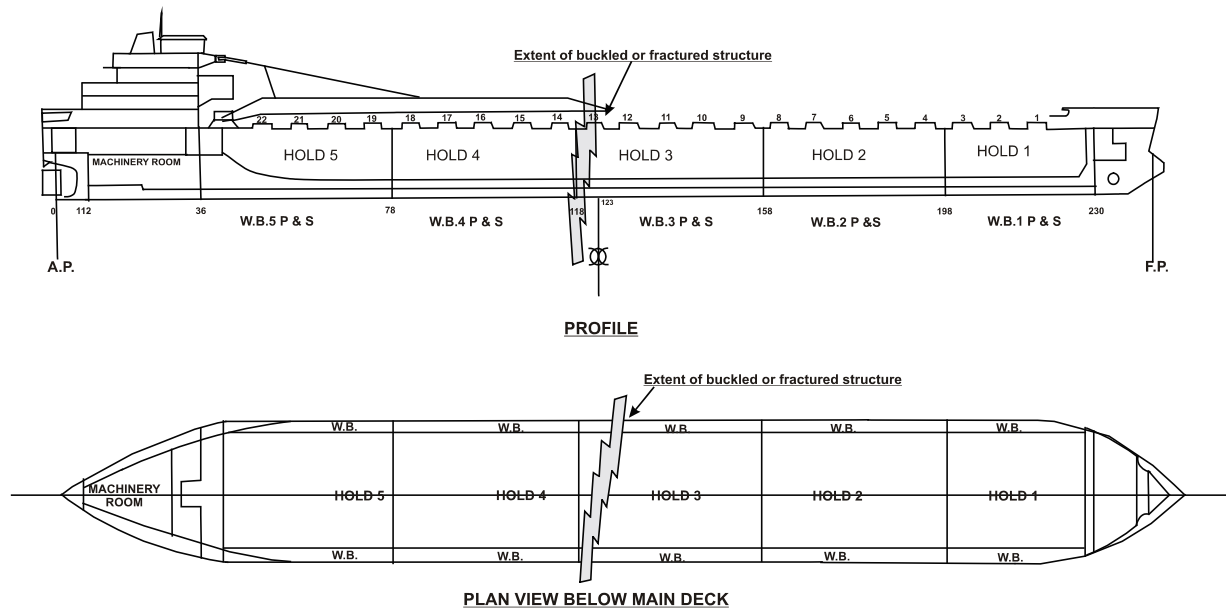
The *Algowood* experienced a sudden, major structural hull failure, the location, nature, and extent of which are shown in figures 3 and 4 and photographs 1, 2, and 3. Damage surveys, carried out when the vessel was alongside at Bruce Mines, revealed extensive buckling and distortion on the deck (see Figure 4) above waterline P & S shell plating with localised buckling and tensile fracturing of the side shell and of the P & S ballast tank hopper<sup>6</sup> side.

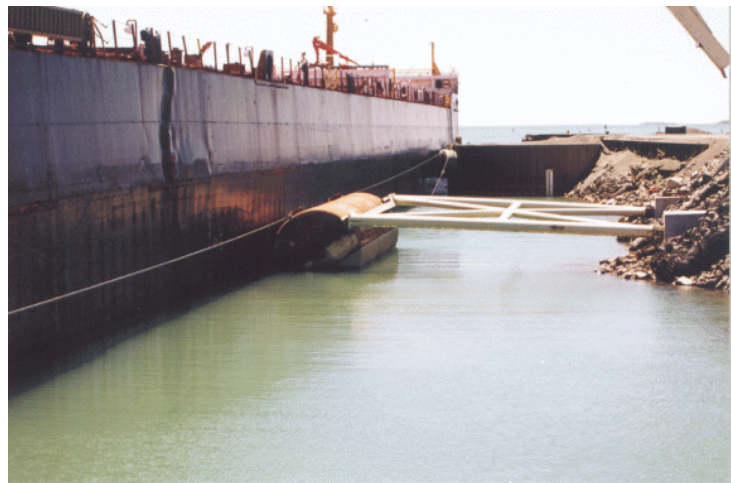
Inspection while in dry dock revealed structural buckling and extensive fracturing from the turn of the bilge<sup>7</sup> to the bottom shell<sup>8</sup>, P & S, inner bottom, and P & S ballast tank hopper side plating in way of the transverse bulkhead between frames 117 and 119, between holds nos. 3 and 4 (see Photograph 2). The inspection in dry dock also revealed other deformations, distortions, and localised fractures in the forward and after sections of the bottom shell plating. These were caused by the vessel contacting and settling on the bottom during the occurrence.

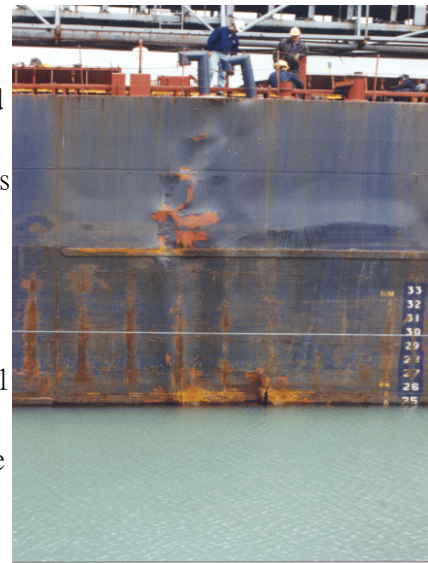
On 18 July 2000, while the vessel was in dry dock for a damage survey and before the start of permanent repairs, material thickness was gauged ultrasonically by the TSB and shipyard personnel to determine the current thicknesses of principal structural members in the frame spaces immediately forward and abaft the major hull failure. This survey included measurements taken in a band around the vessel in way of frames 117 to 119.

Gauge readings at each of these locations generally showed wastage of 1 to 7 per cent in the shell, bilge, keel, and bottom structural members. There was a mean thickness reduction of some 13 per cent in way of the tank top plating. None of the recorded material thickness wastage readings exceeded accepted limits at which replacement of the material would be required.

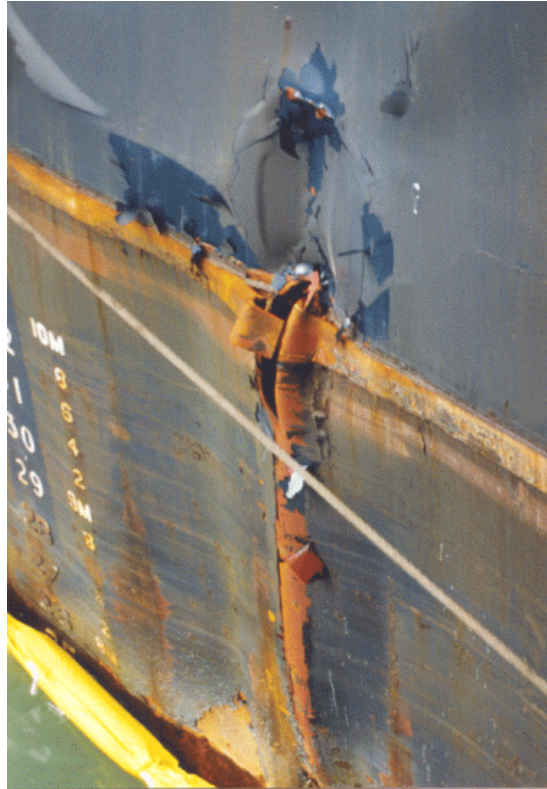
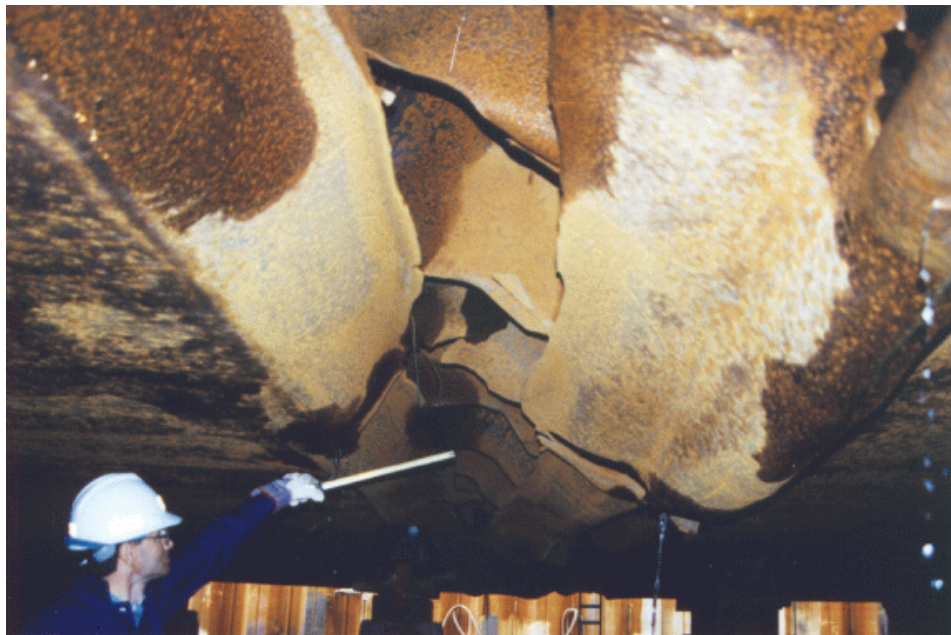
Post-occurrence calculations of the still water bending moment<sup>10,11</sup> (SWBM), imposed on the *Algowood* when partially loaded at Bruce Mines, were made to determine the magnitude and nature of bending stresses<sup>12</sup> incurred by the steel structure in way of the hull failure.

These calculations confirmed that, immediately before hull failure, the vessel was subjected to a hogging/bending moment about 2.3 times the maximum permissible (sea going). A hogging/ bending moment puts the main deck plating in tension and the bottom structure in compression. The hogging condition, induced at the time of the occurrence, was due to the excess of weight over buoyant support at the ends of the vessel.
