MARINE INVESTIGATION REPORT
M00H0008

FOUNDERING

FISHING VESSEL *AVATAQ*
WESTERN SHORE OF HUDSON BAY
25 AUGUST 2000

Report Number M00H0008

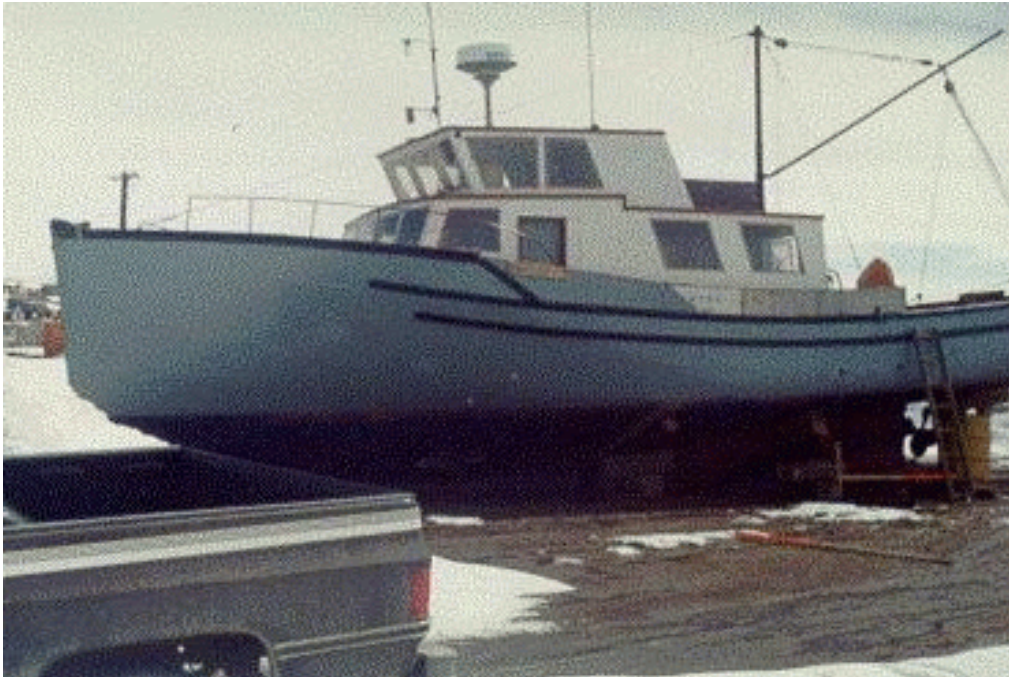
The *Avataq* was a small fishing vessel of open construction, with forward accommodation and wheelhouse (Figure 1). Two flush, non-watertight hatches were inset into the afterwelldeck. The hull was constructed of moulded glass-reinforced plastic (GRP) and stiffened by 19-mm plywood bulkheads spaced 82 cm apart. Some of these bulkheads had been removed to accommodate cargo below decks. Deck beams consisted of 10-cm-by-10-cm spruce overlaid with a 2.5-cm plywood deck. The afterdeck was drained by two threaded 7.6-cm scuppers on each side. An aluminum skiff was carried secured to the foredeck.

Little is known of the stability characteristics of the *Avataq* when heavily loaded, with little residual freeboard. The design to which the *Avataq* was built is such that the space below deck was subdivided into a number of small compartments by transverse bulkheads. As a result, the *Avataq* carried most of its bulky, heavy cargo lashed on the deck. As demonstrated on a previous voyage during which the vessel nearly capsized, when loaded with 15 823 kg of cargo in this manner, the vessel's centre of gravity would have risen to a point where the vessel had little margin of stability. When fully loaded, the vessel's freeboard was 40 cm. The scuppers were therefore below the waterline, and barrel plugs had been screwed into them to prevent water from flooding the afterdeck.

Although this arrangement prevented water from backflooding the afterdeck, it also caused the vessel to retain any water shipped on deck. When the *Avataq* encountered heavy seas south of Arviat, it began to ship water on the afterdeck. Without watertight hatches, some of the shipped water would have downflooded into the hull; however, most would have been retained on the afterdeck. Whenever water is shipped and retained on deck, a free surface effect effectively reduces stability by causing a rise in the virtual centre of gravity. The free surface effect of the shipped water retained on the afterdeck probably reduced the vessel's already marginal transverse stability characteristics, causing the *Avataq* to heel, downflood, and sink.
