MARINE INVESTIGATION REPORT

M00M0083

UNCONTROLLED DESCENT OF FREIGHT ELEVATOR

FREEZER TRAWLER *MERSEY VENTURE*

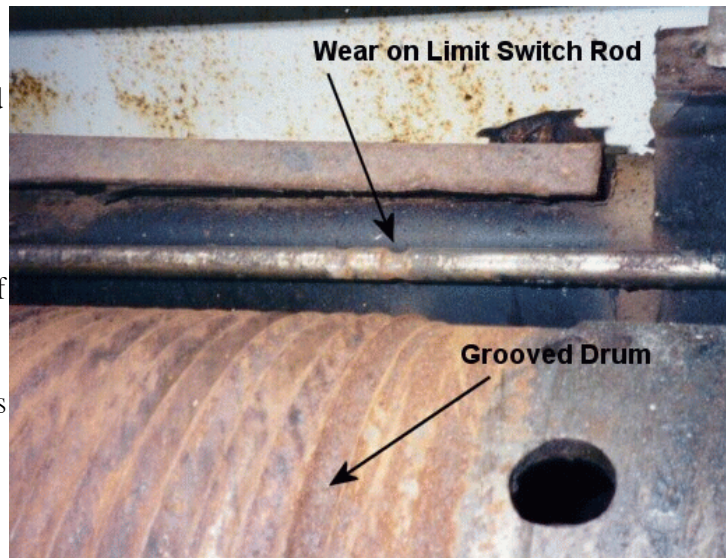
The general appearance of the drum, at the time of the occurrence, indicated the rope hoist had not been maintained to the standard required for this type of hoisting machinery. The wires in the suspension systems and drum were rusted in places and without lubrication. Experienced elevator mechanics, familiar with this type of unit, cite the lack of lubrication on the rope guide as a possible cause of wire nipping. There are no maintenance records for the rope hoist. It was not possible to determine exactly what, if any, preventative or ongoing routine maintenance was done.

Firstly, when the hoist is being operated, the rope guide moves in an axial direction along the rope drum, following the movement of the load rope and ensures that the rope is laid accurately in the rope drum groove. With the rope guide removed, the wire rope is not consistently or accurately laid in its groove on the rope drum. The wire rope can jump grooves and cause riding turns.

Firstly, the wire rope was not accurately laid in the rope drum grooves, causing riding turns of the wire and a slack wire.

In addition to crushing the rope, riding turns result in an uneven load distribution between the two ropes and therefore across the drum. Riding turns of the rope on the right-hand side of the drum resulted in contact between the moving cable and the limit switch rod. Wear on the rod indicates that riding turns had occurred for a significant period of time. When so overwrapped, the starboard wire rope took all of the strain caused by the loading of the platform while the port wire was relatively slack. The effect of the starboard wire overwrapping and taking the entire load strain also caused the load cell measurement to be inaccurate.

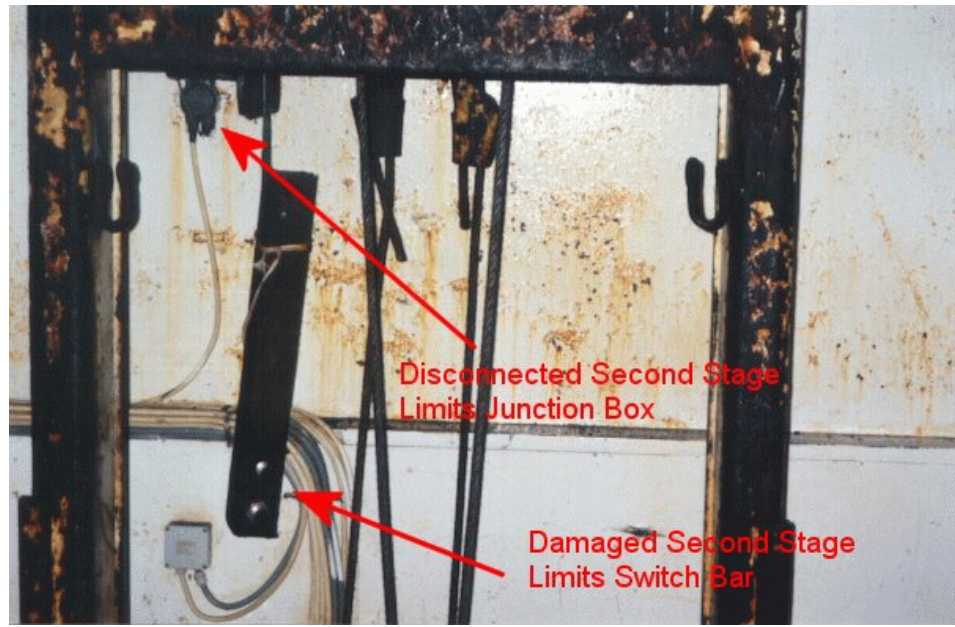
At the time of the occurrence, the proximity switches had been disconnected. The angle iron bar was suspended on a length of nylon twine, such that when the platform was at the upper terminal and level with the factory deck, the bar would strike the top of the cross piece adjacent to the port side sheave on the platform. In this configuration, the bar was being used as a visual cue for the operator to stop the platform by releasing the 'up' push button switch.

Experience shows that magnetic proximity switches are prone to failure under severe operating conditions. When in normal operation, the platform cycles between the heat and humidity of the factory deck and the minus 30°C temperature of the hold, causing ice and frost to build up on the exposed metal surfaces of the elevator. When the elevator was

repaired and placed back in service after the occurrence, five of the six proximity switches installed in the system at the time of the occurrence were inoperative or missing and required replacement. Both proximity switches in the upper final stage limits were replaced.

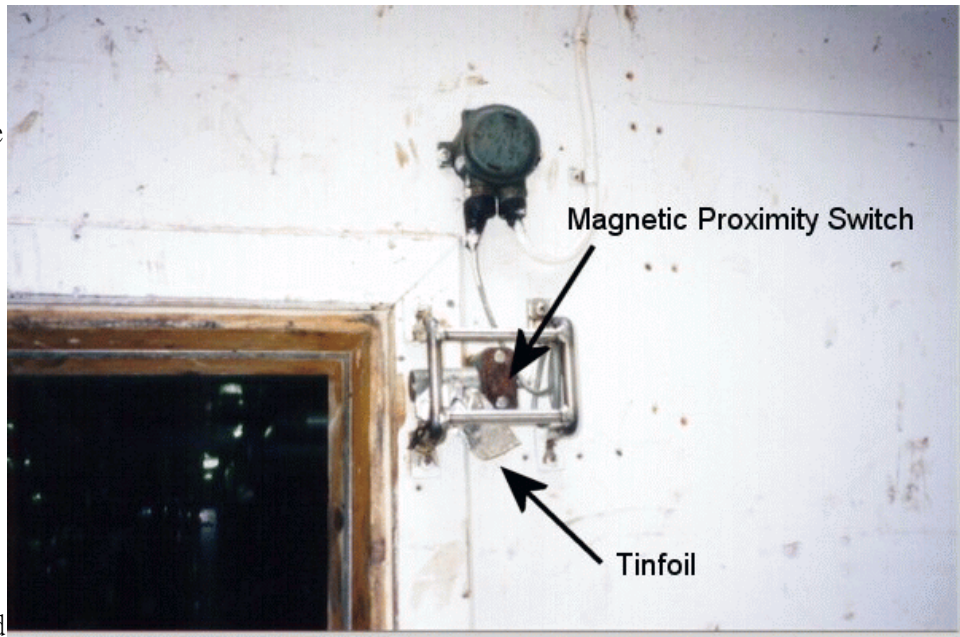
The elevator hoistway at the factory deck level is enclosed on all four sides. A door to enter the hoistway is located on the after bulkhead of the hoistway. A proximity switch is installed to prevent operation of the elevator with the door in the open position. Although not causal, it was discovered by NSDL-OSH division during the initial investigation that a piece of tinfoil had been folded around the sensor,

defeating the proximity switch and allowing the elevator to operate in an unsafe condition. This became an accepted routine situational adaptation done to allow easier access to the elevator hoistway.

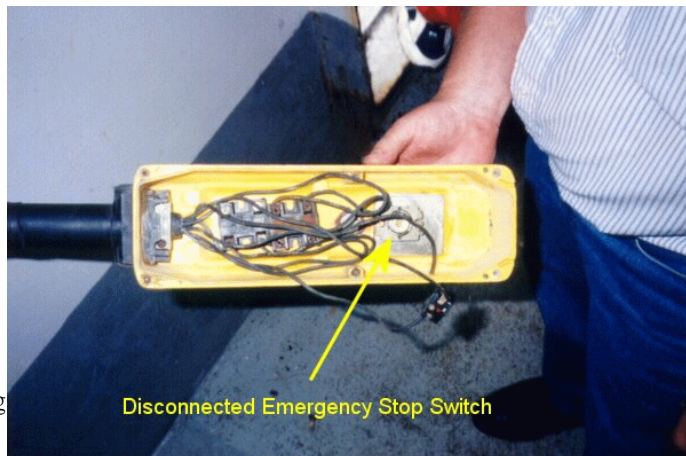
The elevator is operated from the factory deck level using a wander lead (or pendant) with three spring-loaded control buttons: raise, lower and emergency stop. To raise and lower the elevator platform, the operator must push and hold the buttons as required. The elevator platform will travel in the desired direction, stopping when the operator releases the button. The elevator can be stopped at any point along its travel between the two terminals. Activation of the emergency stop on the wander lead has the same effect as opening one of the limit switches and is fitted to counter the failure of one of the raise/lower buttons also located on the lead.

Earlier in the year, the stevedores had experienced some problems with the wander lead and temporary repairs were effected. Upon examination by NSDL-PSD, it was discovered the emergency stop button on the wander lead was not connected. It was not however, causal in this occurrence.
