MARINE INVESTIGATION REPORT

M00W0265

ACCIDENTAL RELEASE OF LIFEBOAT

BULK CARRIER *PACMONARCH*

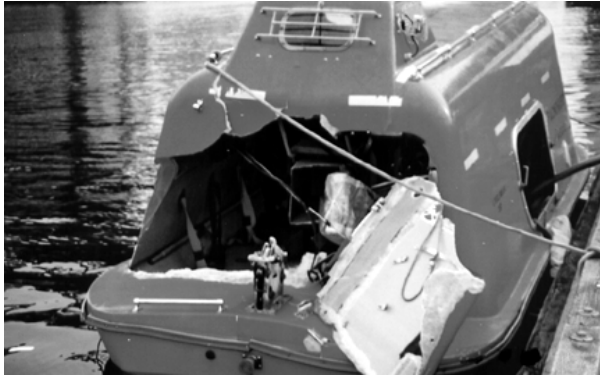
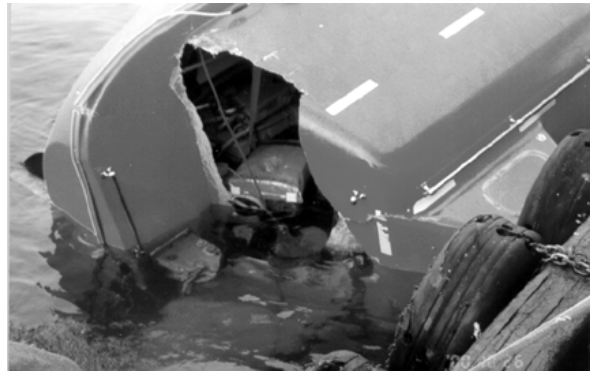
The impact with the water caused considerable damage to the stern of the lifeboat, with most of the damage concentrated around the canopy. The vertical panel was pushed inward, and the glass-reinforced plastic was torn right through. During rescue operations, divers further cut this torn opening and folded back the entire vertical panel, giving them unhindered access to the inside of the lifeboat (see Photograph 14, 15).

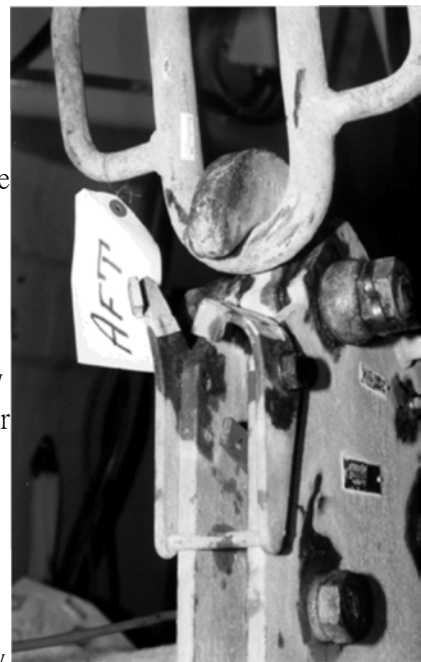
Inside the lifeboat, the coxswain's chair and the frame of the central release control assembly were attached to the after bulkhead. The chair's support frame was badly buckled and broken and the control assembly frame's brackets were found to be completely broken off. The horizontal part of the canopy (onto which the after hook assembly, the towing bracket, and the other attachments were fixed) was bent upward. Portions of the canopy were torn and bolts securing the canopy to the hull were also broken. Other internal damage consisted of bent rudder linkages, holding-down brackets, and holding-down frames.

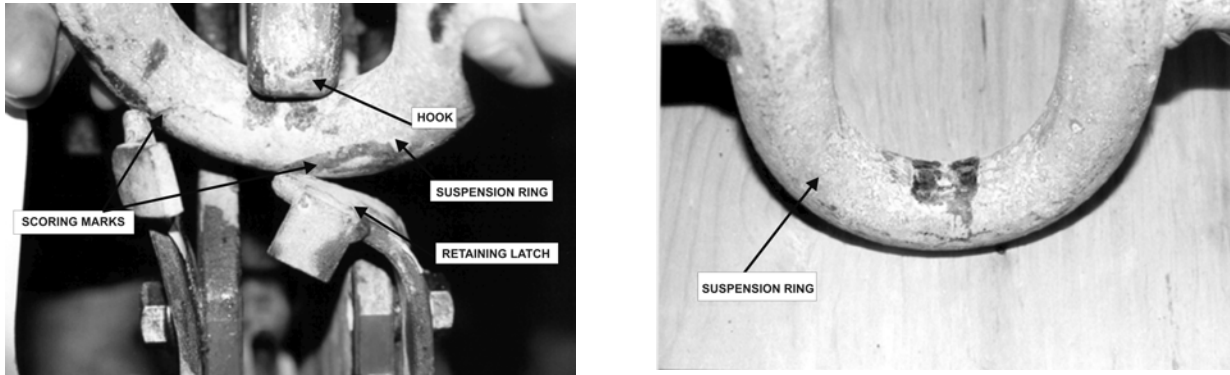
The retaining latch on the after hook assembly was damaged in such a way that its two vertical forked arms were both bent sideways and outboard of the lifeboat (see Photograph 16). The after hook was not damaged, but had scoring marks on its inside surface in the area that comes

in contact with the suspension ring. The after suspension ring was not damaged but did have two small scoring marks on the outside bottom surface in an area that comes in line with the forked arms of the retaining latch (see Photograph 17).

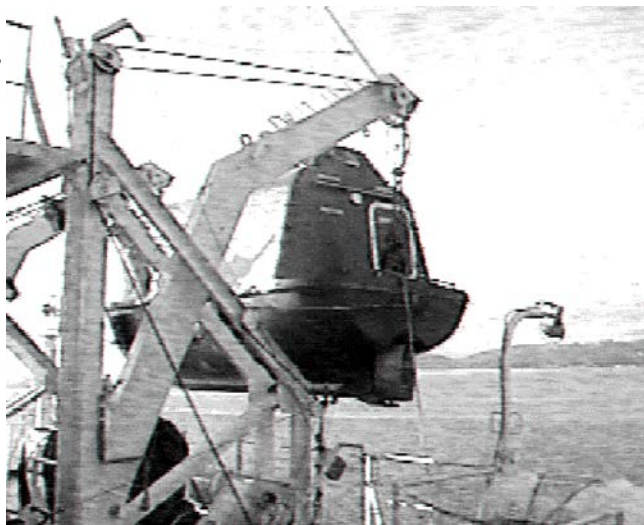
During the initial part of the launch sequence, the davit's luffing action toward the ship's side causes the lifeboat to swing outward. As the davit draws away from its support frame, it creates an ever increasing gap between itself and the rigid frame. This gap frees the rotating lever, to which the davit end of the gripe is hooked, and allows the lever to turn and release the gripe.

The lifeboat's outward motion creates tension in the gripes, which in turn creates angular velocity in the free end of the gripe. The free end of the gripe falls, causing the gripe to loop around the bollard on the lifeboat and, as the relative distance between the free end of the gripe and the bollard reduces, the angular velocity of the free end increases.

By the time the davits have reached an angle of about 60° , the end of the gripe has gained so much velocity that the gripe wraps itself around the bollard. Since the other end of the gripe is fixed to the deck, the gripe is forced to immediately and violently unwrap itself as the lifeboat

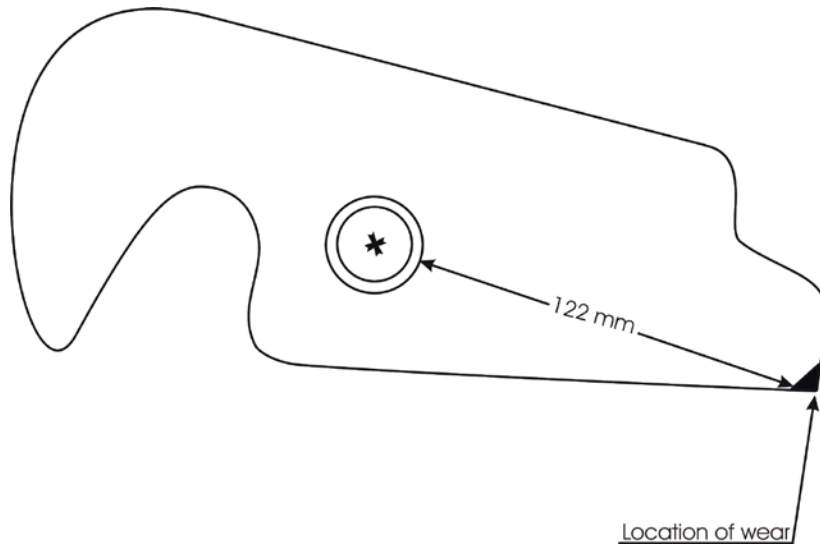
The load-transmitting contact surface on the hook wears with use, reducing the length from the end of its load-transmitting surface to the circumference of its pivot. According to the manufacturer, this minimum distance is 122.0 mm. A shorter length can lead to two effects, both potentially detrimental:

- a) The contact line between the hook and the blocking lever will shift away from the blocking lever. Since this face of the blocking lever has been given a relief angle of 18° , the hook could eventually slip past the blocking lever, rotate, and release the applied load.

Although this length on the after hook was found to be around 121.8 mm (0.2 mm below specification), the design had an adequate factor of safety, and there is no indication that this hook ever slipped past its blocking lever. However, the lifeboat and its hook assemblies were only about a year old, and the lifeboat itself had only been launched about four or five times. This use is not considered sufficient to have caused appreciable wear.

Minimal wear was found on this surface and the original radius was intact. The manufactured length from the end of the hook's load-transmitting surface to the circumference of its pivot was therefore 121.8 mm. Because the equipment was new and the wear minimal, this length is a deviation from the designed profile and indicates a manufacturing nonconformity.
