MARINE INVESTIGATION REPORT

M01L0129

STEERING GEAR FAILURE AND SUBSEQUENT GROUNDING

THE BULK CARRIER *CEDAR*

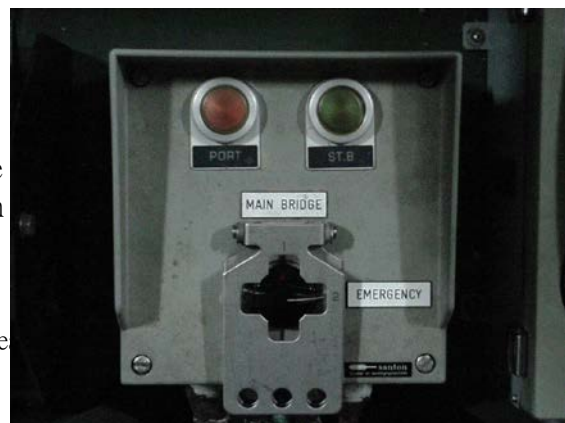
Shortly after the grounding, the ship's electrician went to the steering gear flat and isolated the steering gear control from the wheelhouse using the emergency remote control transfer switch (Figure 3). He then tried the rudder from the emergency steering position using the NFU push buttons on either side of the switch. The rudder responded normally

During the course of the investigation, a loose wire was found within the emergency remote control transfer switch in the steering gear flat (Figure 3). This wire was the low voltage control signal to the starboard servo power unit DCV solenoid for port rudder activation. Other wires within this switch were also found loose. The wires exhibited signs of being crimped with a tool other than a proper crimping tool.

1. Servo power unit hydraulic piping was changed for steel pipes, properly bent and sized. The piping was also fitted so as to forego any welding or braising.
2. Main power switches for both port and starboard servo power units were changed for more robust switches.
3. Single telemotor use was instigated by installing a selector switch on the bridge and decoupling activation of each servo power unit from its respective main steering gear pump.
4. Port and starboard servo cylinder bypass valves were re-installed in an appropriate fashion.
5. Hydraulic servo power unit plans were drawn up and filed on board.
6. All loose connections within the steering flat emergency remote control transfer switch were properly crimped and secured.

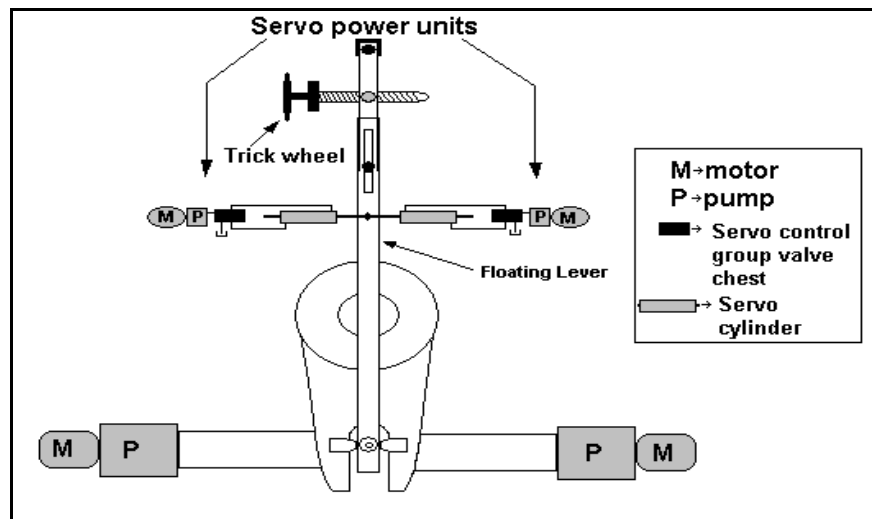
receivers. Each telemotor receiver consists of a servo power unit and cylinder. The servo cylinders are mounted axially opposed to each other and connected to the floating lever at a common point (Figure 4).

The servo power units and their associated electrical arrangement were supplied by the shipyard. Each unit comprises an electric motor, hydraulic pump, control group valve chest as well as connecting hydraulic pipe. The control group valve chest of each servo power unit includes a solenoid-operated directional control valve (DCV) and a hydraulically-operated servo cylinder bypass valve. The DCV solenoid receives a low voltage (24 V dc) control signal from the telemotor transmitter. The servo cylinder bypass valve is held in the bypass condition by a spring when system pressure is zero (servo pump off). When the servo pump is activated, the

pressure builds up and overcomes the spring's force, closing the bypass and hydraulically locking the associated servo cylinder.

After the grounding it was found that, although both port and starboard bypass valves were in place on the control group valve chest of each servo power unit, they had been incorrectly installed (spring for spool valve on same side as servo pump pressure).⁵

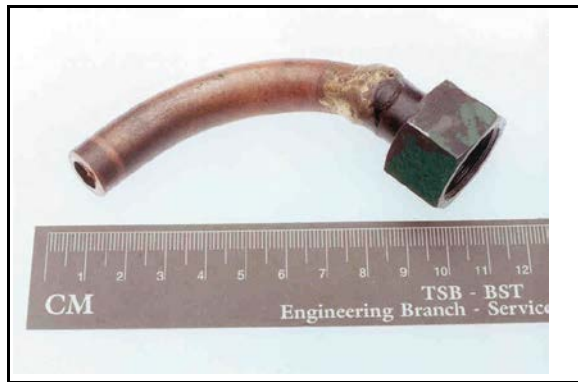
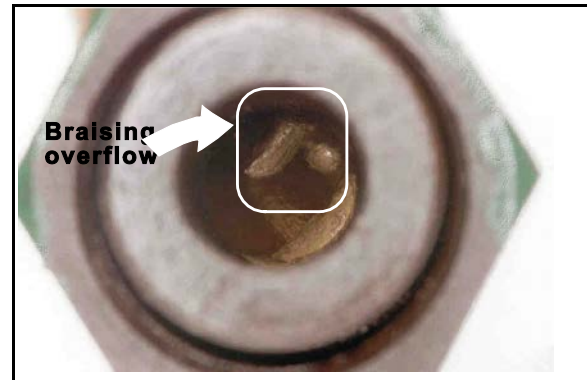
When installed at the shipyard, the connecting piping of the servo power units was copper. The piping connections were installed using direct braising methods and simple butt joints (Figure 5). Joints contained much excess braising material on the exterior, and the one examined in detail during the course of the investigation showed an overflow of braising material into the internal bore (Figure 6). It is estimated that the obstruction would restrict flow to about 70% of the design rate.⁸ Bends in the piping were unsymmetrical and flattened at points to the extent that, during repairs subsequent to the grounding, TCMS required all servo power unit piping be replaced with steel piping, properly bent, fitted, and sized.

- servo cylinder bypass valves improperly installed;
- inadequate crimping of wire connections;
- no detailed plan available for the servo power unit system;
- bending, fitting and braising work for the servo power unit's hydraulic piping less than adequate (although not a factor in the grounding).

5. The quality of workmanship, the material used and the method of bending and connecting the servo unit hydraulic piping of this new ship were substandard. These defects were neither remarked upon by the vessel's classification society nor corrected by shipyard quality control.

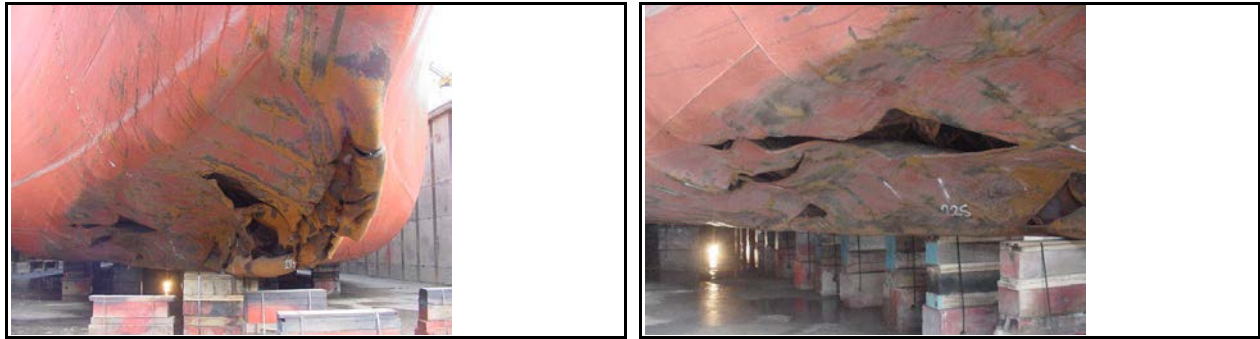
The forepeak and No. 1 starboard double bottom ballast tanks were punctured between frames 216 and 235 (approximately 12 m in length) running from the keel plate to the starboard bilge. The shell plating in way of damage was set in approximately 600 mm. The duct keel plate in way of frames 175 to 185 was also set in. Other bottom plates were set in as far astern as frame 151 and affected tanks 1 P, 2 P&S, 4 P&S, 5 P&S, and 7 S.

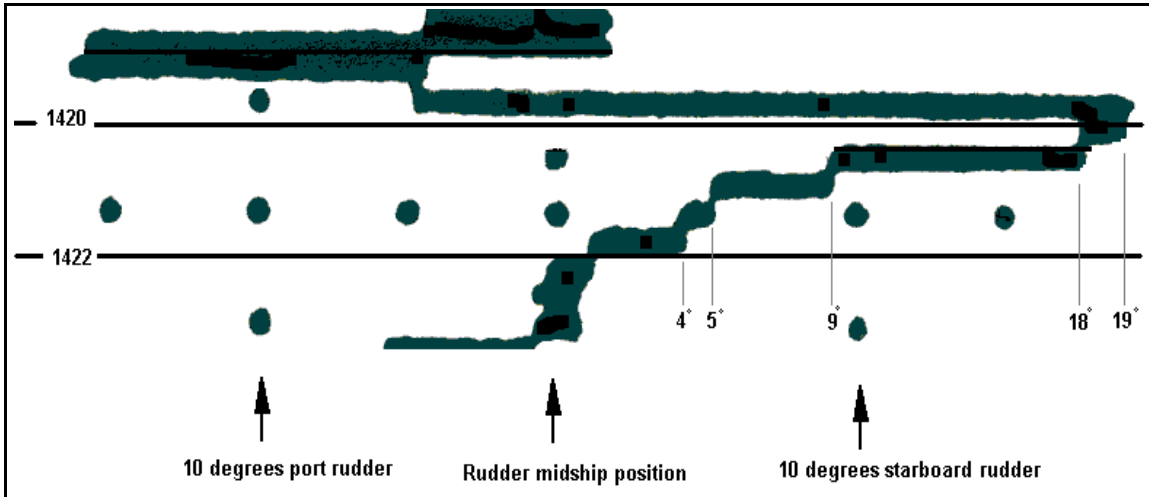
unit DCV solenoid. Between 1420 and 1422, port helm was applied in an attempt to stop the vessel's swing to starboard. An analysis of the recorded rudder movement shows that the rudder replied to the port helm commands in brief bursts (Figure 9). This would indicate intermittent performance of the rudder which is consistent with an on/off activation of the DCV solenoid for port helm, most probably caused by a loose wire alternately making contact and then losing contact.

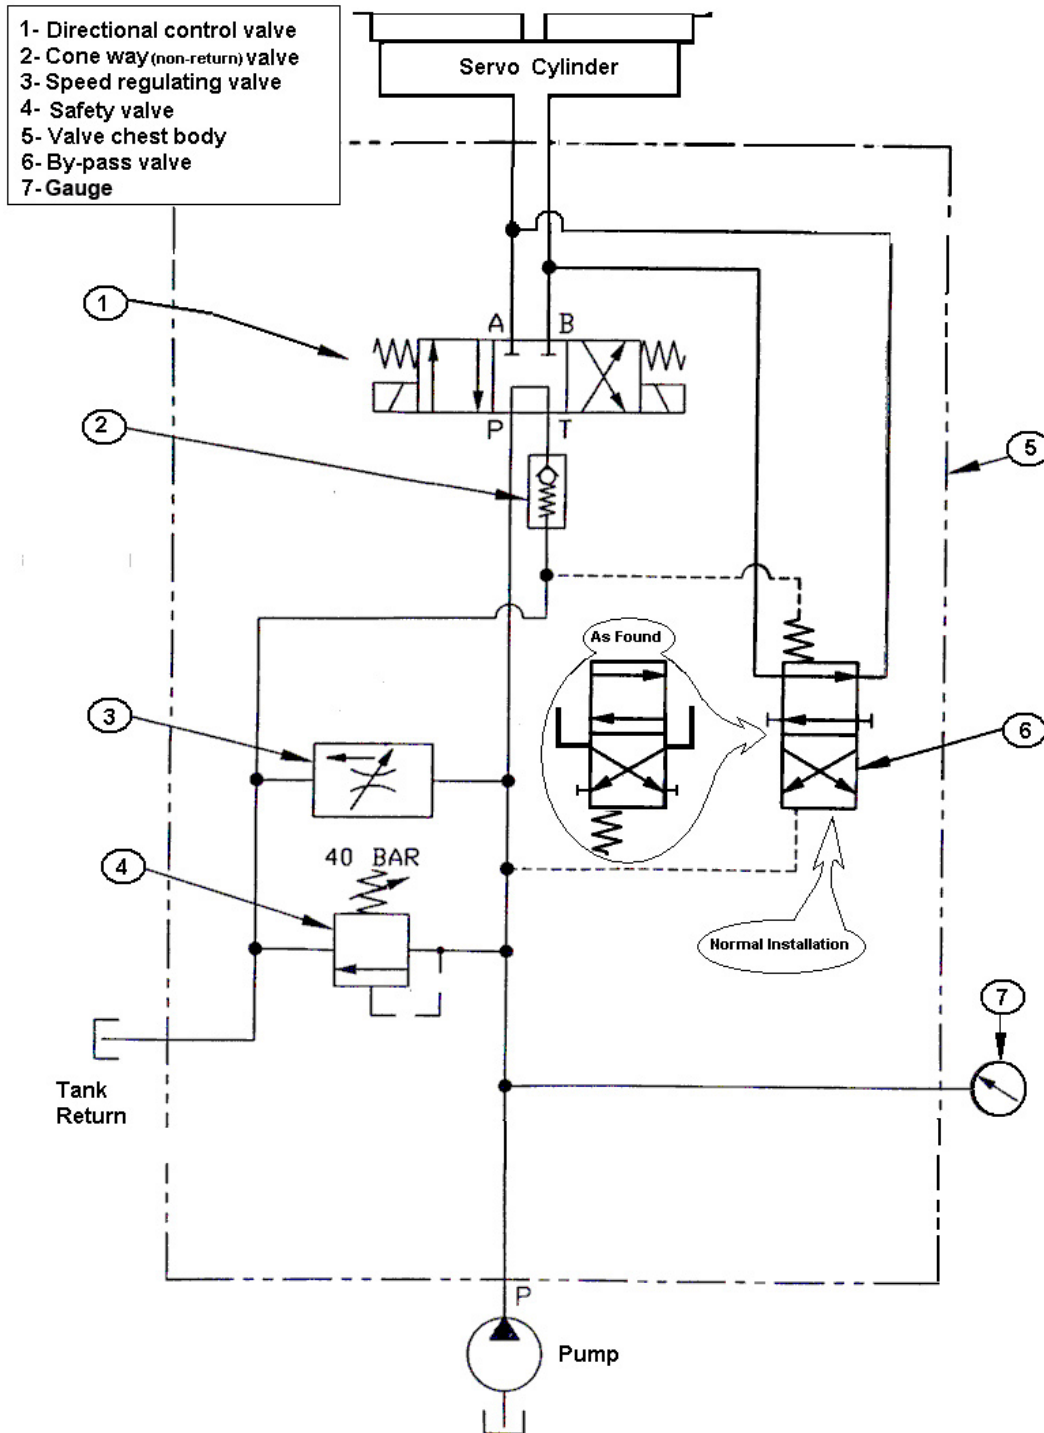
Appendix A - Servo Control Group Valve Chest

Trick wheel operation is necessary in the event of servo power failure. Incorrect installation of the servo power unit bypass valves on the *Cedar* meant that even when the servo pumps were off (or not functional), the associated servo cylinders were still hydraulically locked instead of in the bypass condition. In order for the trick wheel to operate the floating lever under these conditions, it would now require the extra step of decoupling both servo cylinders from the floating lever.

The installation of the port and starboard servo power units did not conform to the plans submitted to LR. Specifically, these units did not have a functional hydraulic bypass arrangement for the servo cylinders. As noted, both port and starboard DCV solenoids are normally activated during steering operations, even if only one servo power unit is in use. The DCVs had thus acted as *de facto* bypass valves and had concealed the inappropriately installed servo cylinder bypass valves when only one servo power unit was being used. A malfunction of (or lack of control signal to) the DCV solenoid of either servo power unit, regardless of whether one or both units were in use, would create a hydraulic lock. The incorrectly installed servo cylinder bypass valves were not a factor in the grounding but under other circumstances, such as with only the port servo power unit in use, it could well have become one. Also, the mis-installation would have repercussions in the event that the vessel was steered using the trick wheel.

Even though the port servo power unit was in operation, it could not overcome the starboard servo cylinder that was in hydraulic lock (positive servo pump pressure but DCV in the neutral position due to lack of control signal). This effectively rendered the steering gear inoperable, without an accompanying alarm. Redundancy, while intrinsically a good thing, must be properly applied within a system in order to serve its intended purpose.
