MARINE INVESTIGATION REPORT

M01M0100

SWAMPING

SMALL FISHING VESSEL *ALAIN-JOSÉE*

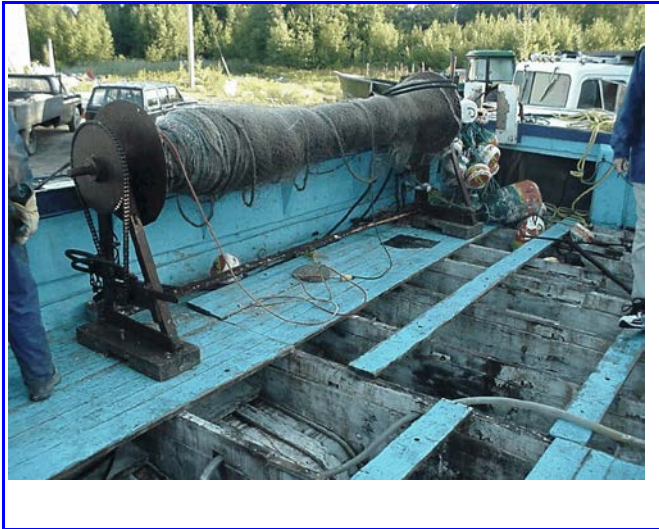
A hydraulic net drum winch is located along the starboard gunwale where the empty gill-nets are launched and set (see Photograph 2). The loaded nets are then retrieved over the port side and across the well deck, where the herring is systematically shaken from the net onto the open deck. The emptied net is then stowed on the drum, ready to be launched again. Several gill-nets may be set during the course of a fishing cycle.

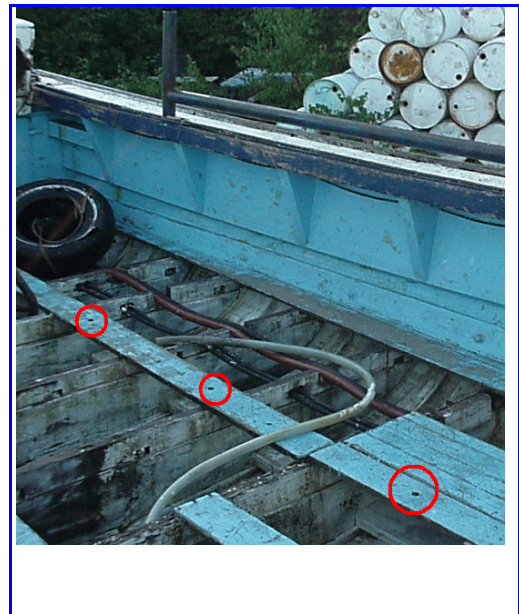
Water which accumulates on deck while fishing is drained into the bilge through holes in the well deck planking (see Photograph 3). The $\frac{3}{4}$ inch holes, distributed at intervals on the well deck, are considered, from experience by the owner/operator, to be adequate to drain water encountered during normal fishing operations.

The deck drainage system may work adequately when handling lobsters or shellfish. During the occurrence, with a dense load of herring on deck, the fish covered the small and widely spaced drain holes. This prevented a large quantity of shipped seawater from getting down to the bilges, where it could be pumped out.

1. The *Alain-Josée* carried an excessive load of herring on the open deck after fishing during worsening weather conditions.
2. The vessel had a low freeboard, and water shipped over the stern combined with the unpenned fish on deck, caused the vessel to become unstable, list to starboard and be swamped.
3. The drainage system was not adequate for clearing water from the open well deck when loaded with bulk herring.

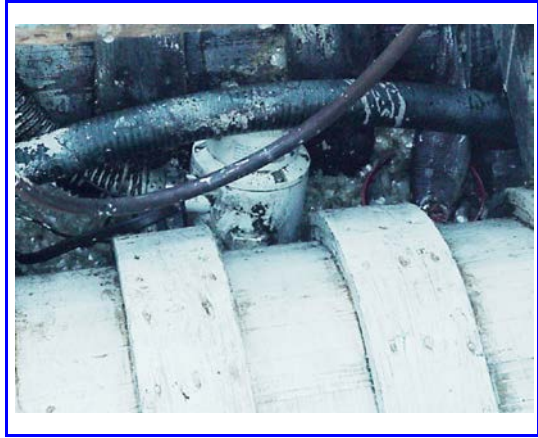
Drained bilge water is normally pumped over the side by an electric, automatic, submersible bilge pump, model "Rule 3700GPH" (see Photograph 4). It is installed aft of the main engine, secured near the bottom of the hull at one side of the propeller shaft tunnel.

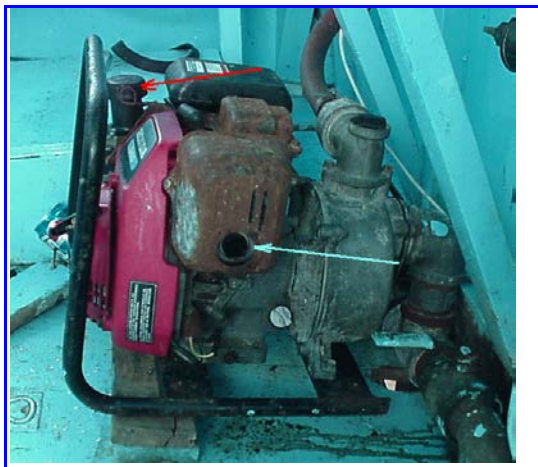
When the electric bilge pump cannot cope with the inflow of water, a gasoline-powered pump, model Honda WN20, located in the wheelhouse, is used to pump the bilges of excess seawater (see Photograph 5a). One side of the lifting cradle for the once-portable Honda pump had been removed and the unit is wedged tight onto the deck, inside of the rear bulkhead of the wheelhouse. The pump's gasoline engine exhausts directly into the wheelhouse, where fuelling of the unit by hand also takes place. This poses the risk of

asphyxiating the operator conning the vessel and/or causing

a fire within the compartment.

1. The gasoline-operated bilge pump exhausted into the wheelhouse and the fuel filling spout was also within the compartment.
2. The gasoline-driven pump is of a type not recommended for use with sea water.
3. Owners of Cape Island type fishing vessels may be unaware that loading heavier catches, with corresponding decreases in freeboard, may place the vessel in a condition unfit for its intended purpose.
4. The crew was not wearing lifejackets.

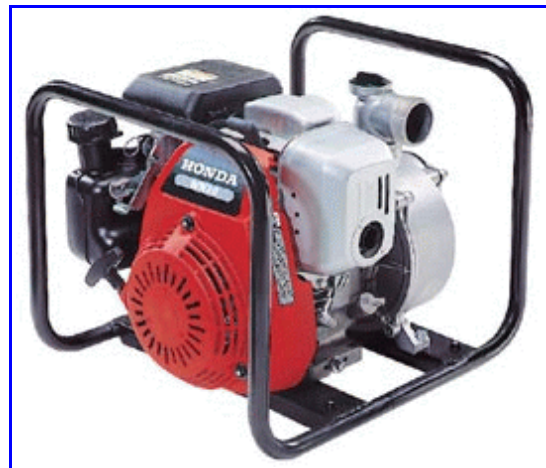
Honda portable pumps (see Photo 5b) have given rise to safety issues in the past, as referenced by TSB investigations M97M0005 and M97N0099.³ Due to their dissimilar metal components, and galvanic corrosion problems, these pumps are not recommended for use with sea water. A Ship Safety Bulletin (SSB 98-04) was issued by TC relating to the suitability of portable pumping equipment for the marine environment. The owner/operator reported having heard of Ship Safety Bulletins, but had never received one.

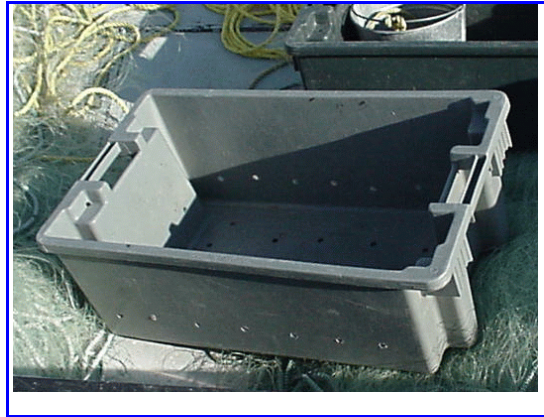
Of the 9 tonnes of herring brought on board the *Alain-Josée*, only 7.5 per cent of the total catch was contained in secured fish boxes (see Photograph 6). The bulk of the herring (8.4 tonnes) was loose on deck, free to move as the vessel pitched and rolled. Unlike some other open-decked herring boats, the deck of the *Alain-Josée* is not equipped with portable wooden pen boards, which are slid into vertical stanchions attached to the deck and at the perimeter of the well deck. These pen boards are arranged such as to divide the well deck both longitudinally and transversely into small penned areas to contain the catch, thus dramatically reducing the movement of the herring on deck. Had such an arrangement been used on the *Alain-Josée*, it would have increased the vessel's stability and improved its behaviour at sea.

At a very low freeboard of about 30 cm, the vessel had poor stability and little reserve buoyancy. The free movement of fish, worsened by shipped sea water over the well deck, threatened to capsize or founder the vessel.

The water on deck combined with the herring to form a fluid deck load, rendering the *Alain-Josée* unstable. When the vessel broached after the first wave, the fish moved to the starboard side, causing the vessel to list and allowing more waves to wash over the starboard rail and swamp the vessel.
