MARINE INVESTIGATION REPORT

M01N0020

FLOODING AND SINKING

SHRIMP FACTORY FREEZER TRAWLER *FAME*
120 NAUTICAL MILES NORTHEAST OF
BELLE ISLE, NEWFOUNDLAND AND LABRADOR
19 APRIL 2001

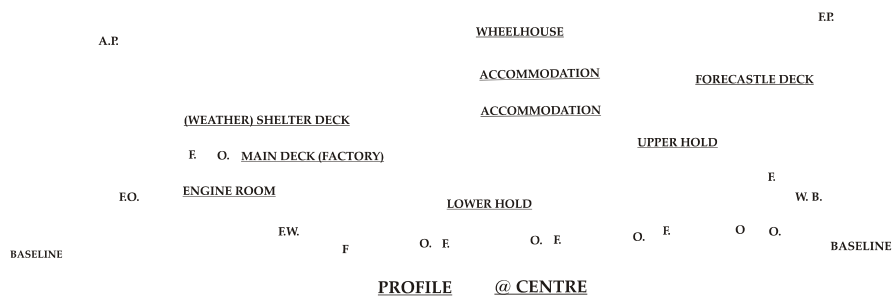
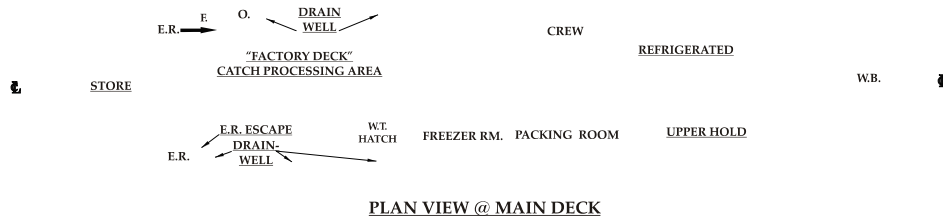
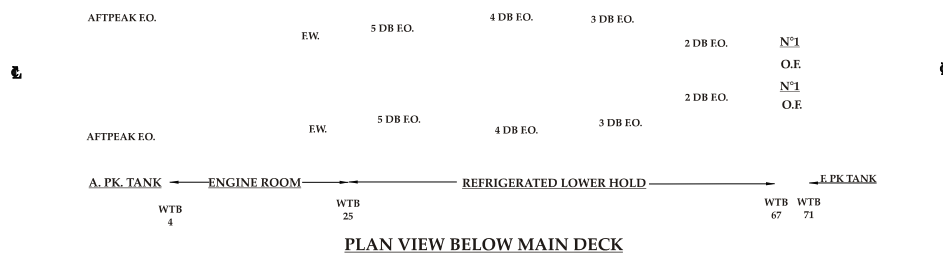
OUTLINE GENERAL ARRANGEMENT

The location of the engine room, decks, watertight hatches, oil fuel, water ballast, and freshwater tanks, refrigerated upper and lower holds, shrimp-processing areas, and crew accommodation, etc. were as shown in the Outline General Arrangement (see Figure 1).

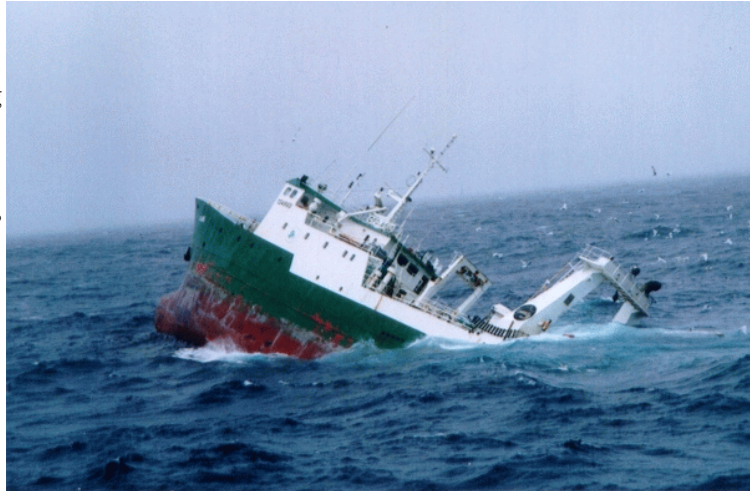
As the trim by the stern increased, the shipped water downflooded over the coaming of the door in the engine room port side casing and immediately gravitated to the starboard side of the engine room of the heeled vessel. The accumulation of water in the engine room further increased the after trim and angle of heel, and continued until the after starboard quarter of the weather deck became completely immersed (see Photograph 2).

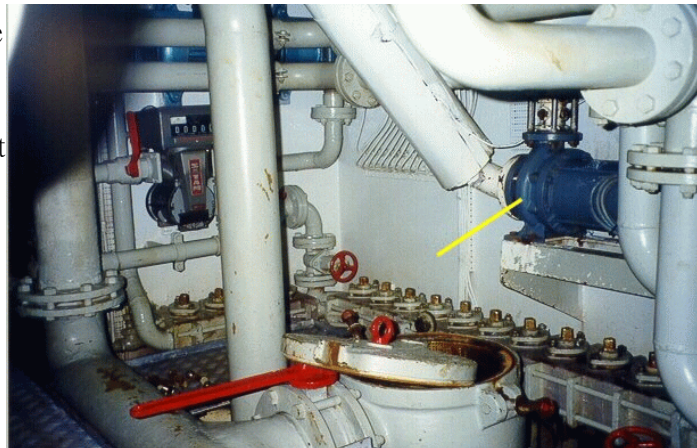
According to the two engineers who entered the engine room several times after the blackout, the only piece of equipment noted to be damaged was the standby (starboard) refrigerant pump. The pump was reported as having disintegrated or exploded. Although the pump was not in service at the time of the failure, its isolation valves were still open and when the pump failed, the entire charge of refrigerant was free to escape to atmosphere.

As the vessel sank, the starboard liquid refrigerant pump was not recovered and the cause for its failure could not be determined. No photograph is available of the pump. Photograph 3 (taken before the occurrence) shows the similar port liquid refrigerant pump.

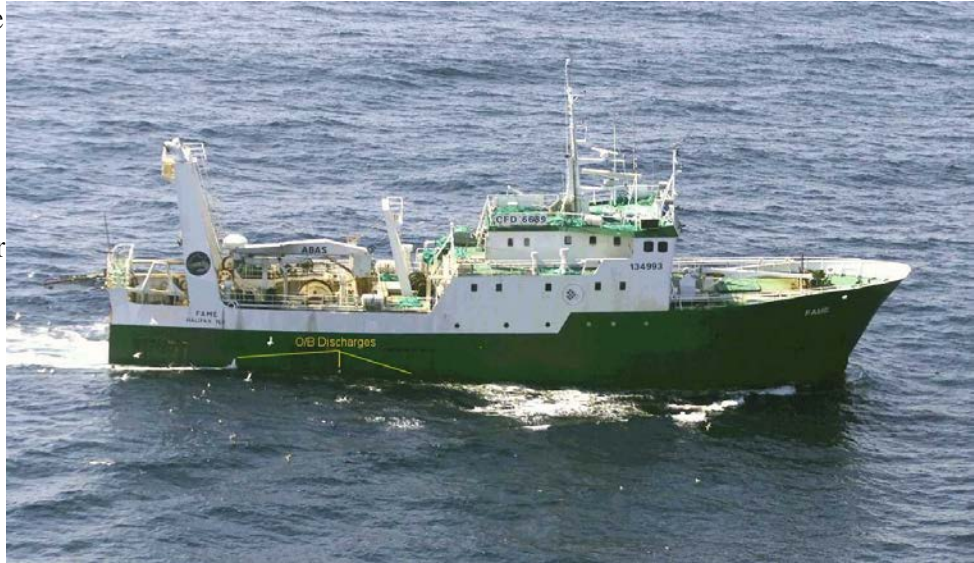
In the absence of any record of damage to the wave gate drain, offal, turbot fishing, and galley waste chutes closing devices or any other structural hull failure affecting the watertight integrity of the vessel, the most likely source of the ingress of seawater onto the factory deck was through one or more of the overboard discharge valves in the starboard side shell plating of the factory tween-deck.

After pumping power was lost, it is likely that entrained discarded fish material and other waste debris remaining in the piping system, settled and became lodged in the non-return discharge valves, causing them to malfunction. The absence of anti-syphon loops in the pump discharge piping inboard of the shipside valves, would also have contributed to the ingress of seawater through the valves onto the factory deck.

The overboard discharge valves were located above the factory deck and relatively close to the operating waterline such that, while the vessel was in calm water and heeled 3° or 4° to starboard, the valves remained above sea level. This trimmed and heeled condition was maintained for some 13 hours after the initial loss of pumping power, and would indicate that the vessel did not ship any significant amount of water throughout that period.

As the wind and seas increased, so did the rolling motion of the vessel. When heeled by the wind and rolling approximately 10° to starboard, the valves were at or just below the trimmed waterline (see Photograph 4), and became more deeply submerged as the two metre high wave crests passed along the side of the immobile vessel. The repeated immersion of the partially obstructed and ineffective discharge valves, together with the loss of electrical power to the pumps, initiated the continuous and accelerating rate of ingress of seawater through the valves onto the factory deck, which ultimately led to the loss of the vessel.
