MARINE INVESTIGATION REPORT

M01W0253

FOUNDERING

SMALL FISHING VESSEL *KELLA-LEE*  
QUEEN CHARLOTTE SOUND, BRITISH COLUMBIA  
25-26 OCTOBER 2001

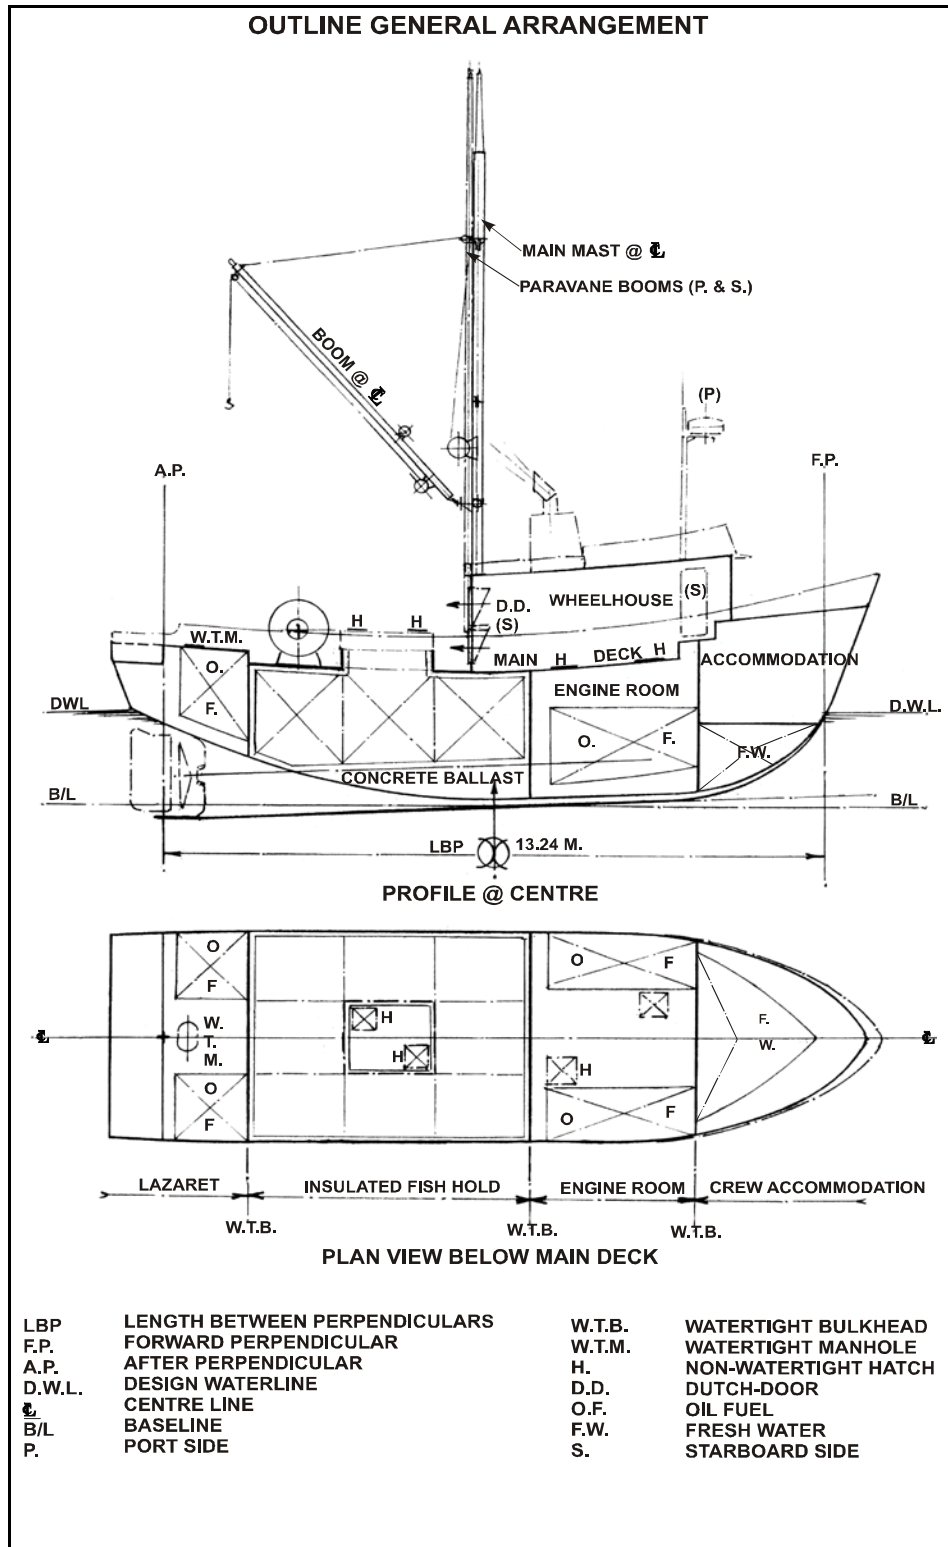
Appendix A – Outline General Arrangement of Kella-Lee

Below the main deck the hull was sub-divided by three transverse watertight bulkheads into the following compartments: forward crew accommodation space; engine-room; fish hold, and lazarette space (see Appendix A).

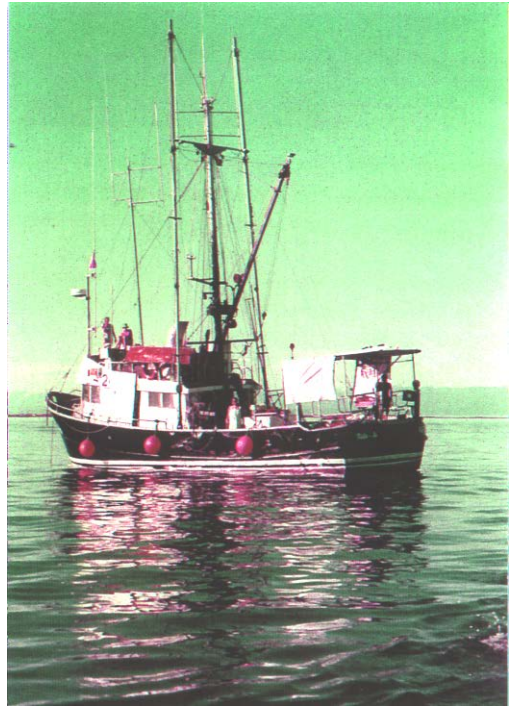
*Appendix C - Photographs*

The *Kella-Lee* - after deck looking aft
