**MARINE INVESTIGATION REPORT  
M02C0030**

**SINKING AND LOSS OF LIFE**

**AMPHIBIOUS PASSENGER VEHICLE *LADY DUCK*  
OTTAWA RIVER  
NEAR THE HULL MARINA  
GATINEAU, QUEBEC  
23 JUNE 2002**

Report Number M02C0030

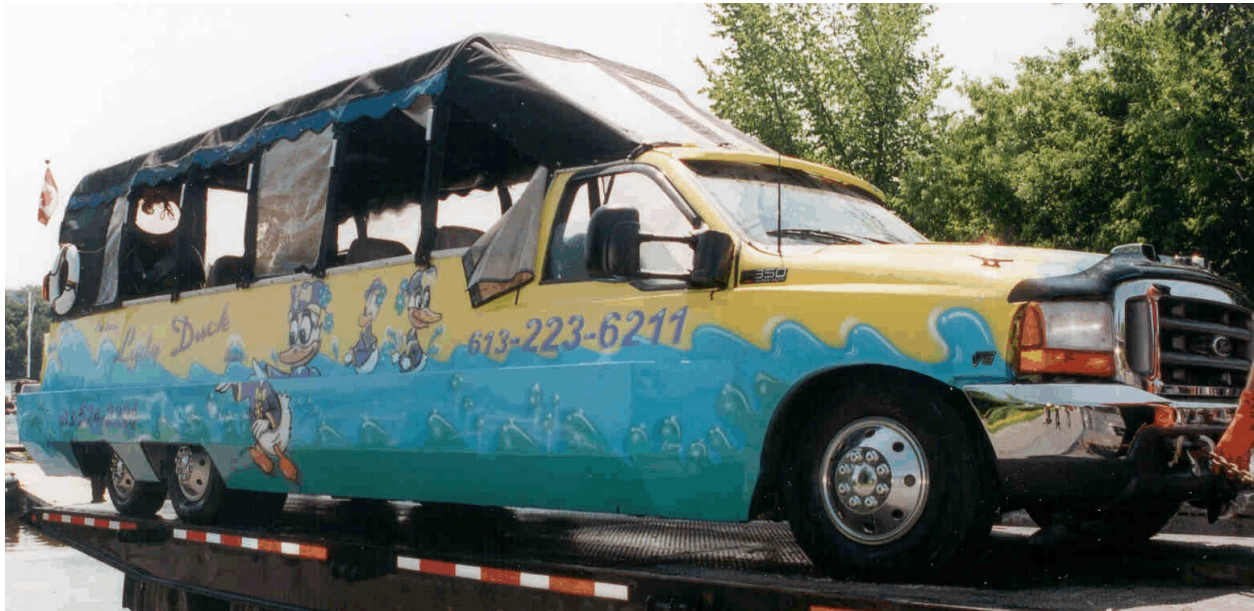
Photo 1. Lady Duck after recovery at the Hull Marina

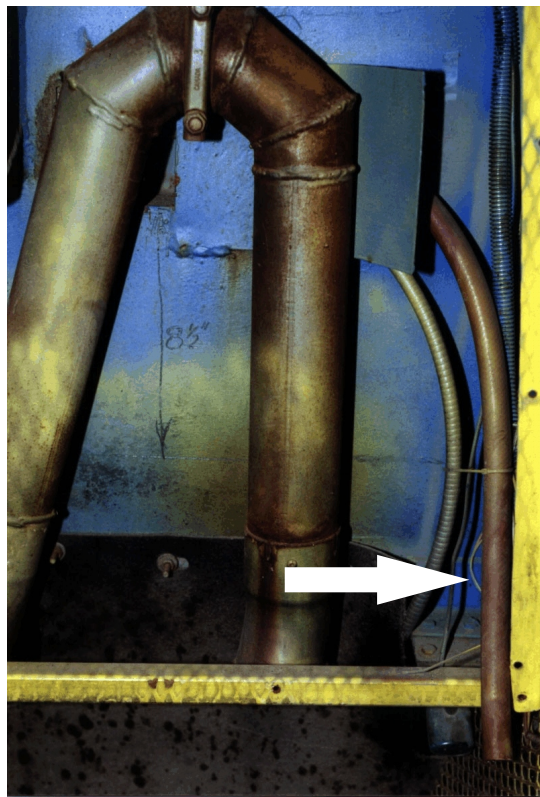
**Photo 2.** After end of the starboard-side main bilge pump discharge pipe

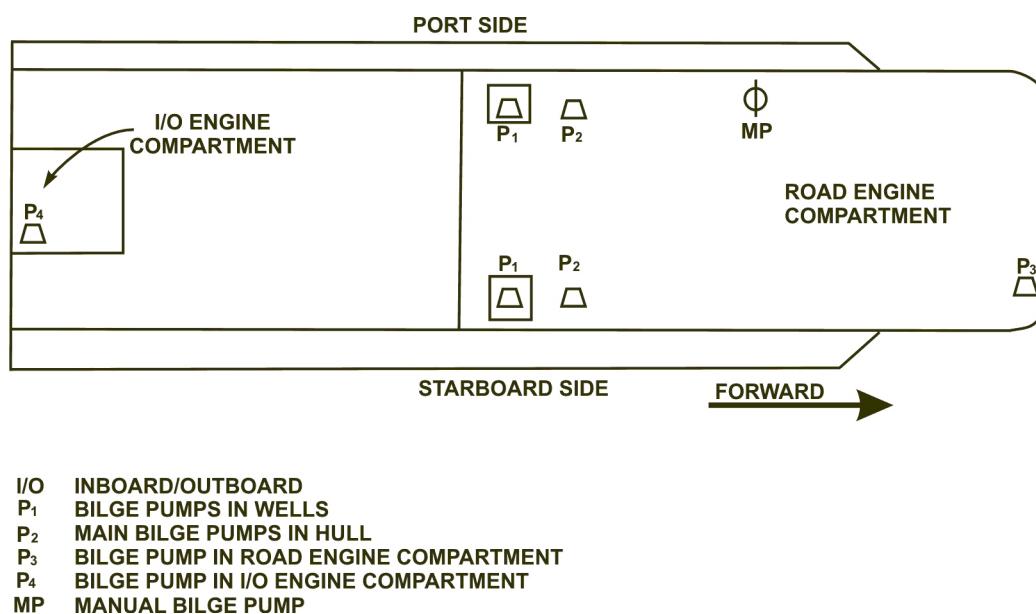
Figure 3 shows the location of the bilge pumps. Table 1 gives a summary description of the bilge pumps and outlines their status. See Appendix A for results of bilge pump examination and testing.

**Figure 3.** Bilge pump locations

Of the six electrically driven bilge pumps on board the vehicle at the time of the occurrence, two were found to be effectively operable. Actual discharge rates measured during the tests of the two emergency bilge pumps (Attwood V1250) that were operational were 335 US gal/h (21.2 L/min) each. This discharge rate was approximately 36 per cent of that specified for this pump model when operating at a comparable pressure head of 3.3 feet (1 m) with an electrical

supply of 13.6 volts (V). The reduction of the designed discharge rate was attributable, in part, to the actual voltage available during the tests (approximately 12.5 V), mud and debris obstruction of the wire gauze strainer, and some internal wear in the pump. However, the primary cause of the reduction was due to the greater back pressure at the pumps, caused by the marked and sudden restriction of the discharge area to 19 per cent of the original 25 mm-diameter (1-inch) pump discharge piping where it joined the 11 mm-diameter (7/16-inch) overboard discharge fitting.

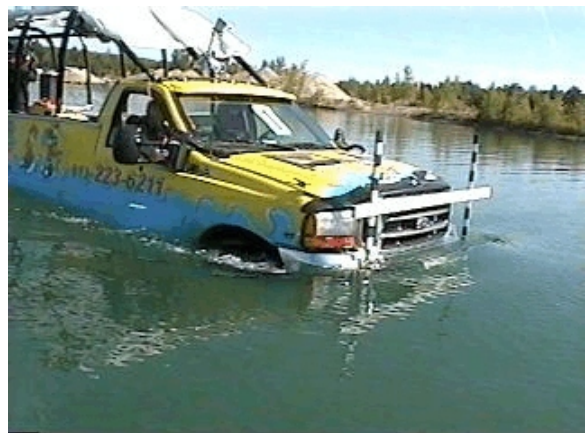
Trial speeds were progressively increased from 5 km/h up to a maximum of 10.25 km/h, and the related bow wave heights ranged from 90 mm (8½ inches) to in excess of 470 mm (18½ inches). At speeds up to about 5 km/h (see Photo 4), the bow waves were comparatively small. However, as the speed was increased, the bow waves became disproportionately higher and the initial effective visor freeboard of 470 mm (18½ inches) was significantly reduced.

**Photo 4.** Vehicle speed of approximately 5 km/h in calm water

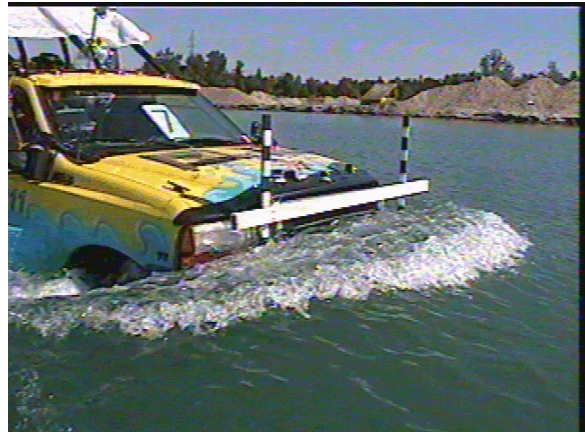
In calm water at a speed of 8 km/h, the bow wave was some 265 mm (10½ inches) high and the effective forward freeboard to the top of the visor was reduced to 205 mm (8 inches) (see Photo 5). At a speed of 9.85 km/h, the bow wave was level with the visor top (see Photo 6). At the maximum speed of 10.25 km/h, the bow wave partially covered the hood with water and heavy spray and overflowed the top of the forward visor. The configuration of the top of the forward visor and its attached gasket was ineffective in preventing entry of water through the space remaining between the top of the gasket and the underside of the hood.

**Photo 5.** Vehicle speed of approximately 8 km/h in calm water

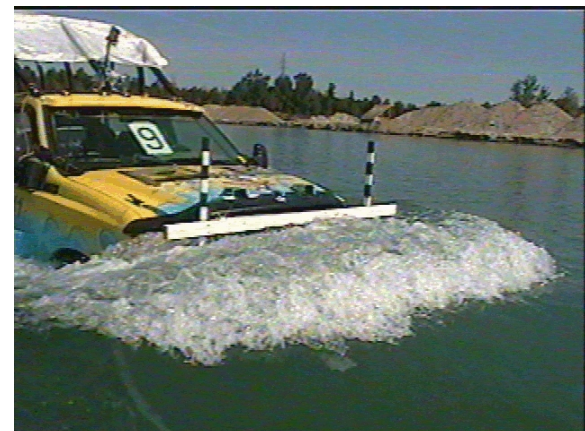
The temporary seals over the hood sides, engine ventilation openings, and forward cowl vents were effective. However, at speeds above 10 km/h, the floodwater continuously overflowed the visor top gasket and accumulated in the forward half of the vehicle. The volume of floodwater from this source was not determined due to the concurrent accumulation of water from the drive shaft bearing and hull leakage. The forward bilge pump and the two main bilge pumps were activated to clear the vehicle of all floodwater.

**Photo 6.** Vehicle speed of approximately 10 km/h in calm water

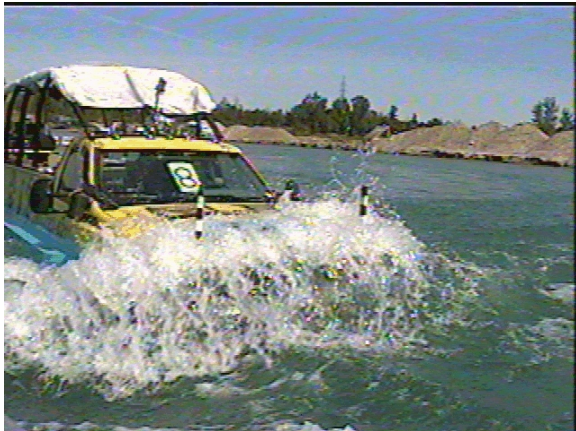
Significantly more floodwater was shipped and retained when in the unsealed condition. In disturbed water, at 8.3 km/h, water overflowed the top of the visor and also downflooded through the ventilator openings, forward cowls and hood sides (see Photo 7). At 9.75 km/h, the rate of downflooding increased considerably, water continuously overflowed the visor top, and a substantial quantity accumulated in the forward half of the hull (see Photo 8). The forward bilge pump, both main bilge pumps, and the two emergency bilge pumps were used to clear the vehicle of this accumulation.

**Photo 7.** Vehicle speed of 8.3 km/h in disturbed water

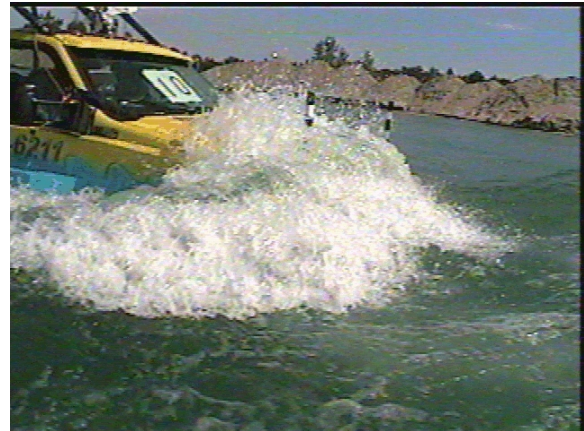
**Photo 8.** Vehicle speed of 9.75 km/h in disturbed water

In disturbed water conditions, heavy spray and some “solid” water covered the hood, causing significant downflooding through the ventilator openings, forward cowls and hood sides. However, the greatest ingress of water was from the front, past the hood front gasket and over the top of the forward visor plate, where the overflow took on a continuous waterfall effect. At 10.24 km/h, the rate of downflooding and rapid accumulation of water in the forward half of the vehicle was such that it was considered imprudent to continue at this speed for the time needed to complete the trial without the operation of all bilge pumps forward of midships.

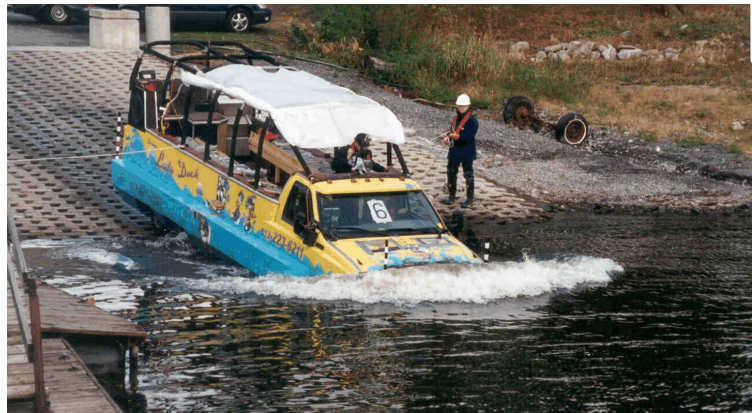
When the vehicle was launched at 8 km/h with all temporary seals removed from the hood, the visor was just submerged, the hood briefly awash and 22 litres of water was shipped (see Photo 9). When the vehicle was launched at 10 km/h, the visor was submerged approximately 80 mm (3¼ inches), the hood and windshield were fully awash, and 32 litres of water was shipped on board.

**Photo 9.** Vehicle launched at 8 km/h, visor submerged by approximately 25 mm

With the vehicle in a fully loaded condition, ramp launching speeds in excess of 8 km/h resulted in a significant quantity of water being shipped. In service, and in the absence of bilge high level alarms, the actual quantity of water shipped at the beginning of each tour would not be known by the operator, and its discharge was dependent on the prompt operation of the forward bilge pump.

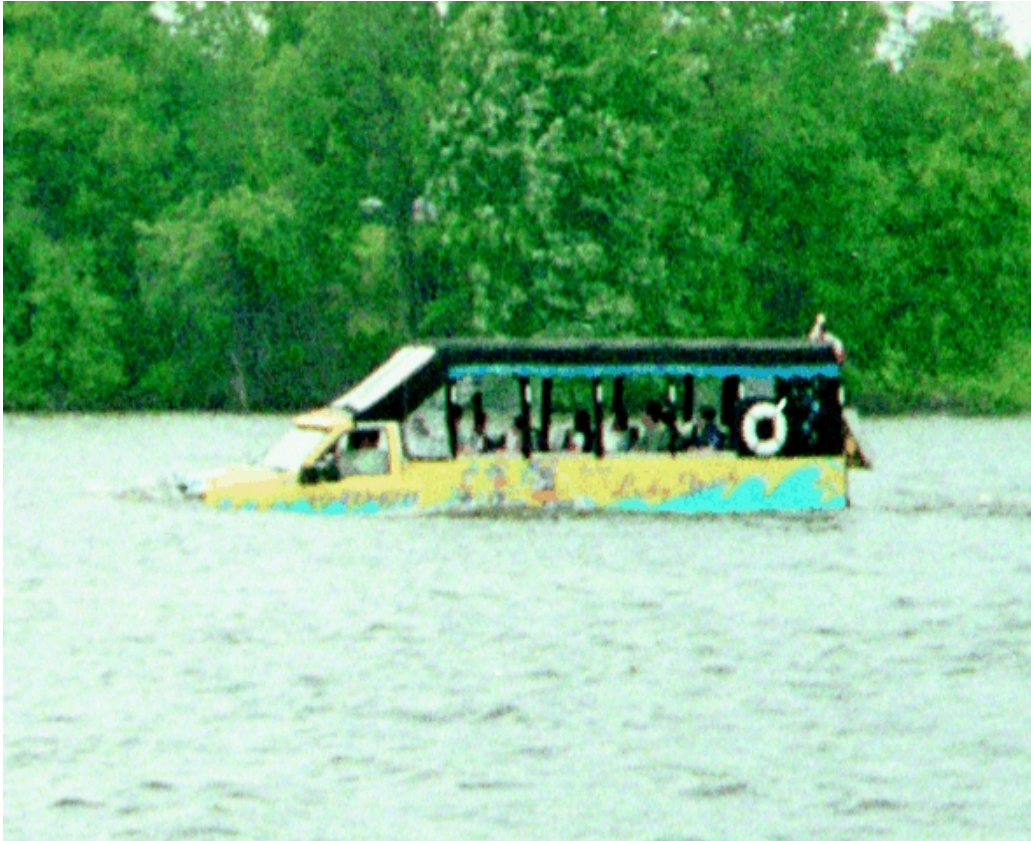
**Photo 10.** *Lady Duck* approximately five minutes before sinking. Reproduced with permission.

Subsequent photo-geometry and triangulation surveys carried out after the sinking verified the position of the vehicle, at the time the photograph was taken, as being approximately 250 m east of the Macdonald-Cartier Bridge. These surveys and the photograph also led to the determination of the vehicle speed at that time.

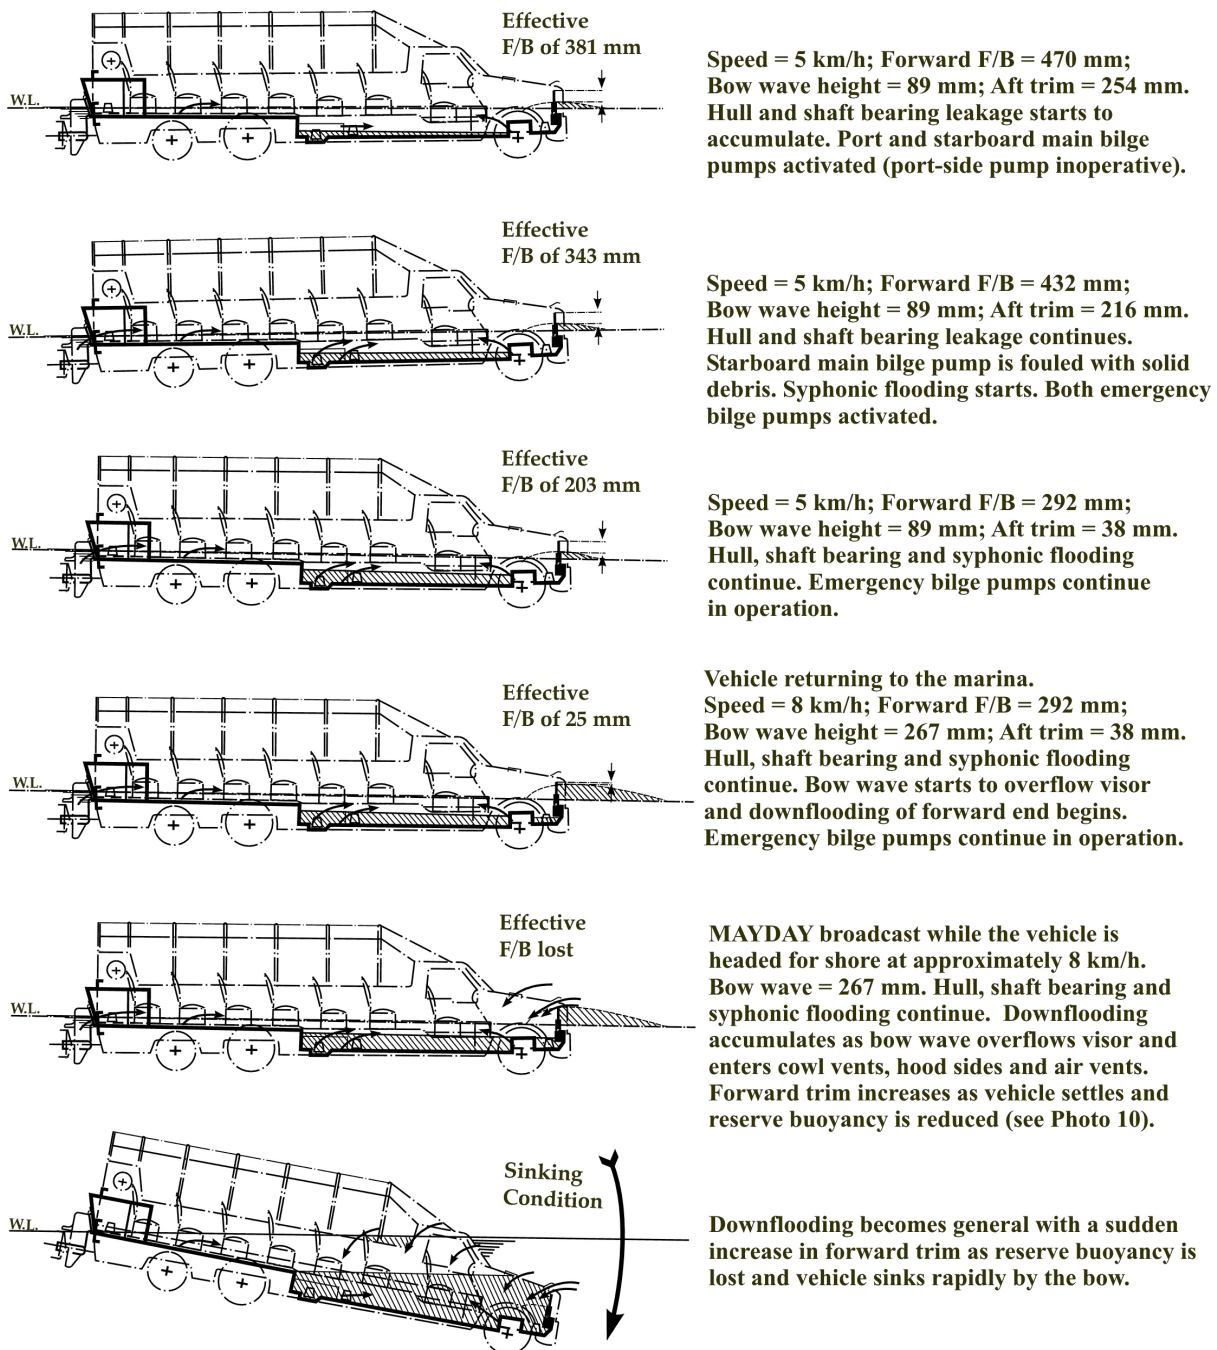
The forward bilge pump, which was best situated to cope with an accumulation of water in the front of the vehicle, was inoperative and the emergency bilge pumps near midships did not stem the total inflow. As the vehicle was headed toward the Hull Marina, the water accumulated in the forward end of the hull and the vehicle continued to trim more and more by the bow, causing the rate of the downflooding to accelerate. This cycle continued until forward reserve buoyancy was lost and the vehicle suddenly sank bow first.

Figure 4. Sinking sequence

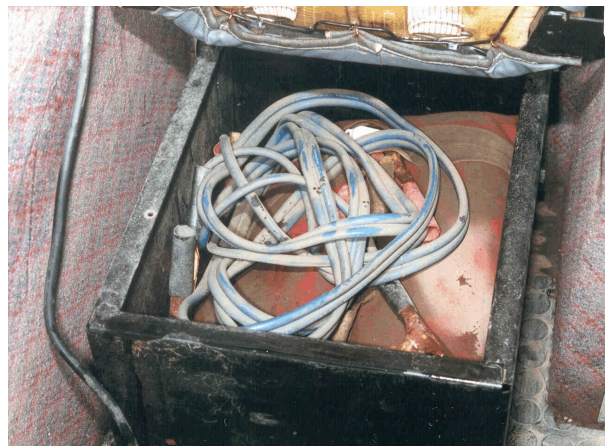
The adult lifejackets were stowed in lockers under each of the passenger seats. Examination after the occurrence revealed that it was not easy to remove the lifejackets from beneath the seats, as they tended to catch on the lip of the

**Photo 11.** Lifejacket under the seat with booster cables on top

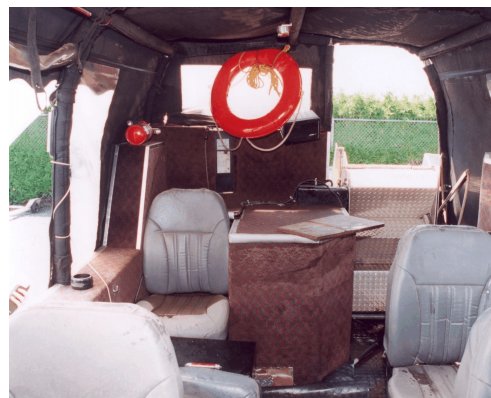
When the passengers boarded, they did so through a boarding ramp on the rear left corner of the vehicle. After all passengers boarded, the ramp was folded up by an electric winch into an opening of 1830 mm high by 685 mm wide (72 inches high by 27 inches wide) that forms a watertight seal for operation in the water. Once the ramp was secured, the opening, which was also an exit in the event of abandonment, was reduced to 788 mm high (31 inches) and 685 mm wide (27 inches) at its widest point, decreasing in width to 533 mm (21 inches) near the top of the exit (see Photo 12).

**Photo 12.** View from inside the vehicle of rear exit with boarding ramp in retracted position

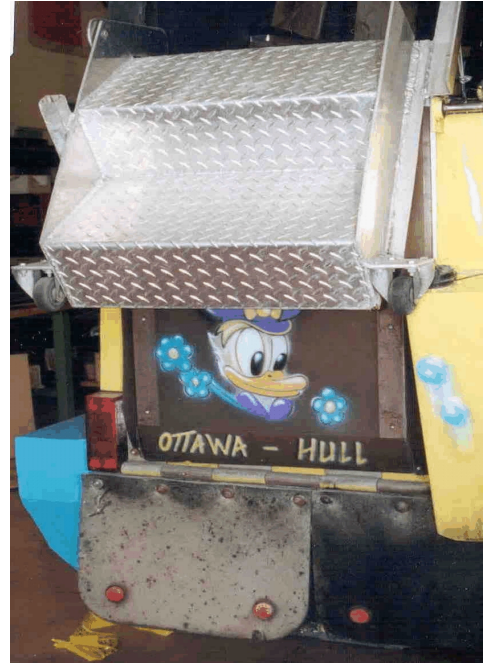
The ramp was articulated in that, when the ramp was retracted, its bottom two stairs folded upside down against the exterior of the vehicle. Once the vehicle was in the water, the boarding ramp could not be lowered (see Photo 13).

To access this rear exit for emergency egress, passengers had to make their way along a 584 mm-wide (23-inch) aisle and then make two turns to move between the rearmost seat on the port side and the front left side of the I/O engine compartment. The narrowest point of this route was 514 mm (20¼ inches). Once at the exit, passengers had to climb approximately 1016 mm (40 inches), with no permanent foothold to aid them, to the top of the retractable stairs to reach the available opening. There were several sharp metal corners on the top of the retractable staircase and winch assembly. The two bottom stairs of the ramp folded upside down against the exterior of the vehicle; the first of the two presented an almost slide-like property to anyone attempting to egress through this exit. Once passengers were at the top of the retractable stairs, there was no platform to step onto to facilitate egress into the water. Passengers had to find a posture to jump without any support structure to aid them in that movement, while ensuring that they cleared the hazard presented by the exterior stairs and the I/O motor.

Photo 13. After boarding ramp in retracted position
