MARINE INVESTIGATION REPORT

M02C0064

COLLISION

Between the Great Lakes Bulk Carrier
Canadian Prospector
and the Heavy Lift Ship *Stellanova*
St. Lawrence Seaway, Quebec
12 October 2002

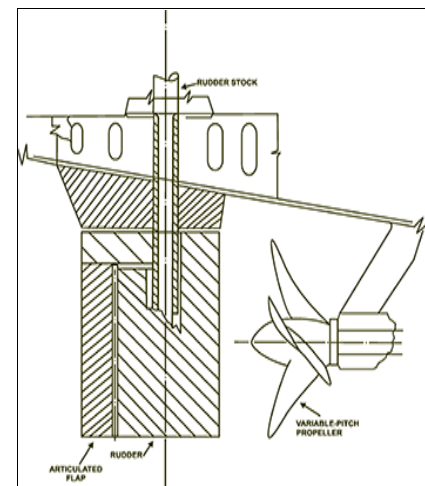
Figure 2. Sketch of a Becker rudder

Unlike the rudder and propulsion system on a conventional vessel, the *Stellanova* is equipped with a Becker rudder and a variable-pitch propeller (see Figure 1). To make the vessel more manoeuvrable, the rudder has an articulated flap on its after edge. The helm can be turned up to 35° (at sea) or 45° (in port). The flap deflects automatically in the same direction as the rudder. This increases the helm angle, and the rudder-to-flap ratio can be as high as 2:1. The efficiency of the rudder gives the ship good manoeuvrability in different conditions. However, the investigation revealed that, when the propeller pitch is decreased quickly with the vessel moving forward, the vessel tends to swing unexpectedly to one side or the other, and the helmsman cannot predict to which side it will swing.

Furthermore, the syllabus does not take into account manoeuvring with a Becker rudder in emergency/threatening situations and normal practical experience will not afford a pilot the opportunity to practice its use.

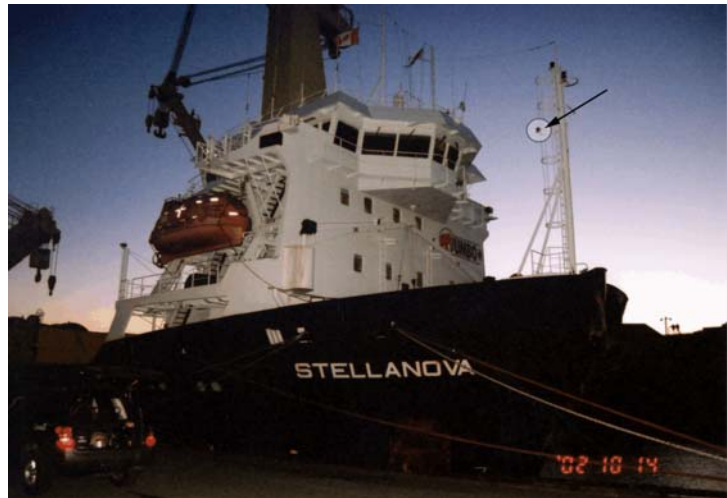
Photo 3. View forward from the bridge showing position of the blue steering light

Visibility forward from the bridge is good. The blue steering light is mounted level with the bridge and aft of the foremast (Photo 3 shows the position of the blue light).

Because the distance between the bridge and the forward mast is short, the blue light is not a good visual steering reference.

In this instance, the vessel's wheelhouse was well forward and the blue (steering) light was not a good visual reference for observing vessel movement. Consequently, a view of the stern was essential to maintain a better appreciation of the vessel's behaviour/response. As the wheelhouse and chart room arrangements restricted view aft, cues necessary to maintain visual reference and situational awareness were not readily available from the conning position. This made navigation from the central conning position more difficult.

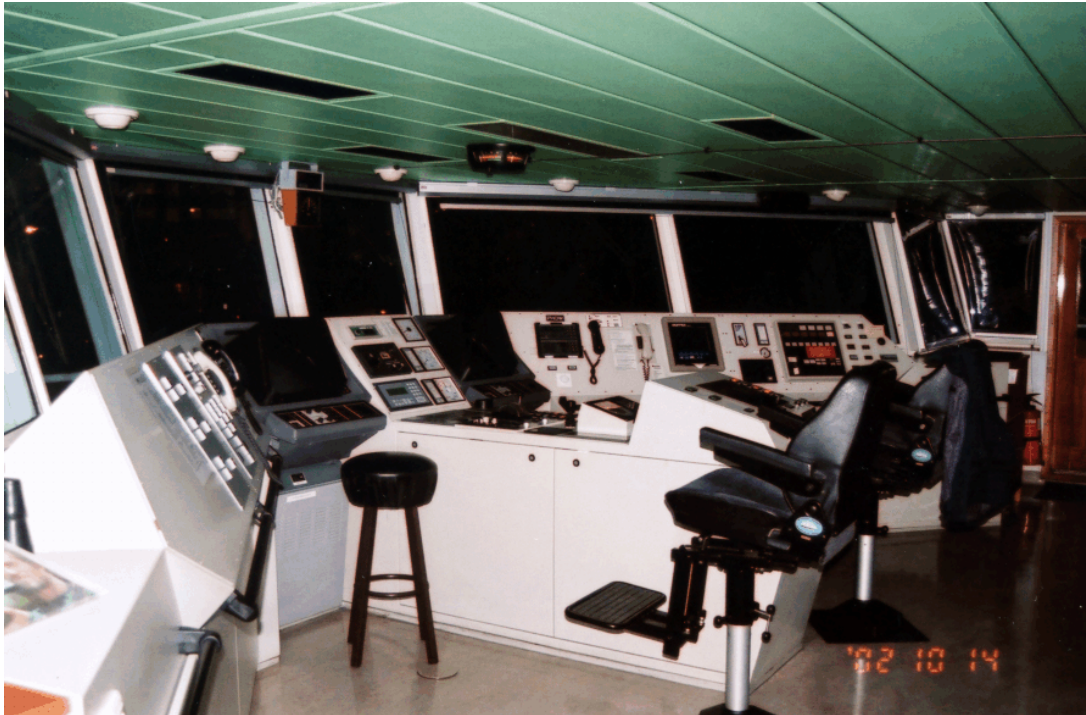
Photo 4. View to starboard from the integrated bridge of the *Stellanova*

On the *Stellanova*, the wheelhouse is laid out as an integrated bridge. From the conning position, the view over the starboard quarter is limited due to the hutch on the chart table (see photos at Appendix A) and the crane on the starboard side. Visibility directly aft is also reduced due to the access to the lower accommodation decks (see photos at Appendix A). During navigation, to have an aft view, a person has to be stationed either on the port side of the bridge or on one of the wings.
