## MARINE INVESTIGATION REPORT

M03L0026

### GROUNDING

THE BULK CARRIER *GREAT CENTURY*  
OFF BATISCAN, ST. LAWRENCE RIVER, QUEBEC

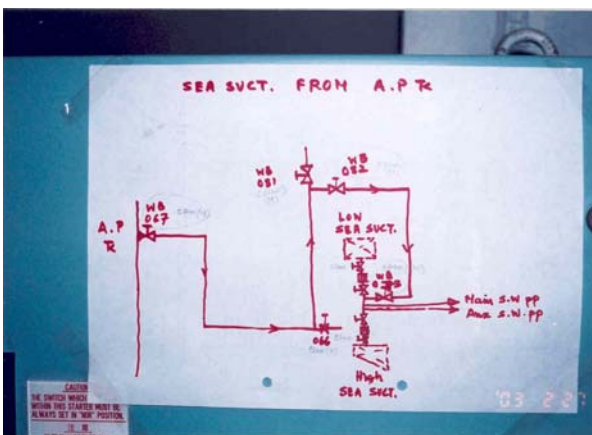
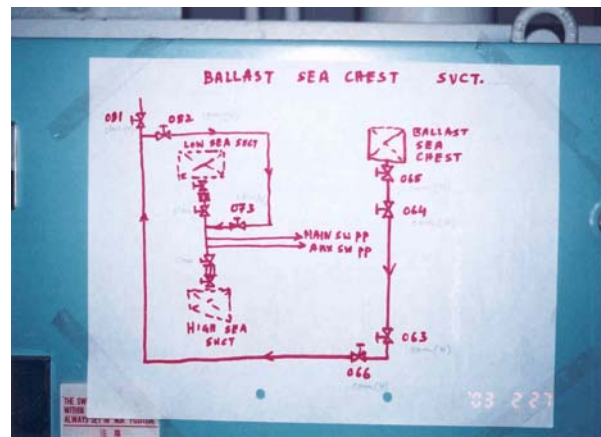
Shortly thereafter, the vessel was anchored for inspection of its cooling system. A Transport Canada (TC) inspector, who had boarded the vessel prior to the refloating operation, began the inspection by examining both sea suction strainers; they were both found filled with ice. Using the ship's plans, the inspector informed the engine room personnel of the different means available to them to cool the onboard machinery while navigating in ice-infested waters. Hand-drawn diagrams were posted in way of the main and auxiliary cooling pumps starter panel to better inform the personnel (see photos 2 and 3).

Photo 2. Hand-drawn diagram

Photo 3. Hand-drawn diagram

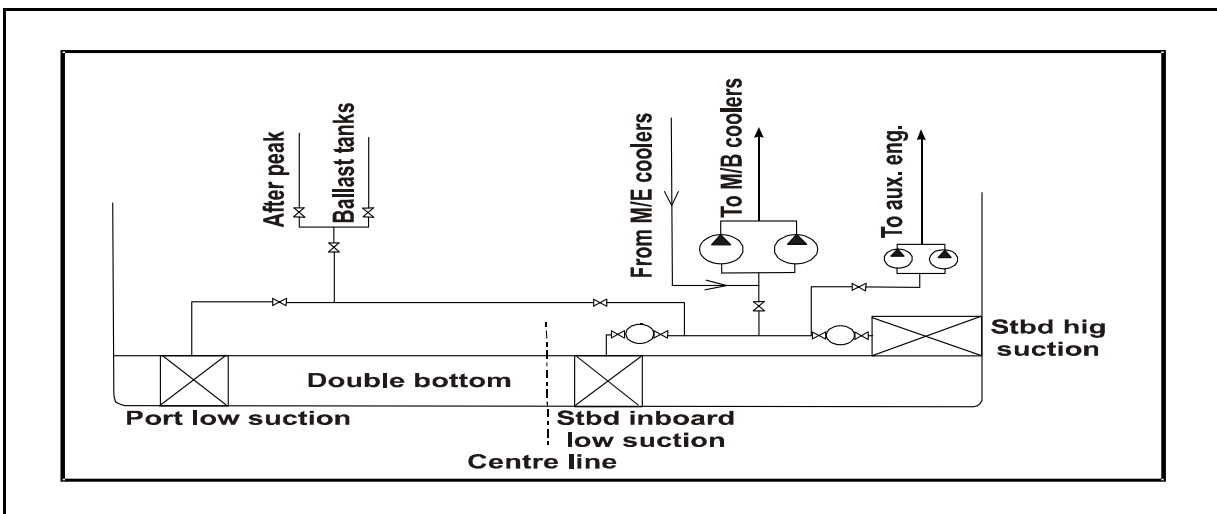
Figure 2. Sketch of cooling water arrangement of the *Great Century*

The vessel had three sea chests that were vented and each was fitted with a flanged vent valve on top. However, there was no permanent steam or air line connected to them. The two sea chests on the starboard(stbd) side were used as a sea-water inlet to cool the main engine and generators (see Figure 2). The high sea suction inlet was located on the ship's side, while the low suction was found on the ship's bottom in way of the centre line. Both were fitted with strainers and isolating valves and linked to a common pipe. The third sea chest, located on the port side, was used mainly for the ballast operations. The circuit allowed interconnection between the three suction.

The cooling system of the main engine was separate from the generators. To protect the generators from overheating, built-in protection devices would automatically shut down the engines. The vessel was not designed to re-circulate the cooling sea water for the main engine and generators when navigating in ice-infested waters. However, a connection was available between the aft peak, ballast tanks and No. 4 cargo hold and the suction side of the main sea-water cooling system, but it was not considered as a recirculating internal cooling system. It was only usable as long as there was water in the tank from which water was being drawn, or as long as the tank could be refilled. In the vessel's ballasted condition at the time of the occurrence, these tanks contained a total of 24 247 metric tons of ballast water available for emergency cooling of the main engine and generators.

The temperature of the main engine sea-water circulating system is controlled by a three-way valve installed on the outlet side of the coolers, enabling part of the water to return to the pump suction. The three-way valve is controlled by a thermo-pneumatic device that is linked to a probe at the outlet end of the air cooler, with a set point of 25°C.

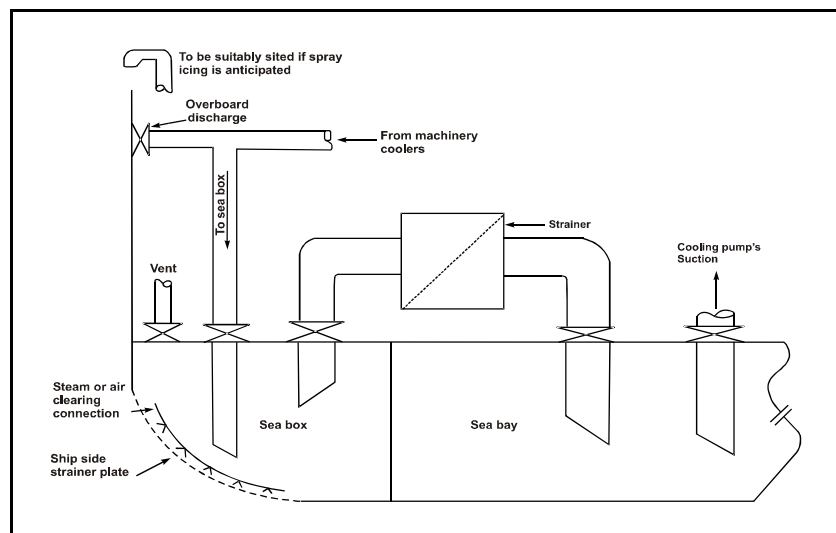
Figure 3. IMO suggested arrangement (port side view, starboard side similar)

*Inlets under Slush Ice Conditions*, in 1989, which provides guidance on the design and construction of sea suction inlets for vessels that navigate under slush ice conditions (see Figure 3).

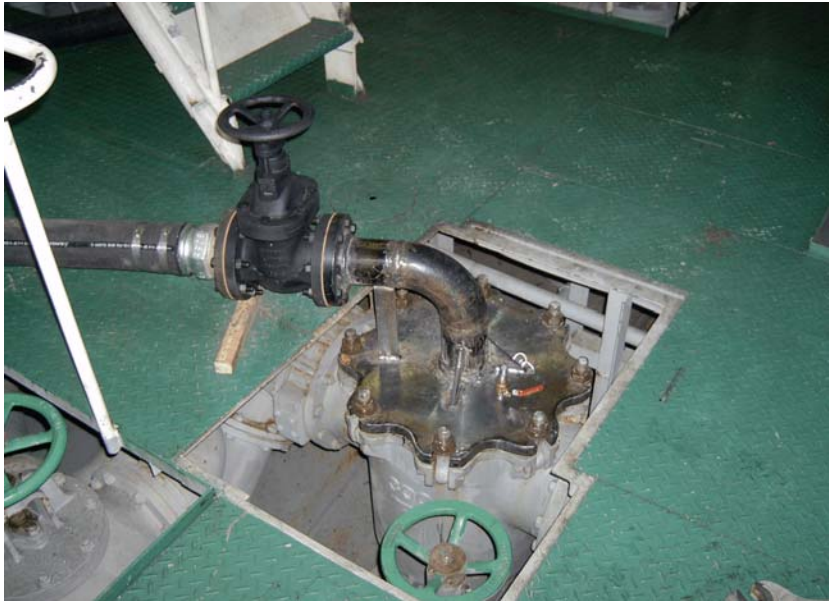
**Photo 4.** Temporary pipe connected to sea strainer returning main engine cooling water directly to sea chest.

TC required the Master of the *Great Century* to obtain proper winter clothing for the crew to work outside. The company was also required to install a temporary pipe connection to the sea water cooling outlet and the strainer of the high sea suction inlet. The latter installation allows water to return to the sea chest instead of the suction end of the main engine sea water pump (see Photo 4).
