Transportation Safety Board  
of Canada

**MARINE INVESTIGATION REPORT**  
**M03M0040**

**GROUNDING**

**LARGE FISHING VESSEL *SHINEI MARU* No. 85**  
**APPROACHES TO HALIFAX HARBOUR**  
**03 MAY 2003**

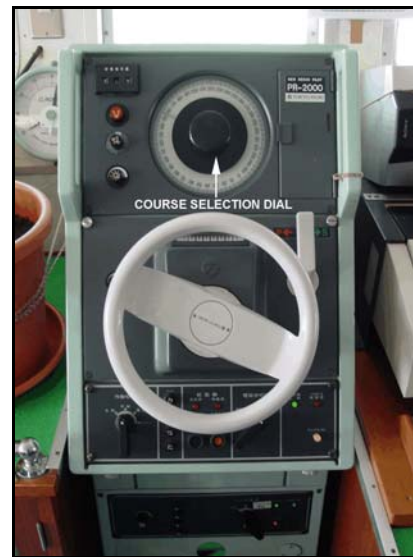
**Photo 2.** Autopilot unit

The vessel's officers and the pilot were aware that the degrees-calibrated dial for course selection on the autopilot was offset by five degrees. To steer a chosen course by autopilot, it had to be set five degrees less than the desired gyro compass heading. The autopilot was reported to have worked well.

The gyro compass and the autopilot were functioning satisfactorily, and those involved with navigating the vessel were aware of, and applied, the five-degree autopilot course selection calibration error. There was no information to conclude that following the departure of the pilot, the gyro compass and/or autopilot malfunctioned, that the heading on the auto pilot had been changed, or that the autopilot had been switched to manual. However, the possibility of the autopilot malfunction, autopilot adjustment, or the autopilot being disengaged cannot be discounted.

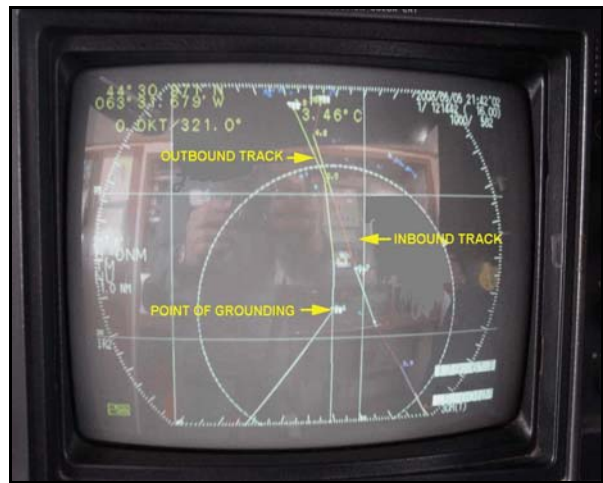
Photo 3. Display of inbound and outbound tracks

The type of video plotter on board was used as a fishing aid rather than as a navigational aid. Nevertheless, the vessel's track inbound to Halifax was displayed on the video plotter, and the outbound course to grounding was also visible. The outbound plot line followed the recommended route up until a point just after Lichfield Shoal (when the pilot disembarked). The straight-line plot of the vessel's track then changes direction from Lichfield Shoal to the point of grounding (see Photo 3). However, the probable track<sup>5</sup> of the vessel is as shown in Appendix A.

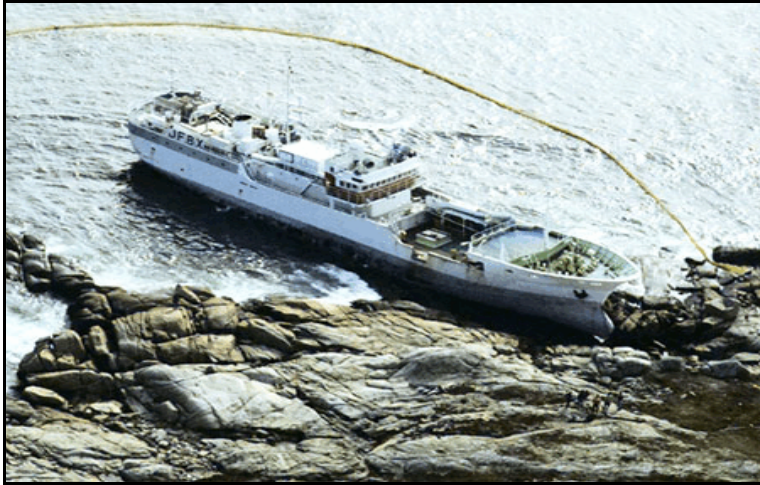
The grounded *Shinei Maru No. 85* and oil spill containment boom

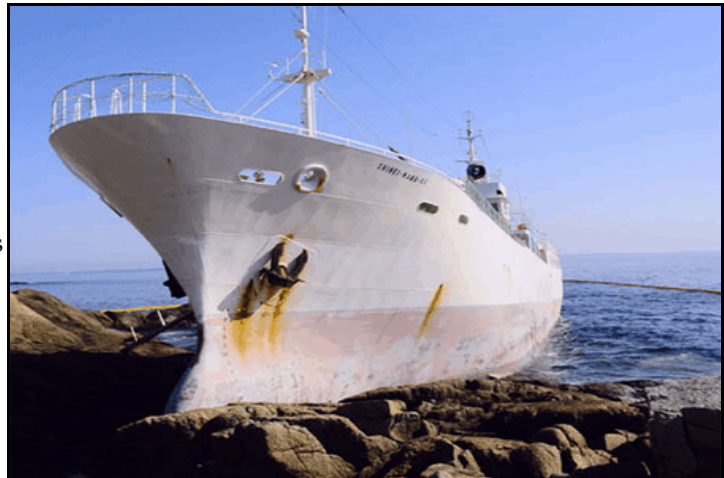
Vessel's bulbous bow stuck fast on the rocks

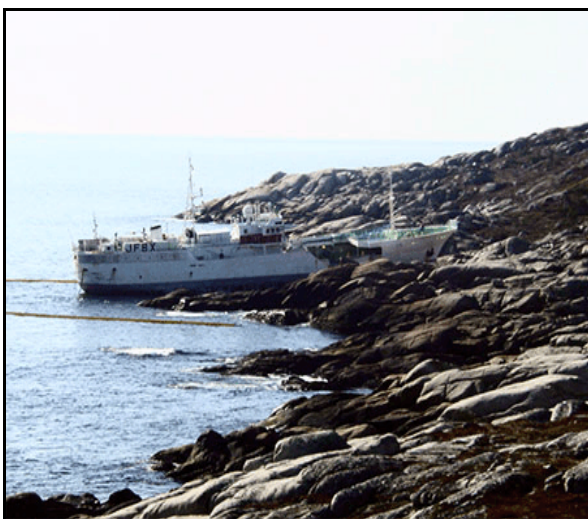
The hull was breached in three places, and the bulbous bow was damaged. A fracture in the bottom plating on the forward end of No. 8 tank at midships measured 175 mm long by 10 mm wide. Approximately 2.4 m aft of this area in way of No. 8 tank was a fracture 51 mm long by 1 to 2 mm wide. On the port side in way of No. 6 tank a fracture 113 mm long by 1 to 2 mm wide was found. The bulbous bow was stove in on the port side—the indentation was 2 m long by 700 mm wide by 450 mm deep.

Vessel sustained extensive bow and forward bottom damage
