MARINE INVESTIGATION REPORT

M04C0090

CAPSIZING

WORKBOAT 59E22354

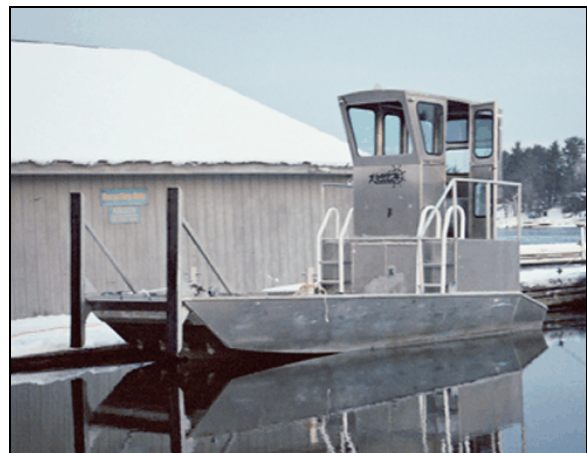
Photo 1. Workboat 59E22354

- The partially enclosed steering station was converted into a fully enclosed wheelhouse.
- The wheelhouse height was raised by 1.25 m above the main deck (see Photo 1). This allowed the creation of a lower storage compartment, with a height of 0.41 m and a sill of 3.5 cm, and an upper storage compartment of a height of 0.84 m (see Photo 2).

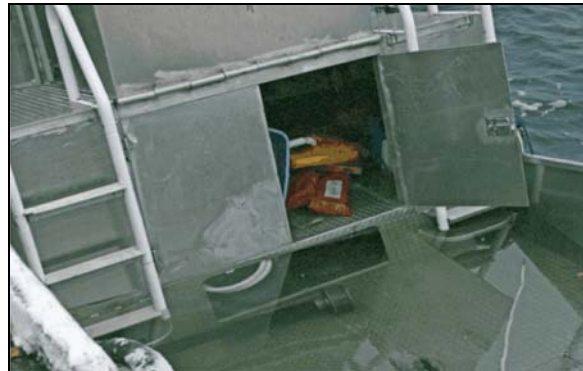
Photo 2. Upper and lower storage compartment

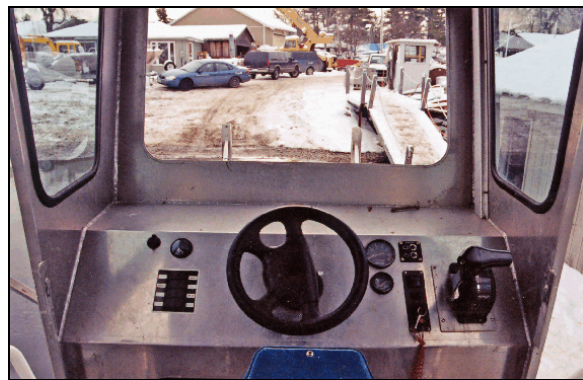
- The wheelhouse was hinged at its forward end so that it could be laid down when the vessel was stored ashore.
- A steering control panel with basic instrumentation, controls for engine operation and a toggle switch to operate the bilge pump were located in the wheelhouse (see Photo 3).
- The wheelhouse was designed to accommodate two persons, with a seat for the operator and a small shelf space behind it, where one other person could sit.
- Access to either side of the wheelhouse was by way of ladders from the main deck.

Photo 3. Wheelhouse

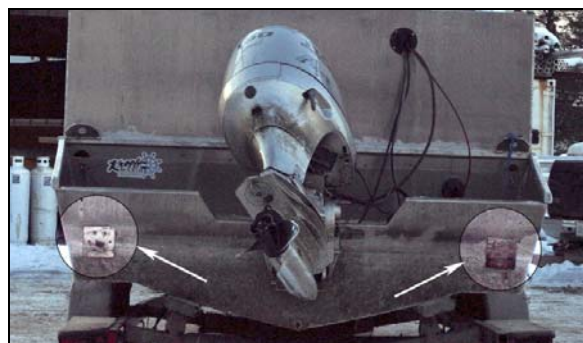
Forward of the wheelhouse, the gunwale on the main deck was 0.52 m in height. A 1.9 cm-diameter hole, port and starboard, in the forward superstructure bulkhead, with pipes leading through the lower storage compartment and terminating at the motor well, provided drainage from the main deck. The sloped deck in the motor well permitted water to drain overboard through two drain holes in the transom. These holes were covered by fastened pieces of plywood. Subsequently, a hole was drilled through the plywood on the port side in way of the drain hole (see Photo 4, which shows that the drain holes were below the waterline indicated by the scum line).

Photo 4. Stern view showing motor well with port and starboard drain holes

In this condition, the drain hole on the port side was submerged. When the vessel went astern, the motor well flooded rapidly and submerged the lower part of the transom.

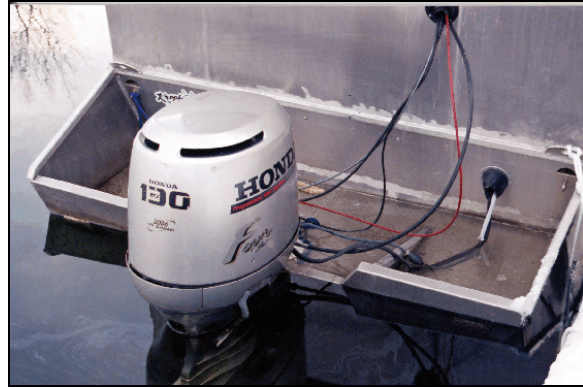
Photo 5. View of motor well

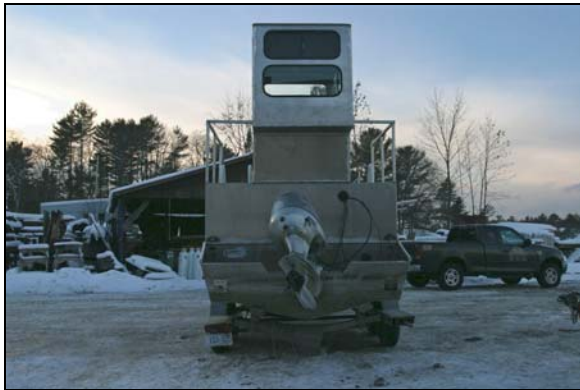
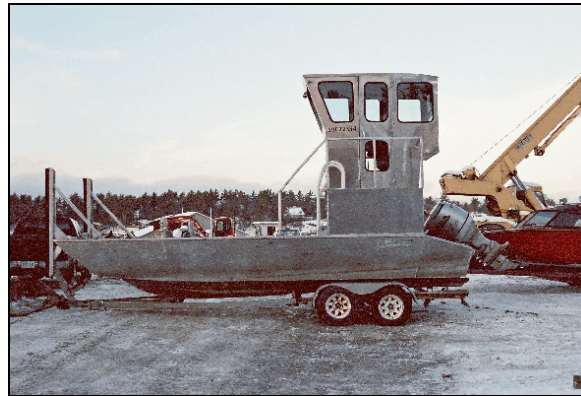
The structural modifications made to the workboat in 2002 decreased its inherent transverse stability characteristics (see Photo 6 and Photo 7).

Photo 6. Stern view

Photo 7. Side view

In a lightship condition, the freeboard at the aft end in way of the drain hole was minimal and the workboat had an initial trim by the stern. The trim was further increased by the loaded condition of the boat at the time of the occurrence.
