MARINE INVESTIGATION REPORT

M04L0065

FLOODING

ABOARD THE FISHING VESSEL *PERSISTENCE I*

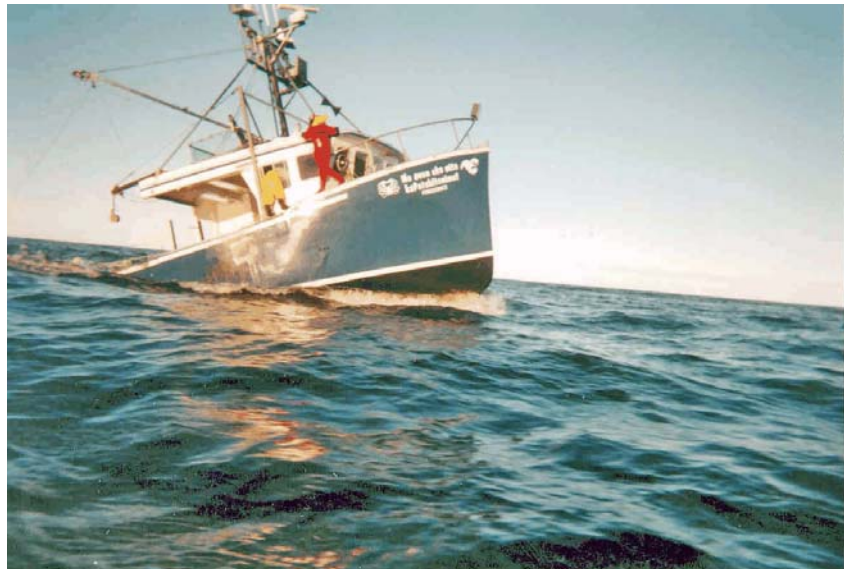
Photo 1. The *Persistence I* reaches the approaches to the Natashquan River

Because the afterdeck was completely submerged, it was felt that towing was not appropriate. The CCGS *Cap de Rabast* approached on the port shoulder of the *Persistence I* and seven of the nine people transferred to the CCGS *Cap de Rabast*. The operator and one crew member stayed aboard to pilot the *Persistence I*. The captain of the CCGS *Cap de Rabast* called off the mission of the R323 aircraft and requested the *Violaine.C.I* to continue its escort into port. The crew member who stayed with the vessel gave the operator an immersion suit, supplied by the CCGS *Cap de Rabast*. Around 0525, the operator headed the vessel onto a cay³ about 15 m north of the

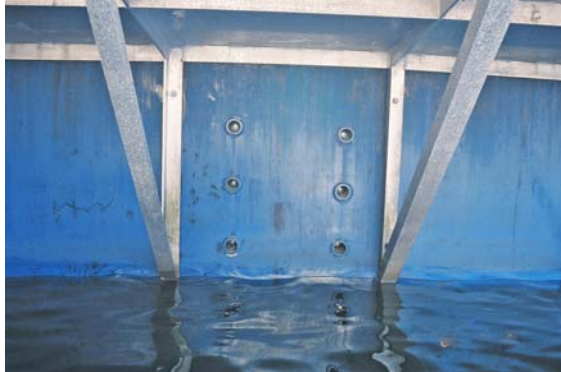
Photo 2. Exterior view of the transom under the platform showing six seawater discharge ports connected to the live-well tanks

The partial flooding of the fish hold and the lazarette caused the after part of the vessel to trim further by the stern submerging the six seawater discharge ports of the live-well tanks in the transom. Since the discharge valves were open, gravity caused the seawater outside the vessel to pour directly into the live-well tanks, thereby increasing the flooding in the live-well tanks and the fish hold causing the vessel's stern to sink even more. The situation was further exacerbated when the fish hold hatch cover was lost overboard. Downflooding ensued, and opportunities to control the situation were lost.

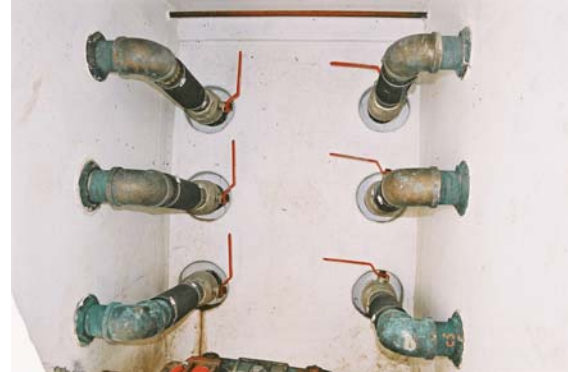
A mechanical pump located in the engine room supplies sea water to the live-well tanks, which are designed to service three tiers of lobster crates. A pipe fitted with a discharge valve, mounted on the transom at each tier level, maintains an appropriate water level in the live-well tanks. The valves, which are located in the lazarette, cannot be remotely operated (see photos 2 and 3). There is no physical barrier to prevent the use of this system.

Photo 3. Interior view in the lazarette showing discharge pipes connecting the live-well tanks to the transom. Each pipe has a 76 mm valve.

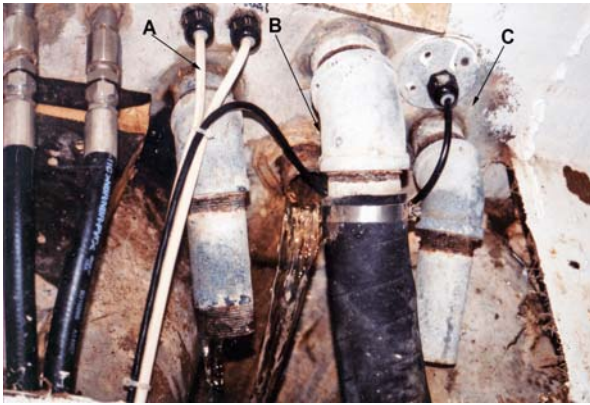
The bilge pumping system for the engine room comprised one hydraulically driven pump and one electric submersible pump. The fish hold is also equipped with electric submersible pumps that, together with the engine room electric pump, can be operated automatically or manually from the wheelhouse. The crew's messroom and the aft compartment are not fitted with a bilge pumping system. To dewater the aft compartment, the water is drained by gravity through three pipes and sluice valves to the fish hold (see photos 4 and 5).

Photo 4. View in the fish hold showing drain pipe for the starboard live-well tank (A), the lazarette (B), and the port live-well tank (C)

Although there is a drainage mechanism in the aft compartment, water is not discharged overboard, but into the fish hold. Transferring the water from one compartment to another creates a free surface effect in the second compartment. This particular design has a direct impact on the vessel's stability. Closing the sluice valves only seals the bulkhead temporarily. This design does not follow the principle of compartmentation, which is based on a subdivision comprising permanent watertight transverse bulkheads.

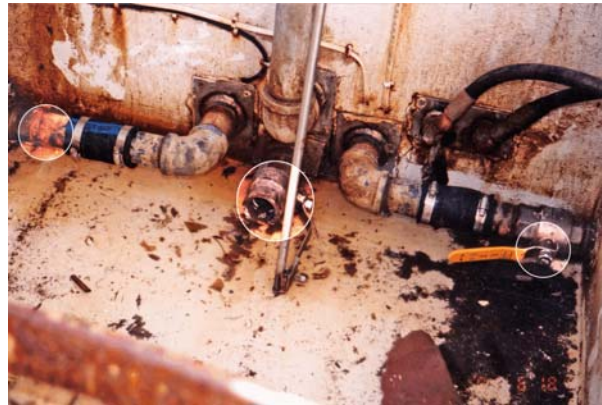
Photo 5. View in the lazarette showing sluice valves for the live-well tanks and the lazarette

The flooding of the compartments was gradual. Starting the seawater circulation system caused the water being pumped by the system to fill the live-well tanks. Because the sluice valves were open, this water then drained into the fish hold. The water that accumulated in the fish hold then drained by gravity into the lazarette since the sluice valve connecting these two compartments was also open (see Appendix B).

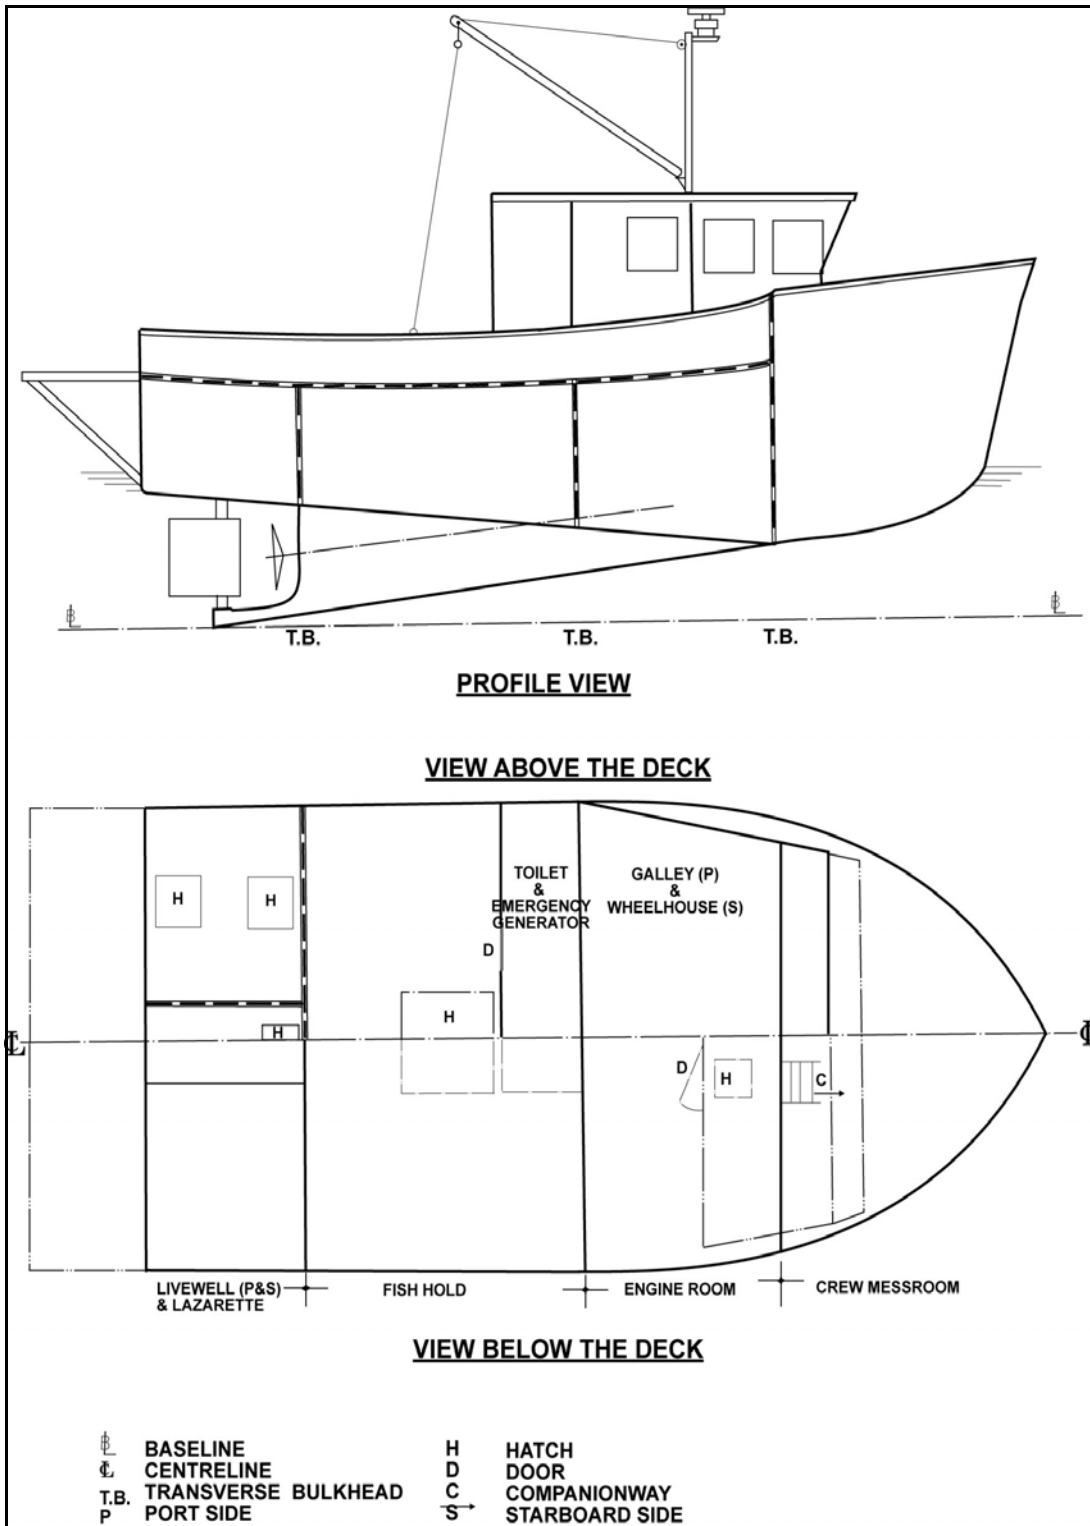
Appendix A – General View of the Persistence I

The *Persistence I* is a decked fishing vessel, built of composite materials, that is used primarily for crab fishing. The hull is divided into four compartments that are separated by three transverse bulkheads (see Appendix A). Starting from the bow, it consists of the crew's messroom, the engine room, the fish hold, and the aft compartment, which includes a live-well tank on either side of the lazarette.
