**MARINE INVESTIGATION REPORT
M05L0192**

COLLISION

**BETWEEN OIL TANKER *MARIA DESGAGNÉS*
AND SAILING VESSEL *EL TIO*
OFF ÎLE D'ORLÉANS, QUEBEC
12 SEPTEMBER 2005**

Report Number M05L0192

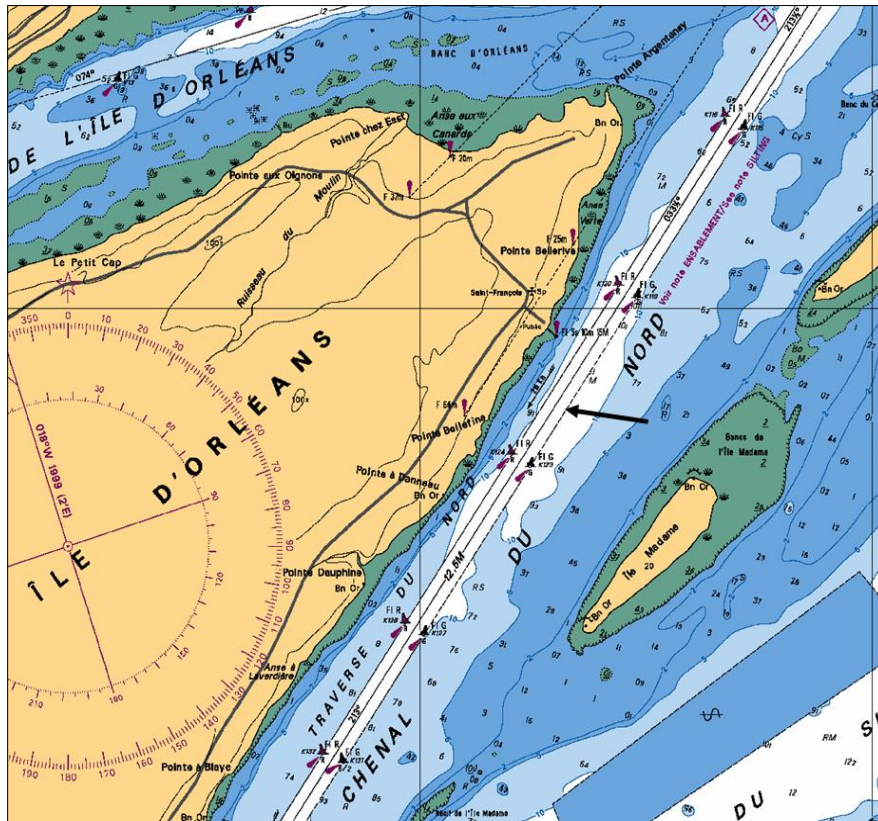
Figure 1. The *El Tio* and the *Maria Desgagnés* collided at about 2300 in the centre of the channel between buoys K119 and K123, one-half mile south of Saint-François quay.

When the sailboat *El Tio* was less than 100 m off the starboard bow of the oil tanker *Maria Desgagnés*, the sailboat quickly veered to starboard and crossed the oil tanker's path. The two ships collided at about 2300 in the middle of the channel, between buoys K119 and K123, one-half mile south of Saint-François quay (see Figure 1).

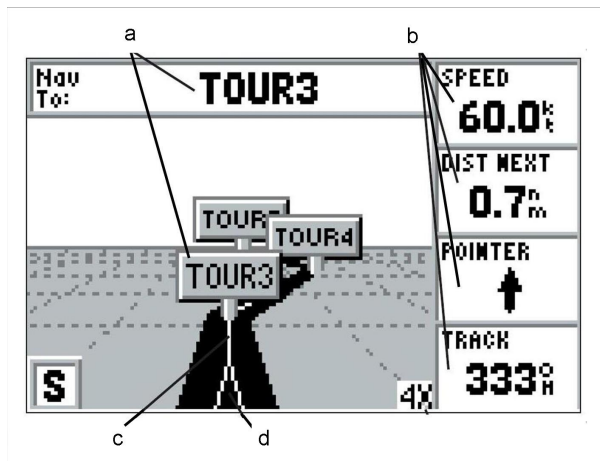
Figure 2.

Due to the fact that the captain had failed to re-program the GPS, the graphic image had not changed and was still based on the WPs along the port buoys. Consequently, when the sailboat began moving back upriver, off Anse aux Bardeaux, it travelled in the navigable channel along the port buoys on the side used by ships moving downstream. However, Rule 9, Narrow Channels, of the *International Regulations for Preventing Collisions at Sea (1972)* stipulates that ships shall keep as near to the outer limit of the fairway, which lies on their starboard side, as is safe and practicable. It also stipulates that ships of less than 20 m in length shall not impede the passage of a ship, which can safely navigate only within the fairway.

- a) Representation of next WP.
- b) Display of 4 of the 28 settings calculated by the GPS.
- c) The black band and the white line represent the path to be taken between WPs.
- d) The icon representing the vessel. The vessel icon is located in the centre of the path on this display, the route to be taken between the preceding WP and WP 3 (TOUR 3).

The sailboat captain was using the “highway page” to navigate from one WP to another (Figure 2). Following the collision, the captain decided to head for the Saint-Laurent marina, located about 12 miles upstream from his position, rather than for the Saint-François quay, less than half a mile away. This was because he was disoriented and had no means of confirming his position.
