MARINE INVESTIGATION REPORT

M05W0111

**LOSS OF PROPULSION, SUBSEQUENT STRIKING OF BERTHED
PLEASURE CRAFT AND GROUNDING**

**ROLL-ON/ROLL-OFF FERRY *QUEEN OF OAK BAY*
HORSESHOE BAY, BRITISH COLUMBIA**

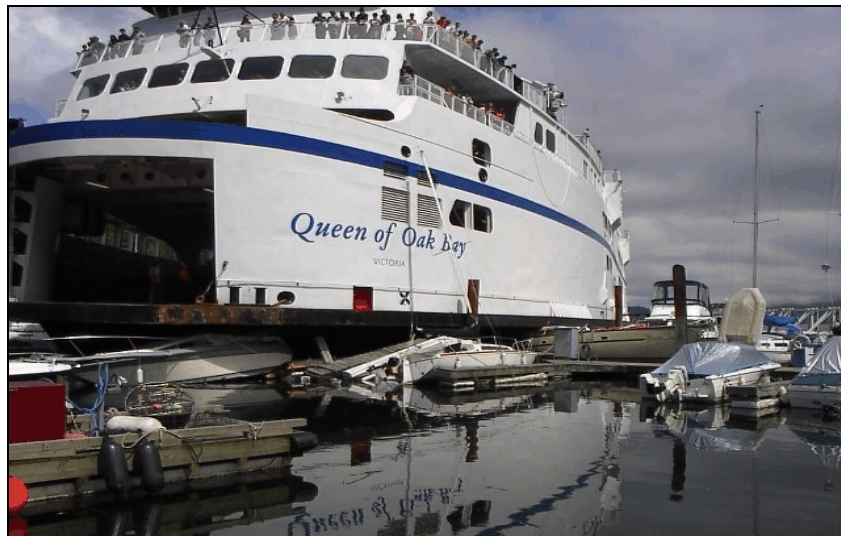
Photo 1. *Queen of Oak Bay* aground in Sewell's Marina

The vessel suffered minor damage to the No. 2 propeller and some scraping damage to its hull. There was extensive damage to the marina and 28 pleasure craft moored there.

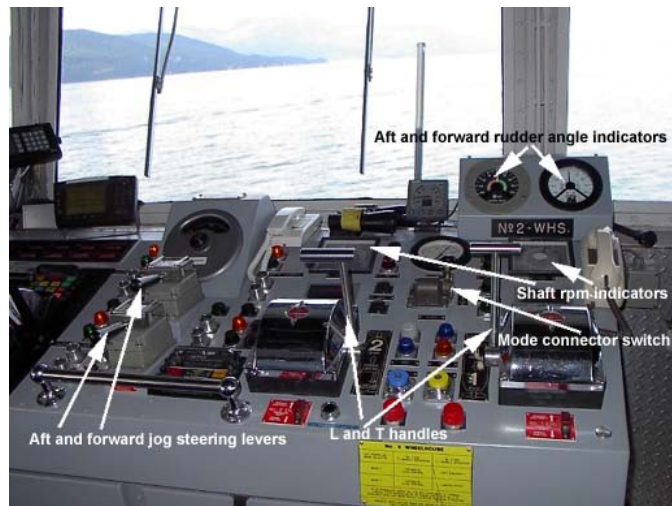
Photo 2. Wheelhouse control console

Wheelhouse manoeuvring consoles on C Class ferries do not have a mimic board showing the propulsion plant's condition. Relying on the propeller rpm gauges may therefore be misleading and, without gauges to likewise indicate engine rpm or the position of the clutches, it is impossible to tell if an engine is declutched but running, idling, or fully stopped.

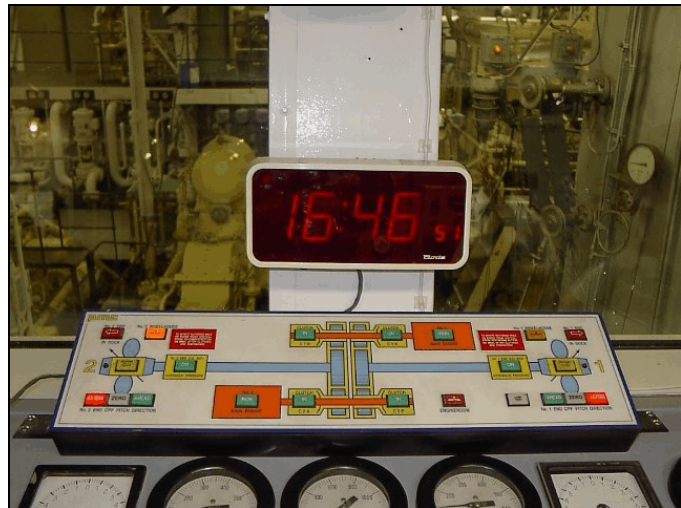
In the event of a malfunction, neither the engine control room nor the wheelhouse has a direct, audible alarm to alert operators to an accidental or inadvertent disengagement of one or more clutches.

Photo 3. Mimic board in engine room

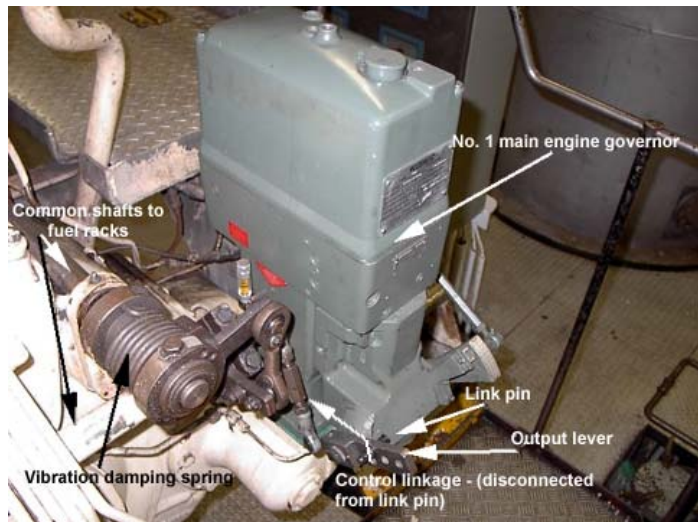
A castellated nut on the link pin for connecting the governor's output lever on the No. 1 main engine governor's output shaft to a control linkage was found on the floor plates beneath the governor. The linkage had slid out of the governor's output lever link pin, causing the governor to become disconnected from the engine's fuel control rack linkages (see Photo 4).

No broken pieces of the locking split pin were found in the vicinity of the nut, nor were any left behind in the bore of the link pin or the nut.

The orientation of the fitted link pin was contrary to that indicated in the manufacturer's drawings, which indicated that the pin was to be inserted with its head on the side of the link rod, with the nut lying on the outer side of the output lever. There was no indication that the orientation of the pin would have resulted in a detrimental effect or condition.

The link pin was designed to slide into its designated bored hole in the output lever. Wear from usage created an excessive clearance between itself and the bored hole.

Photo 4. No. 1 main engine governor and disconnected fuel rack linkage

The absence of a split pin on the securing nut on a governor linkage of the No. 1 main engine thus caused the governor to become disconnected from the fuel racks. The two main engines were interconnected at this time, and this caused the overspeeding No. 1 main engine to drag the No. 2 main engine into a shutdown condition with it, leaving the vessel without propulsion.

The link pin is designed to be a sliding fit in the governor's output lever. Over time, wear resulted in increased clearances, leading to the generation and propagation of vibrations. A correctly tightened nut will not normally lose tension, even if it has been assembled without a locking device. In this case, induced engine vibrations, amplified by wear between mating components, loosened the fastener and allowed the disconnection of the linkages.
