MARINE INVESTIGATION REPORT

M06M0110

CAPSIZING

BARGE *OTM 3072*

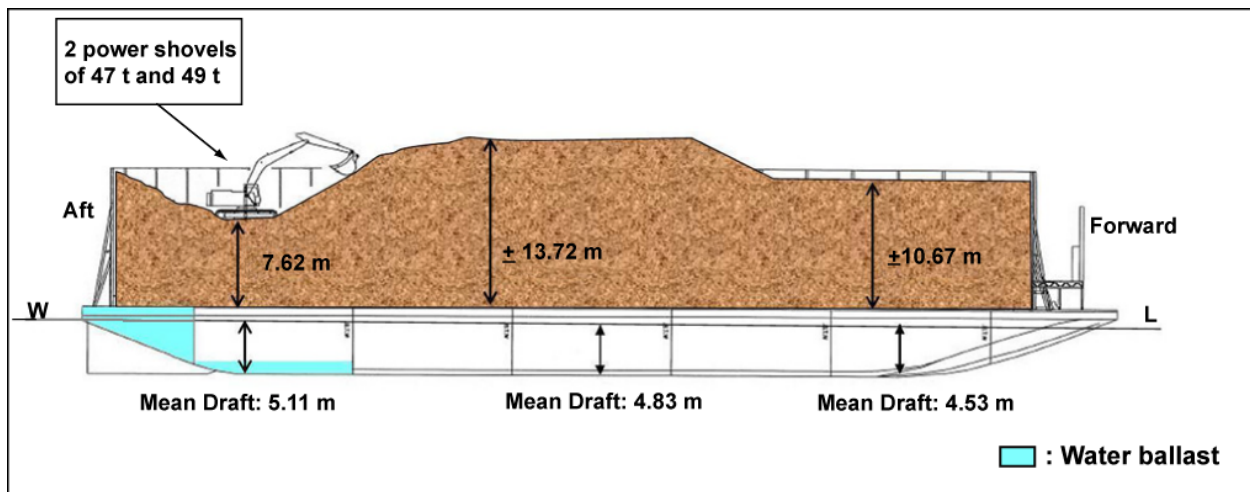
Figure 2. Loading plan on departure from Sheet Harbour

The OTM 3072 was loaded on 26 October 2006 at Sheet Harbour as follows (see Figure 2):

- wood chips were loaded to a maximum height of 13.72 m, for a total of 5563 tonnes;
- the port and starboard No. 5 outer compartments were partially filled and the port and starboard after peaks were completely filled, giving a total of 458 tonnes of ballast water;
- two power shovels used for unloading, weighing 47 and 49 tonnes respectively, were stowed on the cargo in the after part of the barge, more than 7 m above the deck;
- the mean draughts at the forward and aft marks were 4.53 m and 5.11 m, respectively.

- the wood chips weighed 5902 tonnes (not 5563 tonnes);
- the No. 5 compartments and the after peaks contained 513 tonnes of ballast water (not 458 tonnes);
- a "constant" of 356 tonnes, representing all unidentifiable weights, had to be considered in order to comply with the most recent lightship displacement, established in October 2005; and
- the load distribution was such that the barge had a trim by the stern of 0.57 m and a list to port of more than 2°; the effect of the trim and list reduced the freeboard, in particular on the port quarter, to 0.28 m.

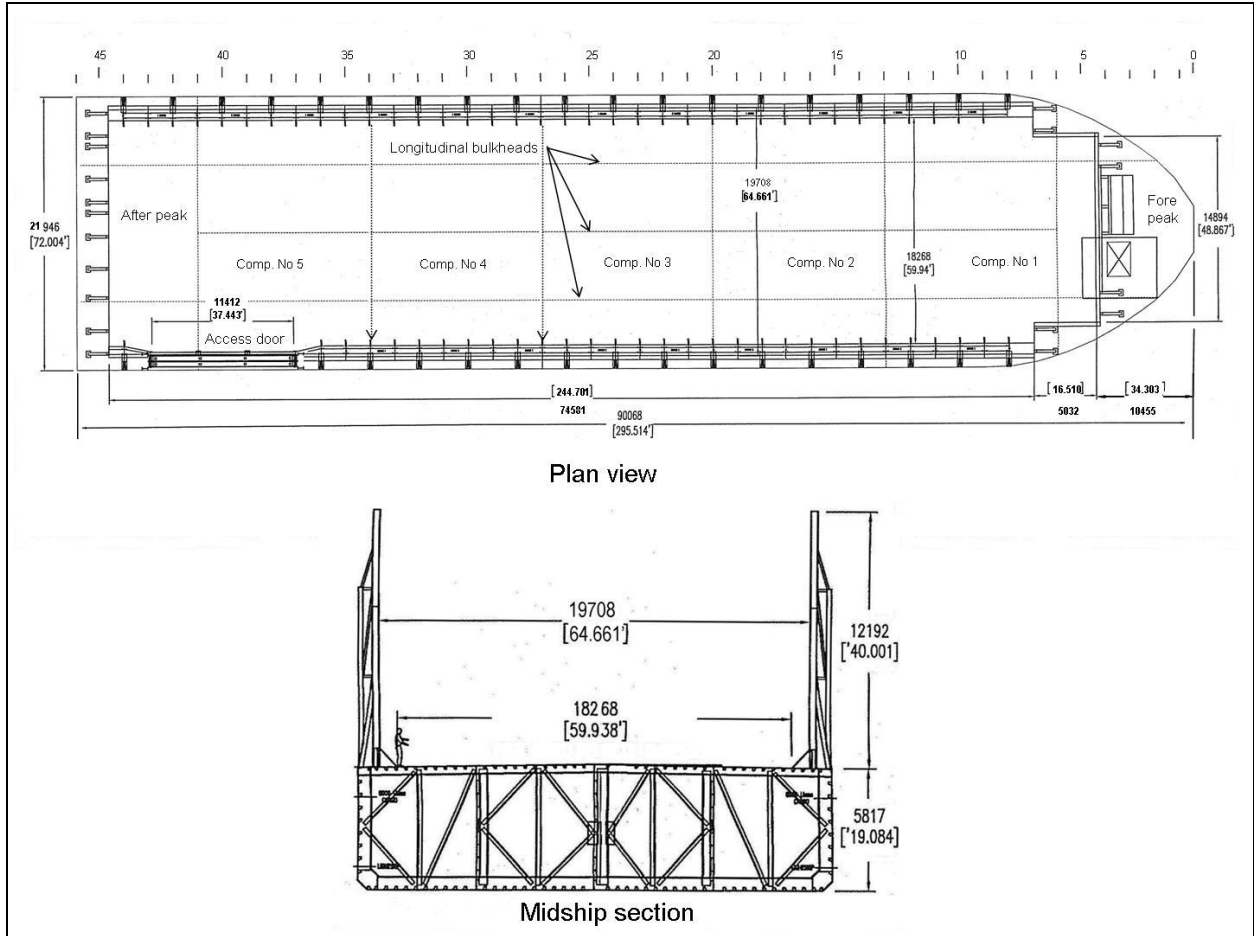
Appendix A – Barge OTM 3072

The barge *OTM 3072* was made of steel. The hull was subdivided by three longitudinal bulkheads and six transverse bulkheads into 26 watertight compartments³ (see Appendix A). Uprights and wire mesh form a 12.19 m-high enclosure around the outside of the deck to contain dry bulk cargo.
