MARINE INVESTIGATION REPORT
M06N0082

CAPSIZING AND SINKING

SMALL FISHING VESSEL *CAPE FIN-TOSE*
2.4 nm NORTHEAST OF KING'S POINT, GREEN BAY
NEWFOUNDLAND AND LABRADOR
01 NOVEMBER 2006

Report Number M06N0082

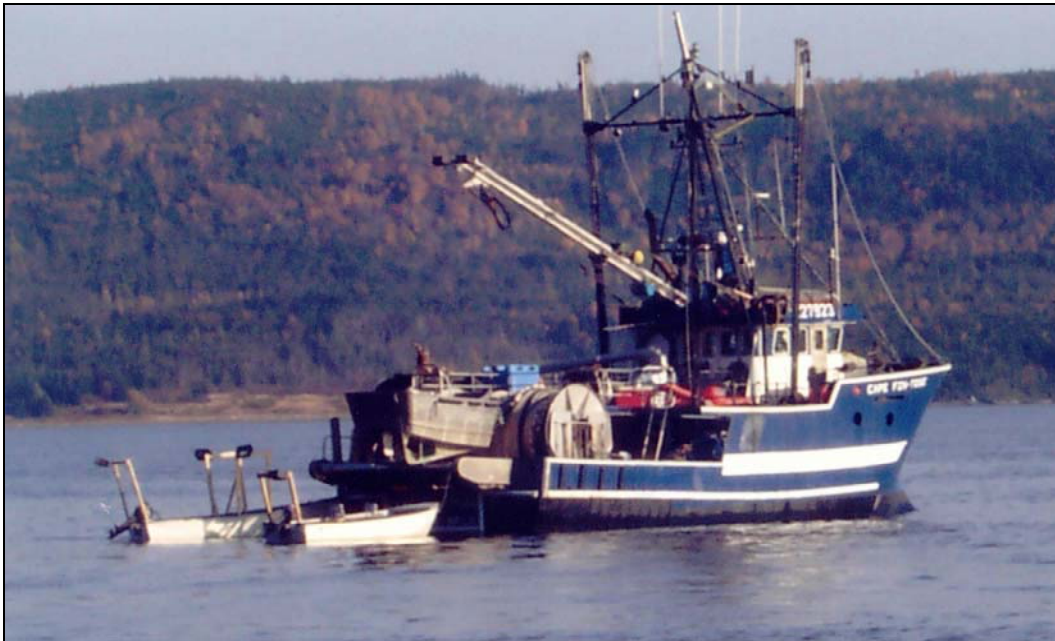
Photo 2. *Cape Fin-Tose* configured for mackerel seining (2006)

On the morning of the occurrence, the vessel was fitted-out to harvest mackerel. The first five items from the list above had been removed and the final three items added.
