MARINE INVESTIGATION REPORT
M08C0081

COLLISION

**BETWEEN THE BULK CARRIER *QUÉBECOIS* AND
THE BULK CARRIER *CAPT. HENRY JACKMAN*
BEAUHARNOIS CANAL, SAINT LAWRENCE SEAWAY, QUEBEC
17 DECEMBER 2008**

Report Number M08C0081

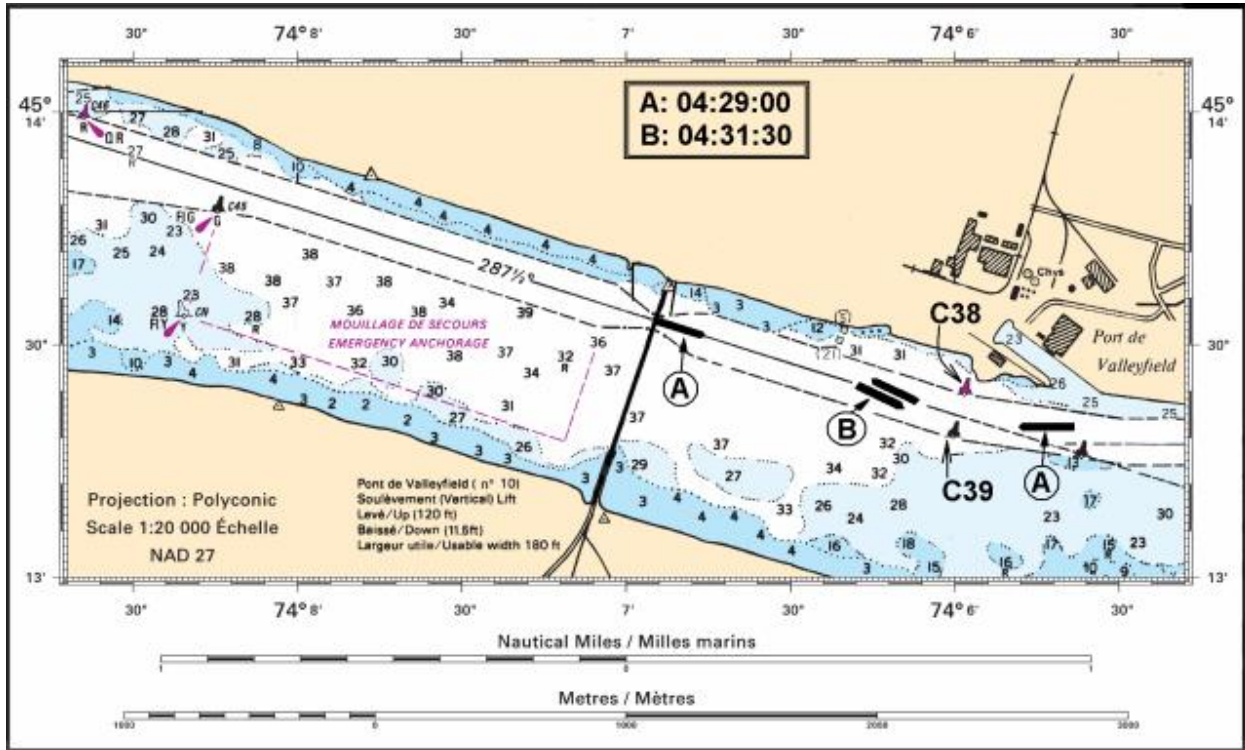
At 0431 in the centre of the channel and just above buoys C38/C39, the vessels began to pass each other port-to-port only a few metres apart. When the vessels were almost clear, both 1/Os gave helm orders to port to swing their respective sterns clear of each other. The vessels collided, making contact on their port quarters before clearing.

Figure 1. Vessel positions at 0429 and 0431:30, Capt. Henry Jackman is shown on the left, exiting the bridge.
