**MARINE INVESTIGATION REPORT
M10C0043**

GROUNDING

**PASSENGER VESSEL *RIVER ROUGE*
QUARRY RAPIDS, RED RIVER
NORTH OF WINNIPEG, MANITOBA
29 JULY 2010**

Report Number M10C0043

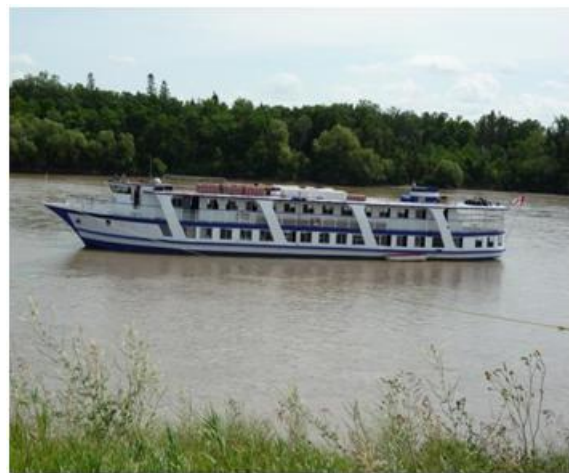
Photo 1. Vessel aground in the Quarry Rapids

At approximately 1030, the *River Rouge* ran aground in the Quarry Rapids, about 2.5 kilometers downstream from Lister Rapids (see Appendix A) on a bottom of mud and rocks, approximately 45 m from the western shore. Upon grounding, the 1/O and the deckhand pushed the throttles ahead and the vessel advanced slightly before stopping. Ahead and astern engine movements to free the vessel were unsuccessful. The engineer examined the vessel and found no damage or ingress of water.
