MARINE INVESTIGATION REPORT
M10L0074

GROUNDING

SMALL PASSENGER VESSEL *LE SURVENANT III*

09 JULY 2010

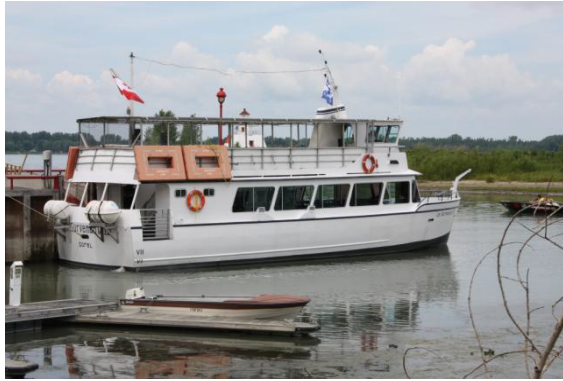
Photo 1. *Le Survenant III*

Le Survenant III is a small, 2-deck passenger vessel of closed welded aluminum construction with a transom stern (see Photo 1 and Appendix B). The navigation bridge is located at the forward end of the upper deck. The upper deck windows are hinged to swing down in case of inclement weather (see Photo 2) and are not weathertight. The vessel is powered by twin diesel engines, with twin screws and rudders. The vessel is also equipped with 2 anchors at the bow.

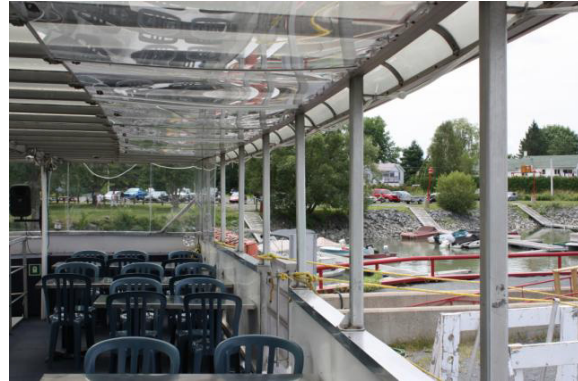
Photo 2. The upper deck hinged windows in raised position.

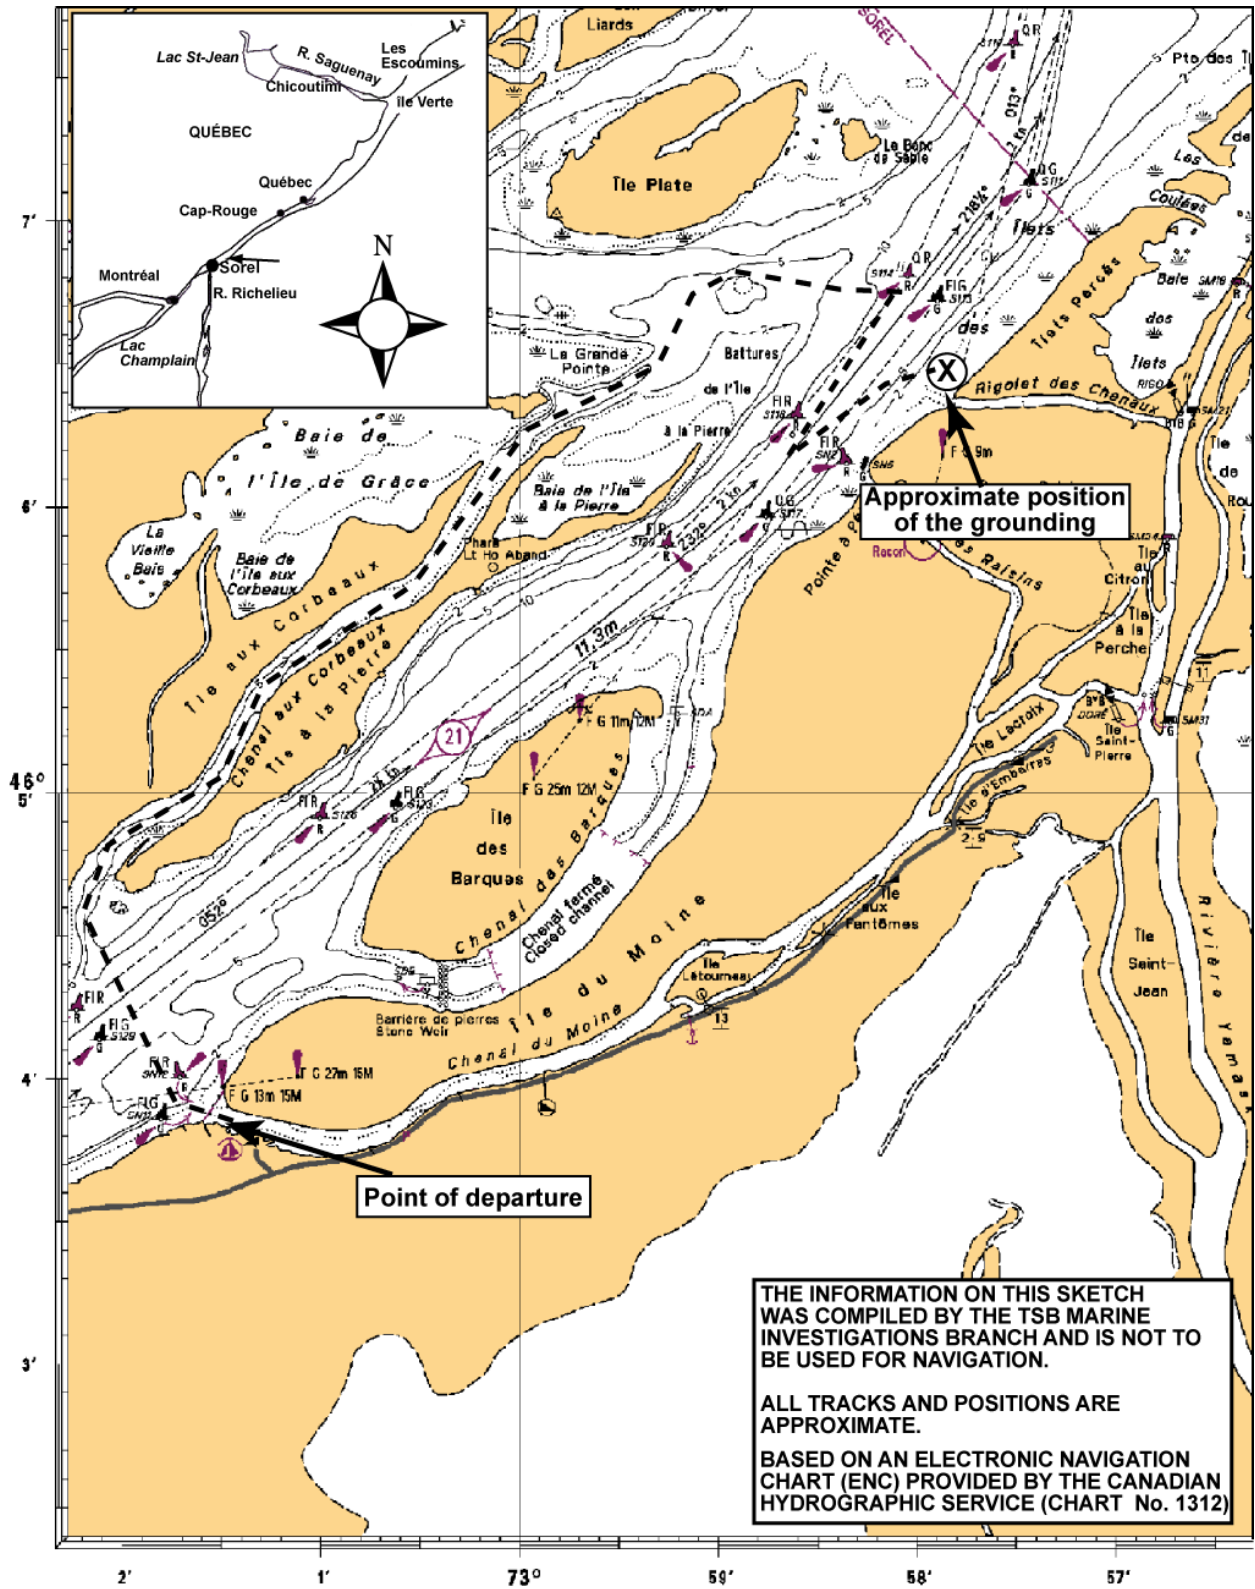
Appendix A – Area of Occurrence

Unaware of the vessel's position relative to the buoy, the master stopped the engines. The vessel drifted for a few minutes until, at 1435, while still in the squall, it grounded in mud at the entrance to Rigolet des Chenaux, in position 46° 06' 24" N, 072° 57' 58" W.
