Transportation Safety Board  
of Canada

**MARINE INVESTIGATION REPORT  
M11L0050**

**TAKING ON WATER AND ABANDONMENT**

**SMALL FISHING VESSEL *LADY JACQUELINE*  
OFF CAP DU PHARE, ÎLES-DE-LA-MADELEINE, QUEBEC  
21 MAY 2011**

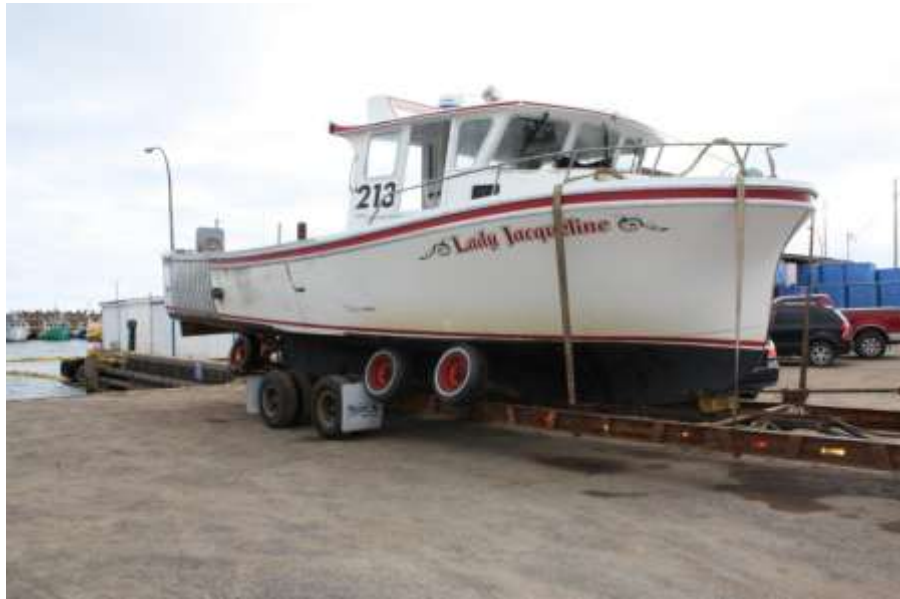
**Photo 1.** *Lady Jacqueline* at l'Anse-à-la-Cabane (Millerand) following salvage off Îles-de-la-Madeleine, Quebec

After recovery, the hull was examined and was found to be intact, but the machinery and equipment had extensive water damage. The lobster tanks were lost overboard. Only one of the 2 hatch covers to the engine compartment (the aftermost) was found to be secured to the deck opening. The remaining unsecured covers were found on deck, attached by their safety chain, but not in place (Photo 2). The vessel was subsequently repaired and put into operation.

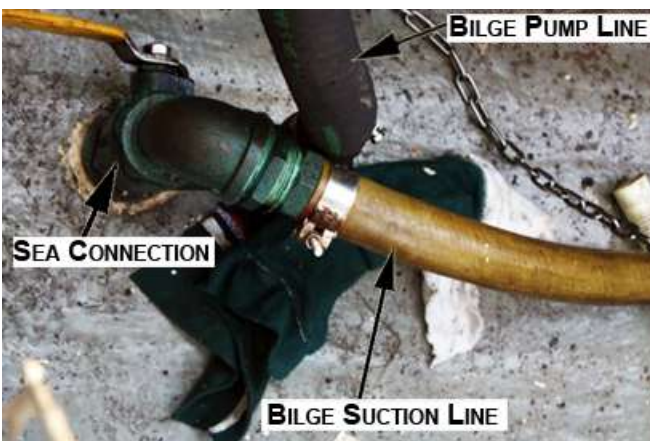
The mechanical pump, used primarily for deck washing, was fitted with a 3-way valve that permitted suction from either the sea or the bilge (Photo 3 and Figure 1). The valve was situated in the engine room, approximately 75 cm below the deck. Access to the valve was through the main engine forward hatch cover. There was no indication on the valve of the direction from which the valve was taking suction. Post-occurrence examination of this valve showed that it was positioned such that it was open approximately 80% to the bilge and 20% to the sea (Photo 4). The ball of the valve was rusted in the position in which it was found after recovery, indicating that the valve had not been operated for a long time.

**Photo 3.** Three-way valve

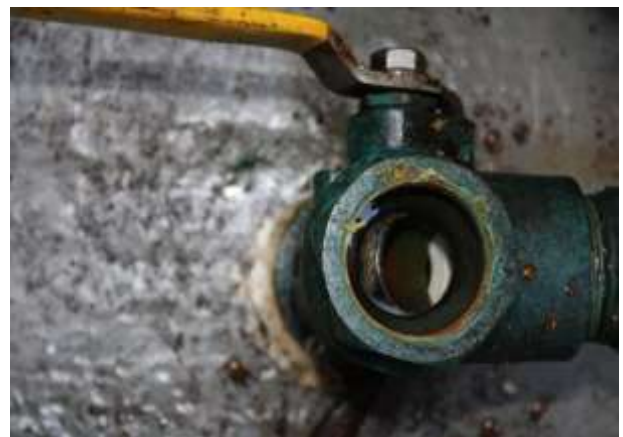
**Photo 4.** Three-way valve partially open to the sea

Furthermore, the 3-way valve was found open 20% to the sea and 80% to the bilge. In this position, when the pump was not running, water continuously leaked into the bilge since there was no non-return valve on the bilge suction line. The watertight integrity of the hull was therefore compromised.

1. The *Lady Jacqueline* left l'Étang-du-Nord with its 3-way valve partially opened to the sea. The vessel was continually taking on water below the waterline, through the valve and the bilge suction line, which was not fitted with a non-return valve.
2. While the crew hauled lobster traps, the vessel was manoeuvred with its stern exposed to the wind and the waves, which were in excess of 2 m, causing water to wash the deck through the freeing ports.
3. The electrical pump ceased to function because it was partly clogged and had a corroded circuit board. Water accumulated in the bilges without the crew being aware.
4. As the water level rose in the bilges, the trim increased by the stern, the freeboard reduced, and water accumulated on the deck.
5. Water progressively downflooded into the bilges through the unsecured hatch covers and the crew was forced to abandon the vessel.

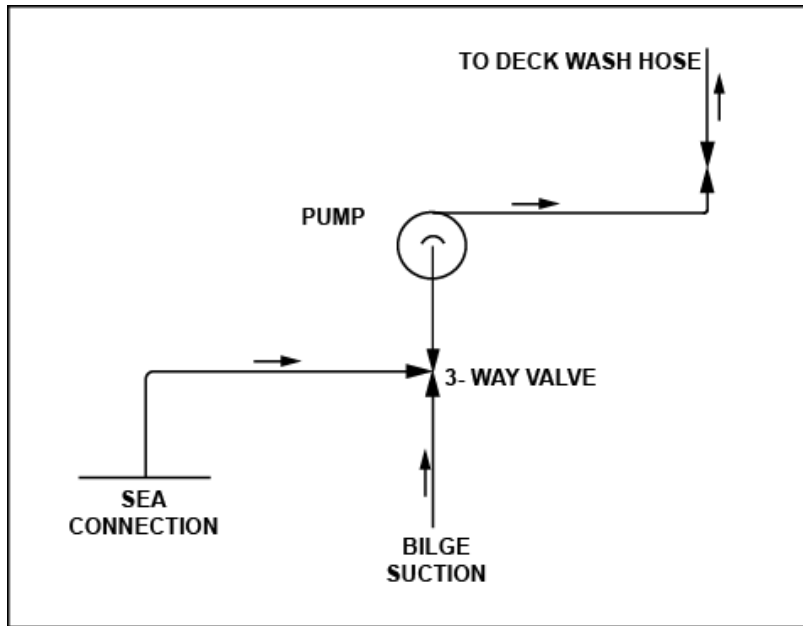
The sea connection was fitted without a shut-off valve. The bilge suction was fitted without a strainer or a non-return valve to prevent back-flooding. The pump discharge was only through the deck wash hose that was fitted with a nozzle, found in the closed position after the vessel was recovered. A schematic of the arrangement is shown in Figure 1.

**Figure 1.** Sketch showing the mechanical pump arrangement on the *Lady Jacqueline*

When comparing the bilge pumping arrangement of the *Lady Jacqueline* as shown in Figure 1 with the recommended bilge pumping arrangement in Figure 4, the following items were noted:

The *Lady Jacqueline* was built with a pumping arrangement that lacked essential components for safe operation. Small fishing vessels with inadequate bilge pumping arrangements may put the vessel and its crew at risk when there is ingress of water or downflooding.

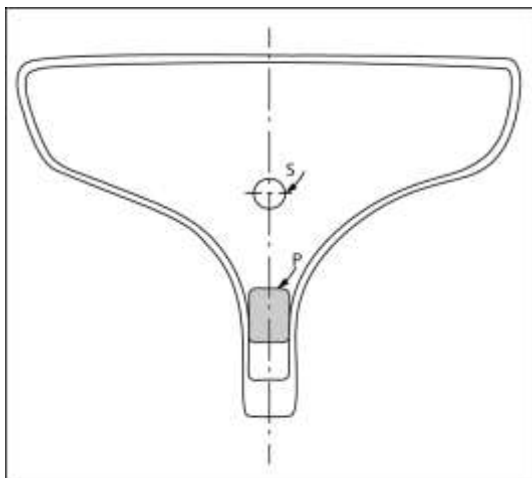
During the 2003 inspection, there were 2 electrical pumps fitted on the vessel. At the time of the occurrence, only 1 electrical pump was fitted on the keel, low in the skeg in a narrow space underneath the propulsion shaft. The position of the pump is shown in Figure 2 and Photo 5.

**Figure 2.** Position of electrical pump (P) beneath the propulsion shaft (S)

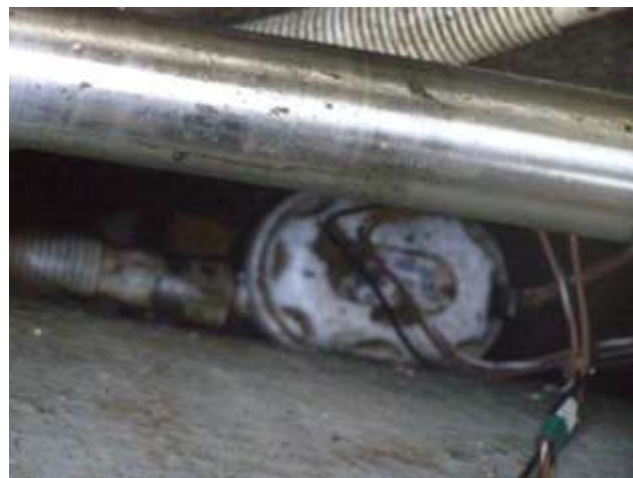
**Photo 5.** Position of electrical pump underneath the propulsion shaft

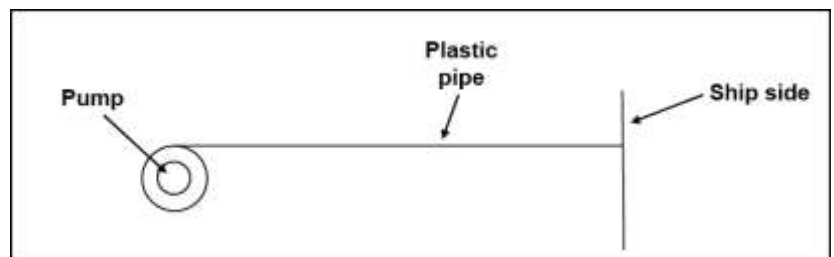
When the pump was installed, the mounting base was removed because of the reduced space available in the skeg. Examination of the pump after the occurrence found that the mounting base was not in place and the electrical pump was jammed into place. The overboard discharge for the pump was not fitted with a non-return valve (Figure 3).

Figure 3. Sketch showing electrical pump arrangement

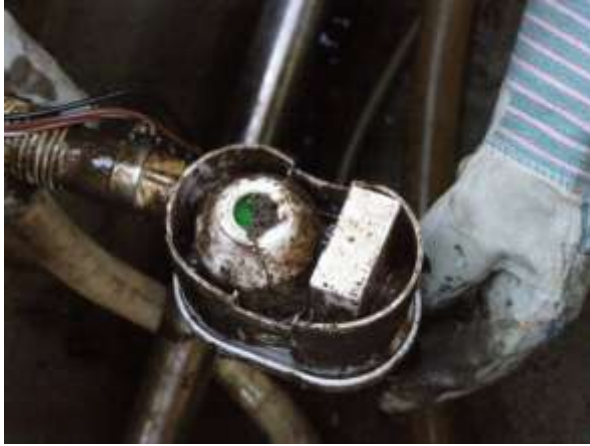
The post-occurrence examination and testing of the electrical pump found that the impeller of the pump was about 50% covered with Olefin fibre, which is commonly used in the manufacture of rope (Photo 6).<sup>8</sup>

**Photo 6.** The electrical pump coated in oil and the impeller partly obstructed with fibre; the mounting base/ strainer is not in place

- The pump was not installed using the provided mounting base, which also serves as a strainer, as specified by the manufacturer. This allowed solid materials in the bilges to interfere with the impeller, potentially causing a motor shaft imbalance that may have affected the integrity of the motor shaft seal.
- Water and silt penetration into the pump's inner housing contaminated and corroded the pump's circuit board, its components and the motor.
- The pump's efficiency in both operating modes was reduced due to damage to the circuitry and motor caused by water and silt penetration.
- The pump failed to operate as designed in its automatic mode due to water and silt penetration. The pump continued to run even when not immersed in water.

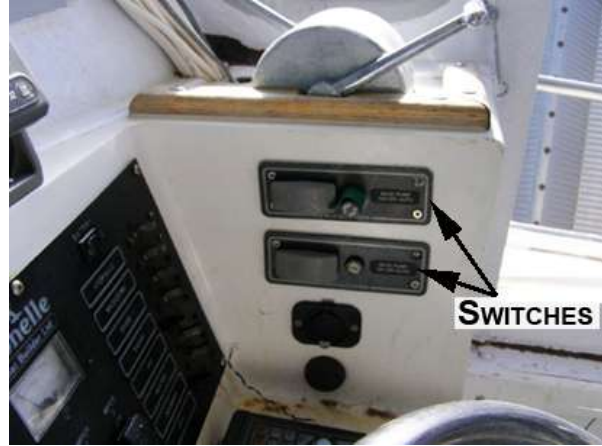
The 2 switches for the electrical pumps were located to the right of the wheel and below the throttle. These switches had 3 positions: on (manual), off, and automatic. Both switches were found in the off position during post-occurrence examination (Photo 7). The investigation could not determine when the switches were turned off.

**Photo 7.** The 2 switches for the electrical pumps in the console area

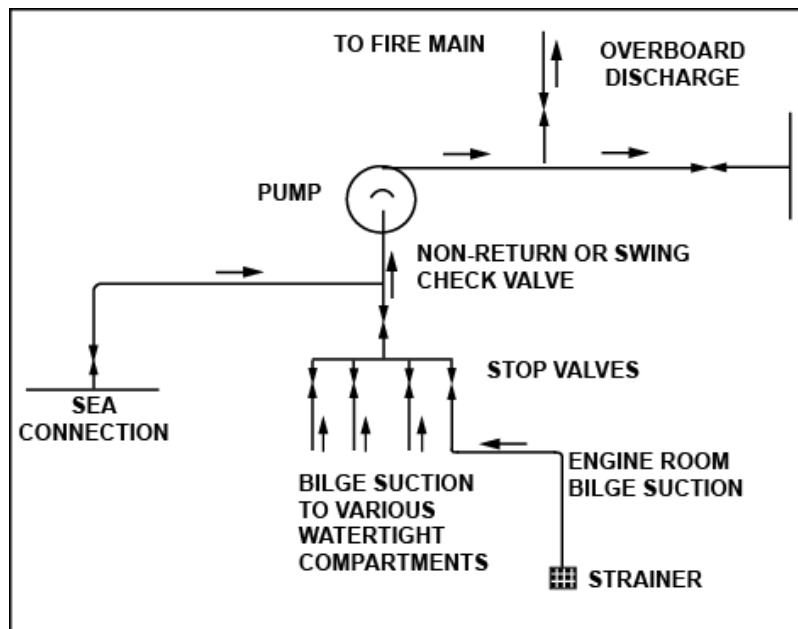
In 2003, TC issued its publication TP 10038, recommending the bilge pumping arrangement shown in Figure 4 below. Such an arrangement is normally comprised of at least one pump; a sea connection valve; a non-return valve installed on the bilge suction line to prevent back-flooding or ingress of water a strainer at each bilge suction line; and an overboard discharge valve.

**Figure 4.** Sketch showing recommended bilge pumping arrangement for small vessels. Reproduced from Transport Canada *Small Fishing Vessel Safety Manual*, publication TP 10038 E, (2003)

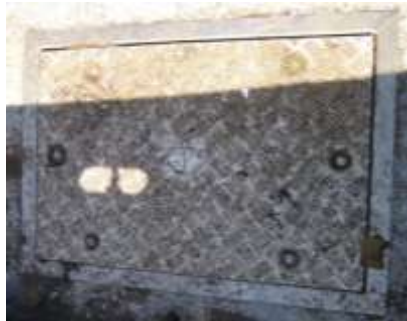
There were a total of 9 flush-deck openings (7 rectangular-shaped hatches and 2 round-shaped handholes) on the working deck of the *Lady Jacqueline* (Appendix A and Photo 8). Hexagonal bolts connected to dogs on the underside of the hatch covers were used to secure them (Photos 9 and 10). Most of the hatches had 6 hexagonal dog bolts with relatively large spacing between the bolts. The hexagonal bolts, approximately 15 mm in diameter, were recessed into the chequered plating.

**Photo 8.** Typical design of *Lady Jacqueline* hatch covers

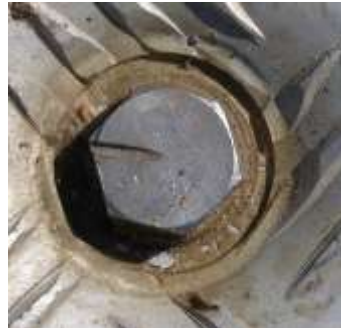
For the hatch cover to be secured watertight, the bolts had to be tightened individually because none of the covers had quick-action closing devices. To turn the hexagonal bolts to set the dogs, the crew used a tool with a 12-point socket. However, the bolts examined showed no evidence of use and most of the dogs were found rusted open (Photo 10). The rubber gaskets around the hatch covers were in place and showed no sign of excessive deterioration that could affect their watertight integrity.

**Photo 9.** Typical hexagonal bolt on hatch cover

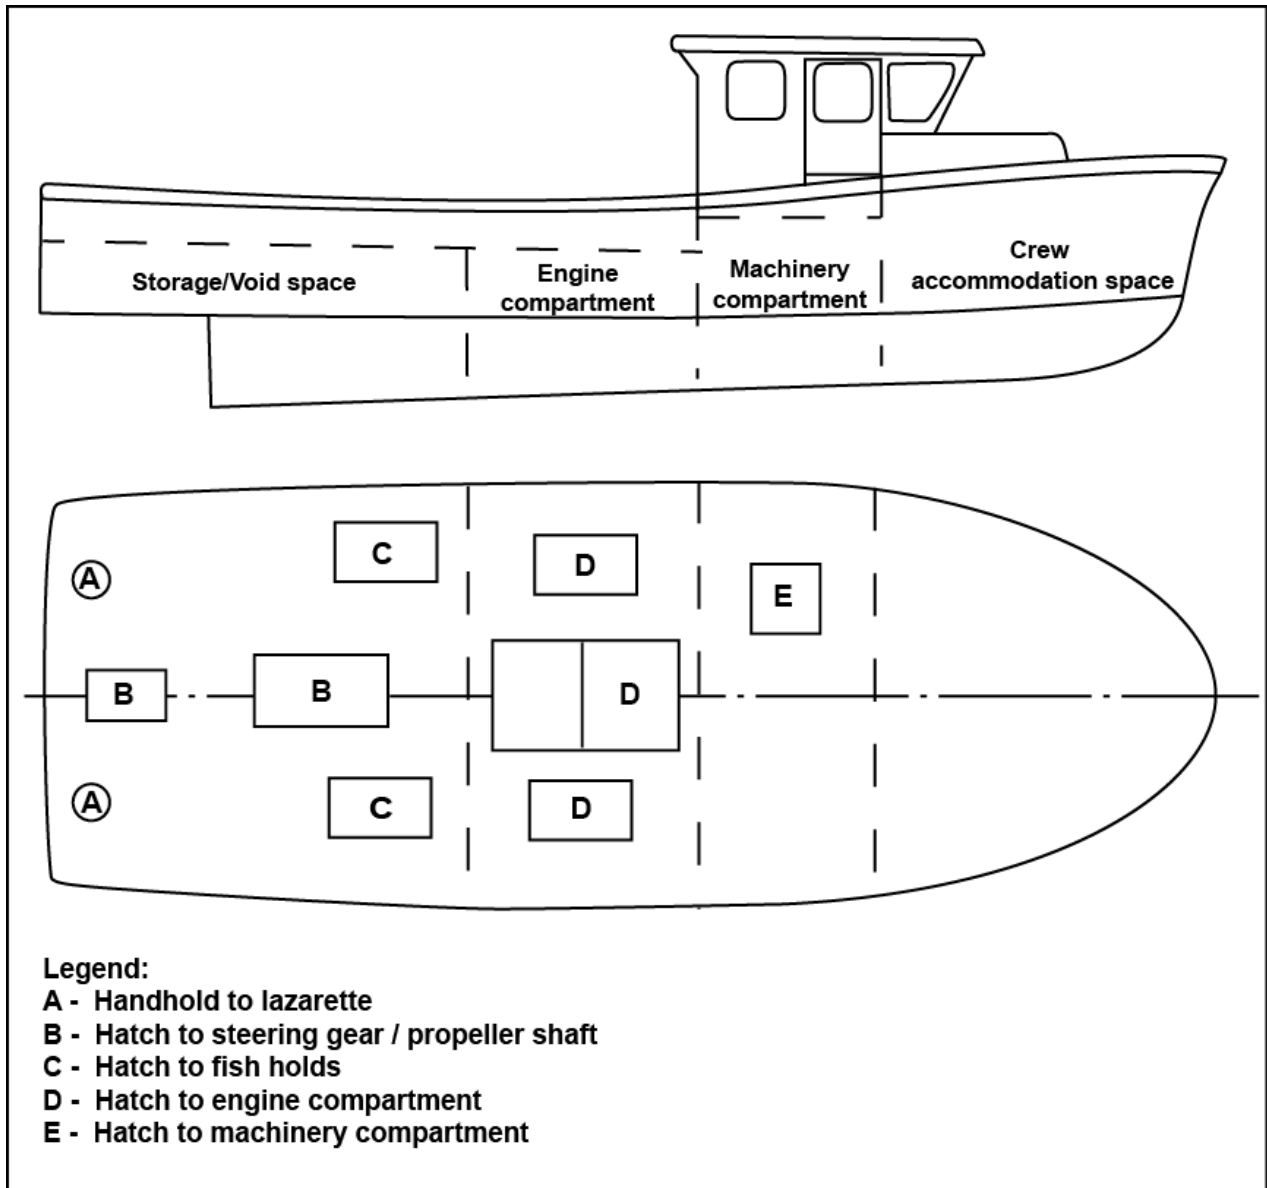
*Appendix A – General arrangement of the Lady Jacqueline*

The *Lady Jacqueline* is a Northumberland-style fishing vessel used mainly for crab and lobster fishing. The glass-reinforced plastic hull below deck is subdivided by 3 transverse non-watertight bulkheads that enclose, from forward, the crew accommodation space, the machinery compartment, the engine compartment, and the storage/void space (Appendix A).
