MARINE INVESTIGATION REPORT

M11W0199

STRIKING OF BERTH

**ROLL-ON/ROLL-OFF FERRY *QUEEN OF COQUITLAM*
DEPARTURE BAY, NANAIMO, BRITISH COLUMBIA
18 NOVEMBER 2011**

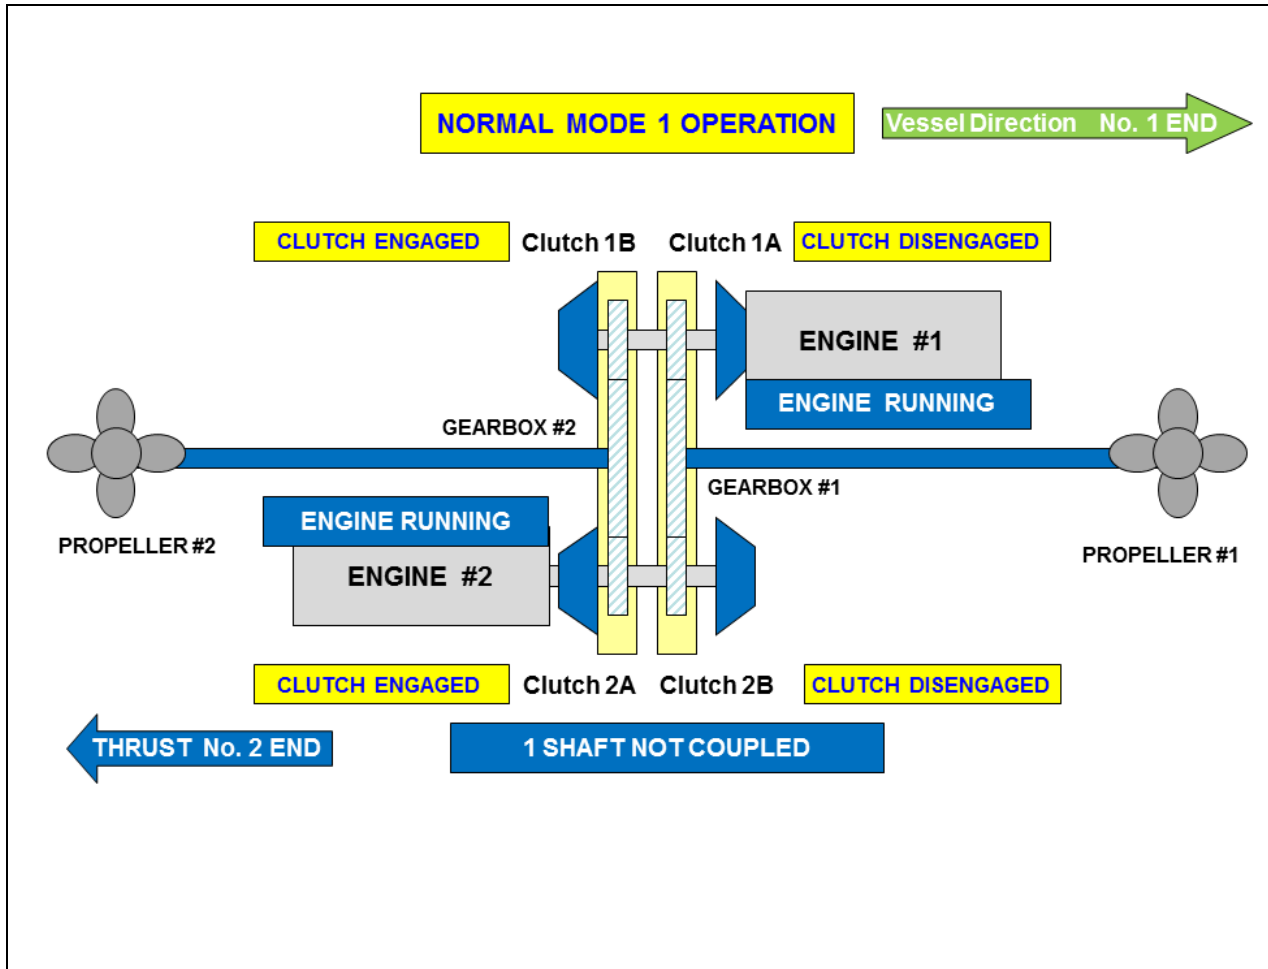
Figure 1. Mode 1 Operation

This mode is primarily used when the vessel has completed manoeuvring and is underway on passage.² In Mode 1, only the stern propeller is under power. Depending on the direction that the vessel is headed and how many engines are in use, the stern propeller can be engaged using a combination of clutches 1A and 2B or 1B and 2A (Figure 1). The forward propeller is feathered to reduce water resistance.

At 1341, the engine room staff members started the lockout procedure for the No. 1 main engine. They also locked out clutches 1A and 1B, thereby further isolating the engine from the reduction gear while the engineers worked on the No. 1 main engine, as per the vessel-specific manual (VSM) procedures. The C/E also decided to lock out clutch 2B, which provides the link between the No. 2 main engine and the forward propeller.

When a problem occurred with 1 of the injectors of the No. 1 main engine, the engine room staff attempted to resolve the problem. Initial attempts were not successful, and the C/E decided to take the No. 1 main engine offline to conduct repairs. Using the company's VSM checklist, the C/E made preparations in the engine room to change out the leaking injector. Part of this process included locking out the clutches linking the No. 1 main engine to both shafts (clutches 1A and 1B). During this procedure, clutch 2B was also locked out, which prevented Mode 2 from being available to the bridge as the vessel approached the berth.

Because the VSM did not clearly specify which clutches to isolate in various operational conditions, the manoeuvrability of the vessel was reduced when clutch 2B was isolated.

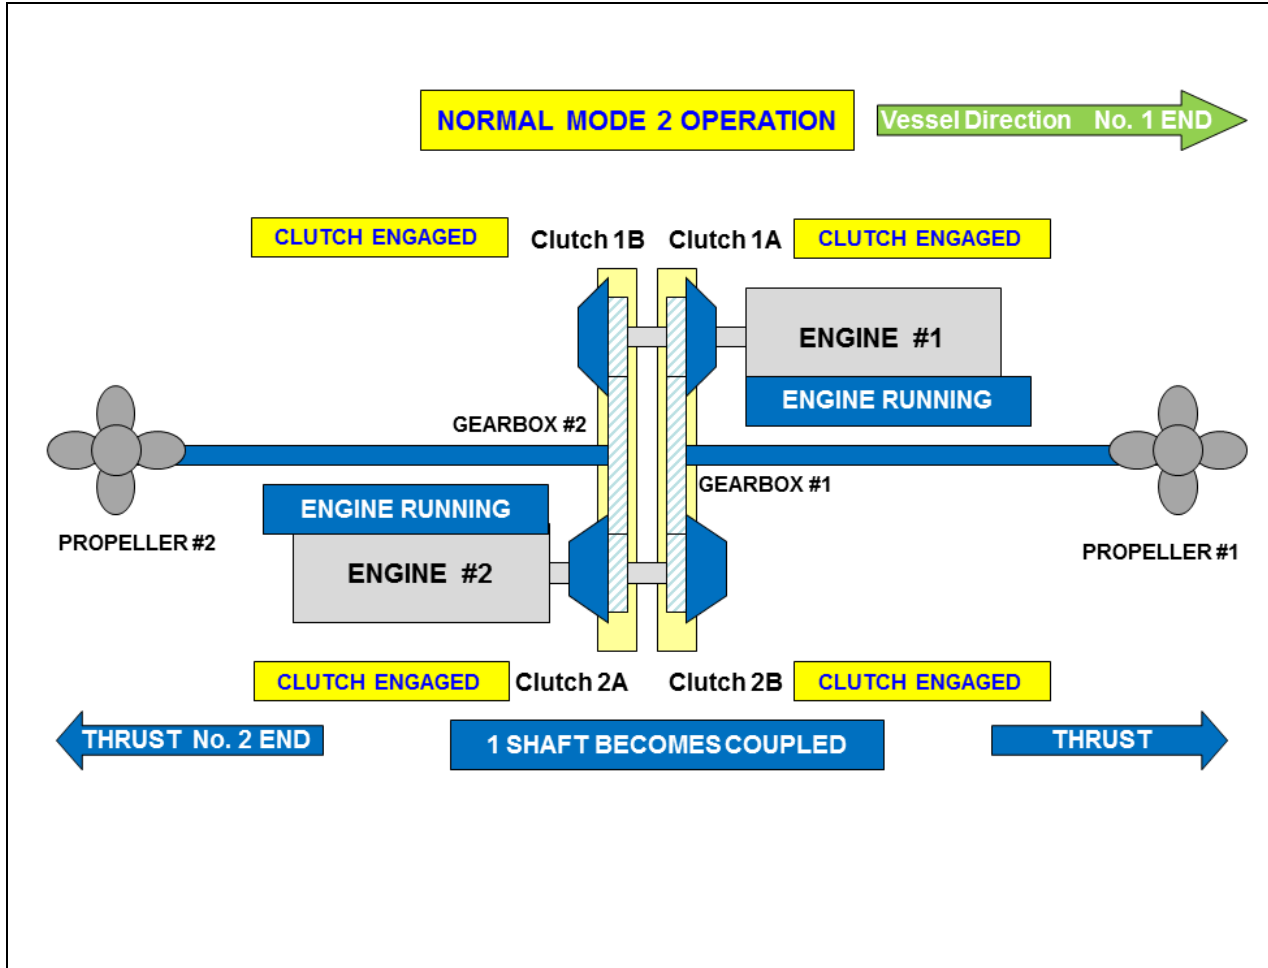
Figure 2. Mode 2 Operation

This mode is primarily used during docking and undocking. In this mode, if both engines are in use, all 4 clutches are engaged and provide power to both propellers (Figure 2). It takes approximately 90 seconds to engage Mode 2, as the bow propeller cycles from feathered to a pitch setting that allows the clutches to engage.

Following the master's attempt to engage Mode 2, the 2/O noticed that Mode 2 had not engaged. ⁸ The master called the engine room to find out why Mode 2 had not engaged. The C/E informed the master that Mode 2 was not available. If Mode 2 had been engaged at this point, it would have taken approximately 90 seconds for the propeller to feather to the right position and then for the clutch to be engaged. Without questioning the C/E as to why Mode 2 was not available, the master decided to berth the vessel using Mode 1. He had previously performed this type of docking. The vessel had less power to reduce speed and only the stern propeller to manoeuvre with.

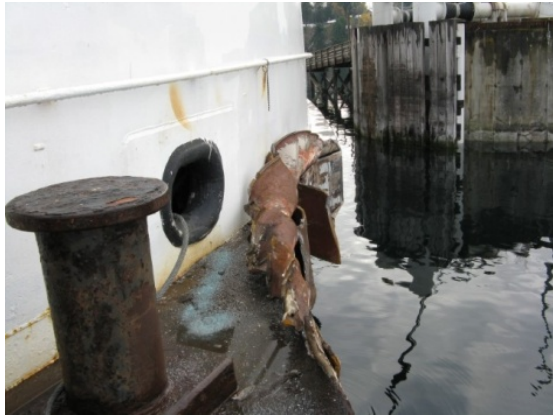
The damage to the vessel was confined to the No. 1 end port bow rubbing strake (Photo 2). The damage between frames 90 and 96 was approximately 7.0 m in length and up to 1.0 m in depth. This resulted in a breach of the hull into the No. 1 end rudder compartment. The plating of the superstructure adjacent to this area was also buckled.

Photo 2. Damage to port rubbing strake

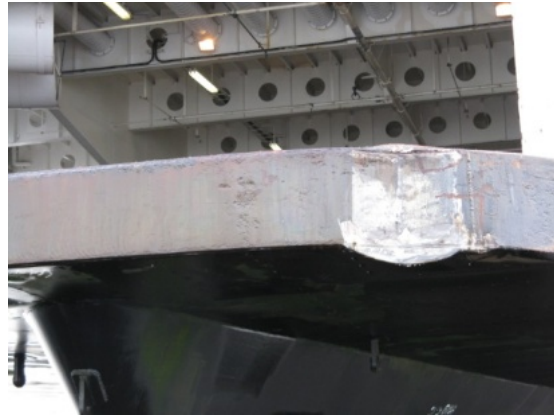
There was a large indentation in the rubbing strake to port of the centreline of the vessel, where the initial contact occurred. This indentation had a width of approximately 0.6 m and a maximum depth of 0.1 m (Photo 3).

Photo 3. Damage to rubbing strake near centreline

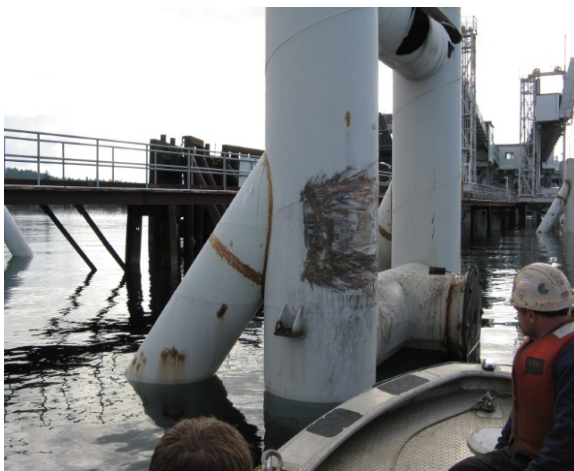
Damage to berth 2 (Appendix B) was limited to the port-side leads. This included damage to the outermost port-side fender and its articulated pad. As a result of the collision, the complete articulated landing pad broke free from the fender and ended up on the ocean floor. The attachment points between the fender and the articulated landing pad were torn away (Photo 4).

Photo 4. Port-side fender showing point of contact and missing pad
