MARINE INVESTIGATION REPORT
M13W0057

STRIKING OF THE HMCS WINNIPEG

FISHING VESSEL *AMERICAN DYNASTY*
ESQUIMALT, BRITISH COLUMBIA

23 APRIL 2013

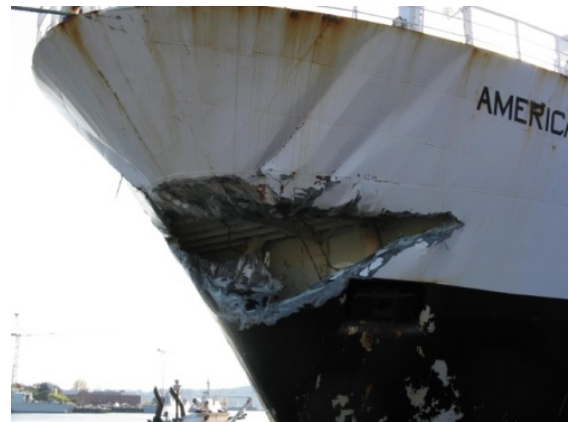
Photo 2. *American Dynasty* damage

The vessel primarily sustained damage to the bow (Photo 2). The shell plating between the main deck and forecastle deck was pushed inward from stem to approximately frame 3B portside and 4A starboard side, splitting open the forepeak tank. The port bow shell plating between forecastle deck 1 and forecastle deck 2 was buckled from frame 5 to frame 4B, as was the deck plating in the forward store. The starboard bow shell plating was buckled between the same decks from frame 5 to frame 3.

Internals in the chain locker space (from the stem to the anchor pocket plating on the port and starboard sides) were deformed. The upper forward corner of the port anchor pocket was also deformed.

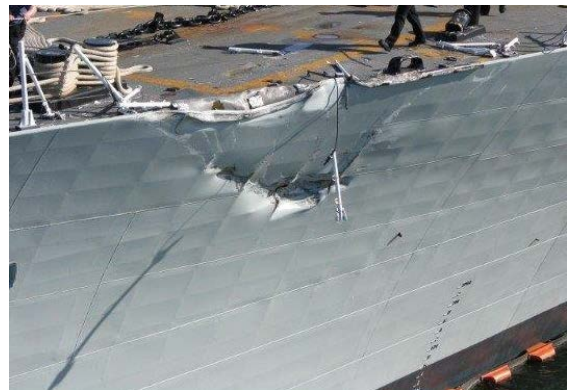
Photo 3. Damage to the HMCS *Winnipeg's* port side

The vessel primarily sustained damage to the bow. The port side shell plating was punctured between frames 1.5 and frame 3, and the associated longitudinals and web frames were damaged (Photos 3 and 4).

Local buckling of decks and bulkheads in the immediate vicinity of the impact also occurred. The starboard side shell plating sustained punctures and dents and some of the associated longitudinals and web frames were damaged. The starboard stern corner was deformed, as were the associated longitudinals and tripping brackets.

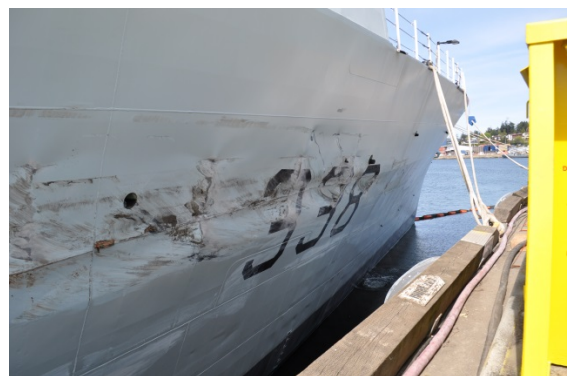
Photo 4. Damage to the HMCS *Winnipeg's* starboard side

The transverse watertight bulkhead at frame 12 was buckled, as was the bulkhead at frame 18. An underwater survey carried out by divers indicated scrapes and damage to the stern flap on the starboard side.

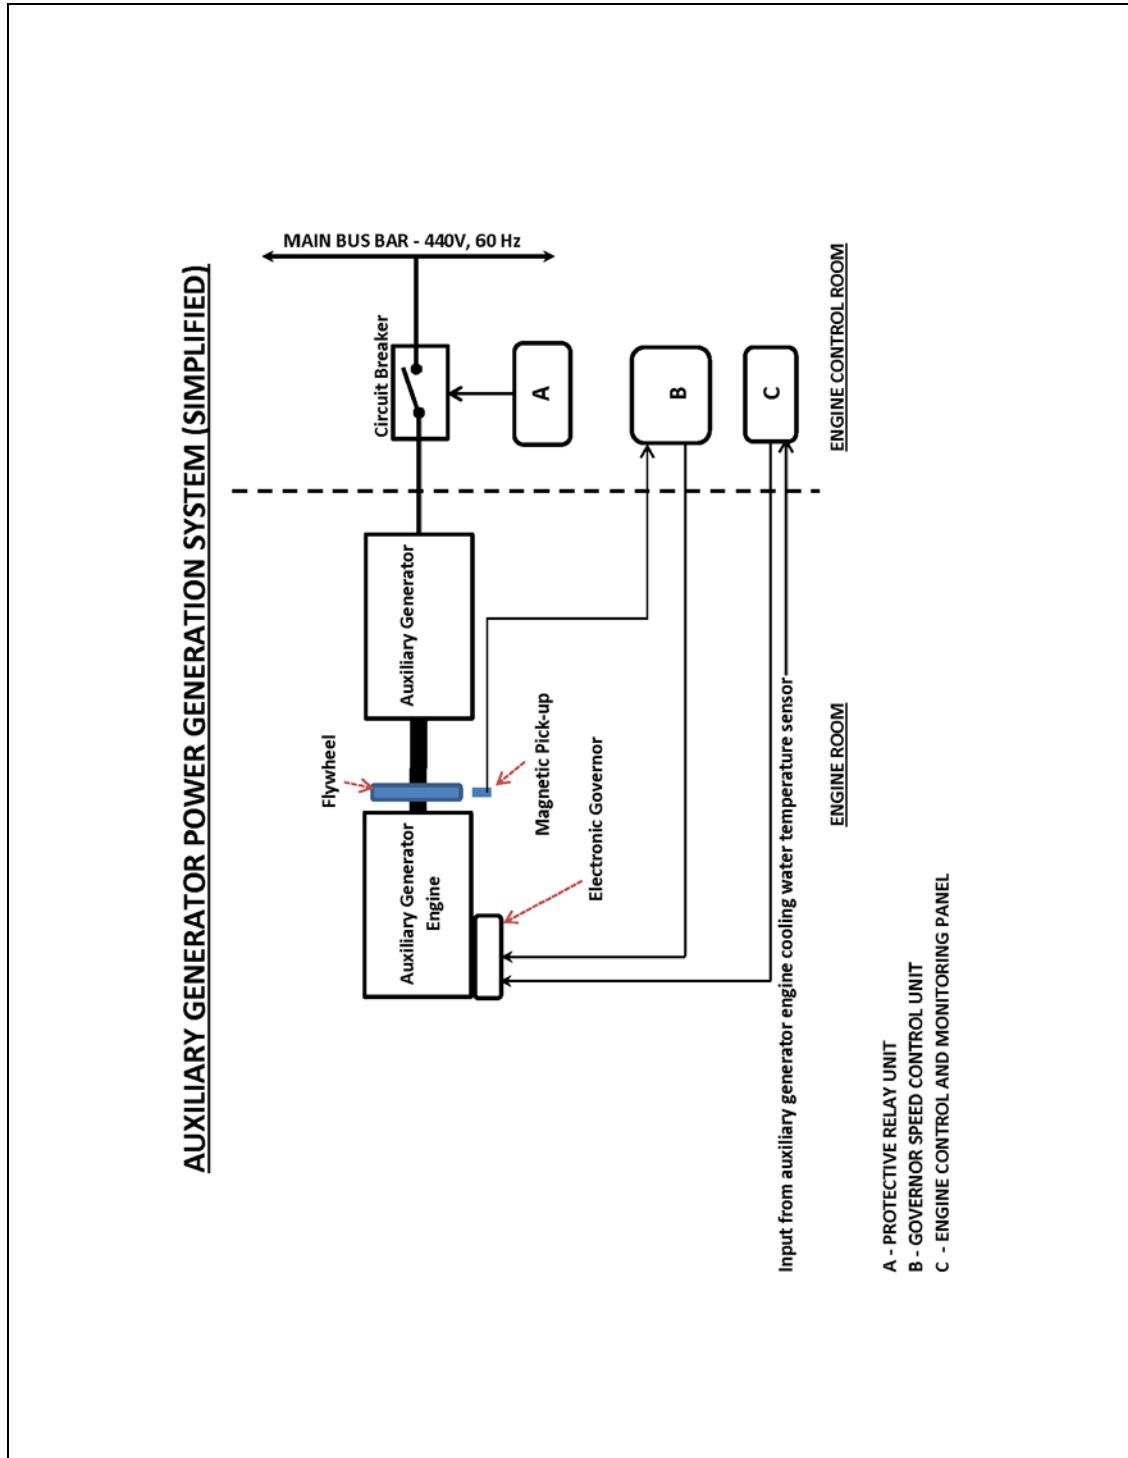
Appendix D – Main power generation

On the *American Dynasty*, main electrical power can be provided by either the shaft generators, the auxiliary generator,²¹ or all 3 simultaneously. At the time of the occurrence, the auxiliary generator was in use. The auxiliary generator is driven by a diesel engine that is fitted with a protective relay unit²² as well as an engine control and monitoring panel that can be used to check engine parameters such as the engine cooling water temperature (Appendix D).

The engine also has an electronic governor with a speed control unit that is used to control and maintain a constant engine speed. The speed control unit receives signals from a magnetic pick-up²³ and these signals are used to regulate engine speed. The speed control unit is designed to shut the engine down if the magnetic pick-up fails.

Post-occurrence, the face of the magnetic pick-up was found to be damaged. In addition, the auxiliary engine's speed sensing failsafe unit (located inside the electronic governor's speed control unit) was found to be bypassed by a jumper wire. Bypassing the speed sensing failsafe unit would deactivate the failsafe circuit and would prevent the engine from shutting down.

Although the exact reason for the blackout could not be determined,³¹ the most likely cause was a damaged magnetic pick-up of the auxillary generator speed control unit. This damage resulted in the intermittent transmission of signals from the the magnetic pick-up to the speed control unit. The speed sensing part of the control unit was also bypassed by a jumper wire.³² When this part of the control unit is bypassed, it is unable to shut down the engine if the magnetic pick-up is malfunctioning, allowing fluctuations in the electrical frequency to occur. Furthermore, when the bow thruster motor was switched off, a large load was suddenly taken off the auxillary generator, which may have caused the frequency to fluctuate above the maximum limit of the protective relay unit.

- Posted an operating procedure to ensure that the emergency generator is set to start automatically;
- Replaced the non-functional set of emergency back-up batteries;
- Replaced the magnetic pick-up sensor and governor speed control unit;
- Tested the auxiliary generator engine for all alarms and tripping functions;
- Overhauled the pitch control oil distribution box; and
- Replaced the pitch control actuator.

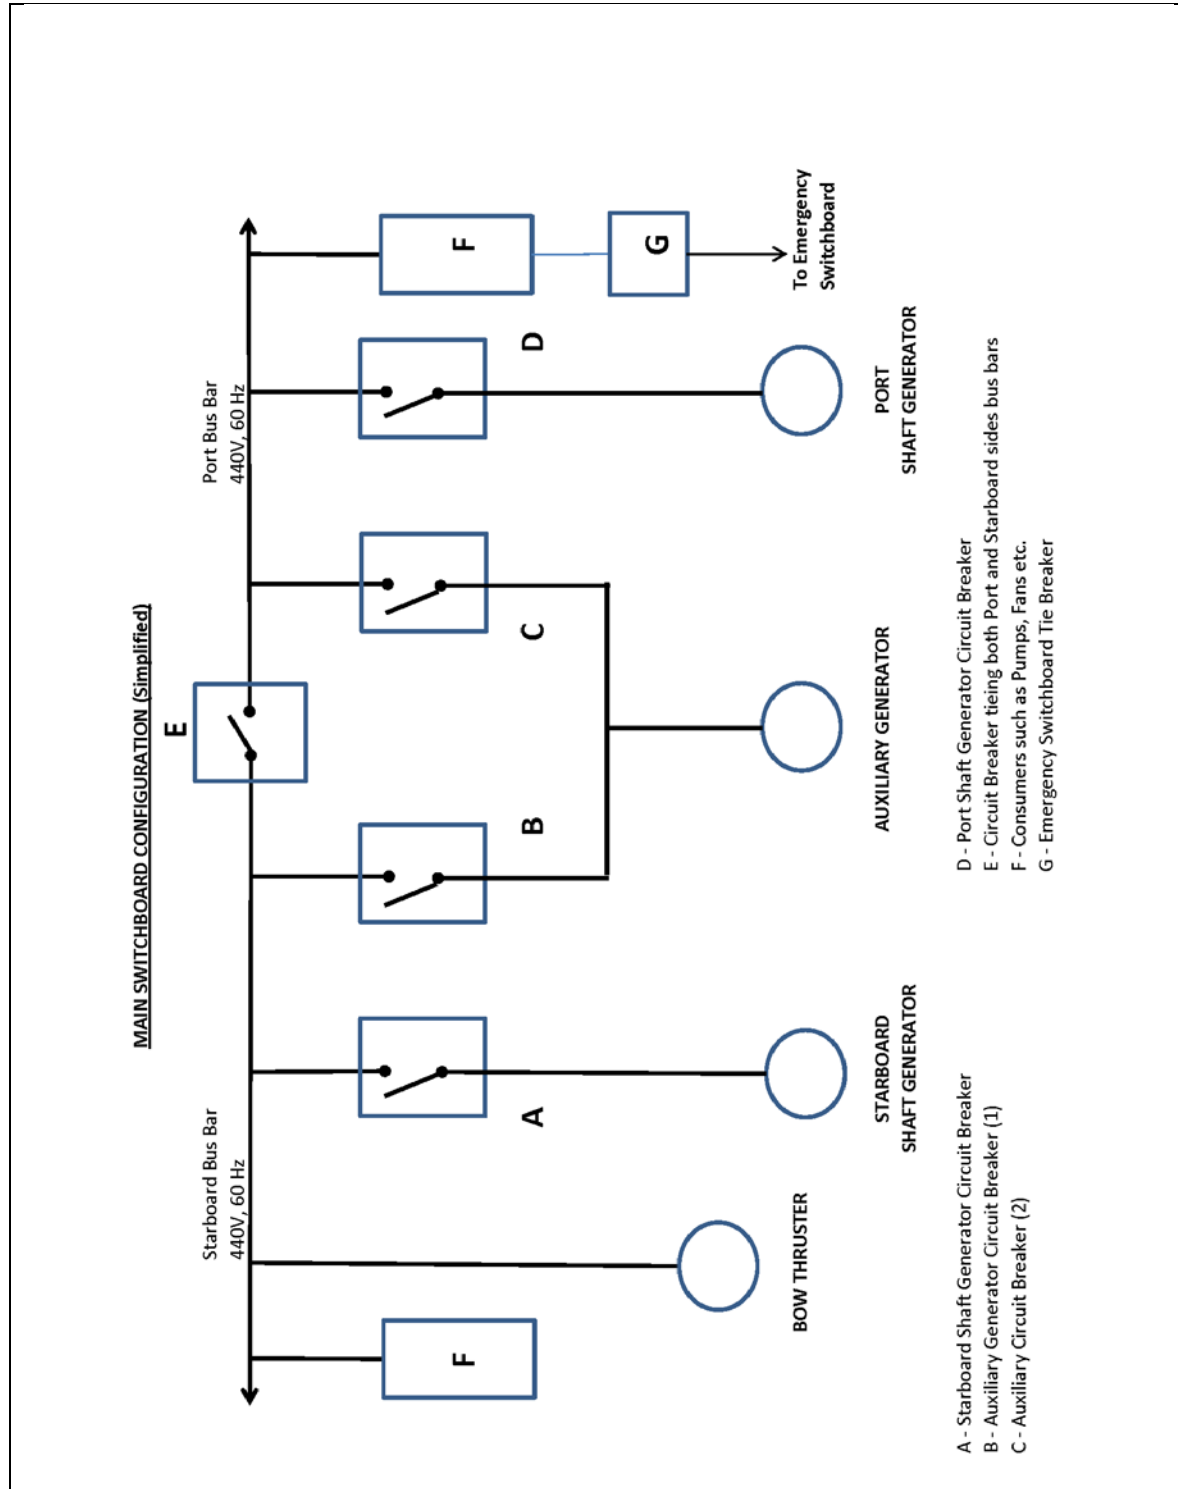
Appendix E – Main switchboard configuration

The distribution of power from the generators to the various systems on the *American Dynasty* is controlled by the main switchboard, which is located in the engine control room. Under normal circumstances, to put one of the vessel's generators on the main switchboard, a rotary synchroscope²⁶ needs to be manually adjusted to synchronize the phase rotation, after which time the circuit breaker for that generator can be engaged. At the time of the occurrence, the auxiliary generator was supplying the electrical power required for the safe navigation of the vessel. As such, additional power from both shaft generators was deemed unnecessary and the shaft generators, though running, were not put on the main switchboard (Appendix E).
