**MARINE INVESTIGATION REPORT  
M14A0051**

**FLOODING AND SUBSEQUENT GROUNDING  
BULK CARRIER *JOHN I*  
OFF THE SOUTHWEST COAST OF  
NEWFOUNDLAND AND LABRADOR  
14 MARCH 2014**

14 March 2014

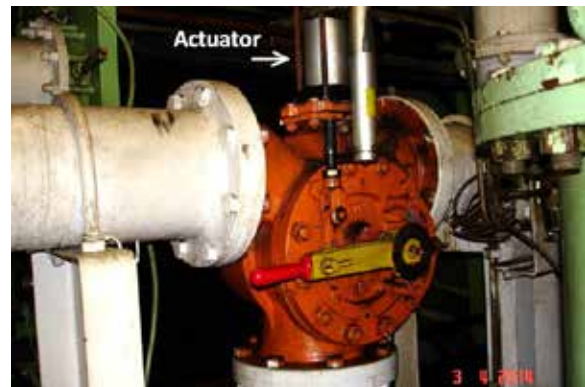
Photo 2. Lubricating oil 3-way valve on the *John I* showing actuator and associated components in place

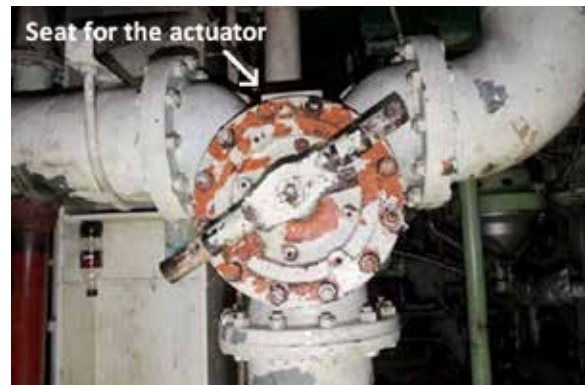
The post-occurrence examination found that the 3-way valve on the *John I* was set so that the warmed sea water leaving the various main engine heat exchangers was being partially discharged overboard and partially returned to the main sea water pump suction.

Although the seat for the actuator assembly on the 3-way valve was still in place at the time of the occurrence and the valve was shown to be fitted with an actuator on the main and auxiliary sea water cooling system drawings, the actuator and its components had been removed (Photo 3). As such, the 3-way valve could only be operated manually. The time at which the actuator had been removed is unknown.

Photo 3. Sea water 3-way valve without actuator installed (this photo has been rotated 180° for comparison with Photo 2)

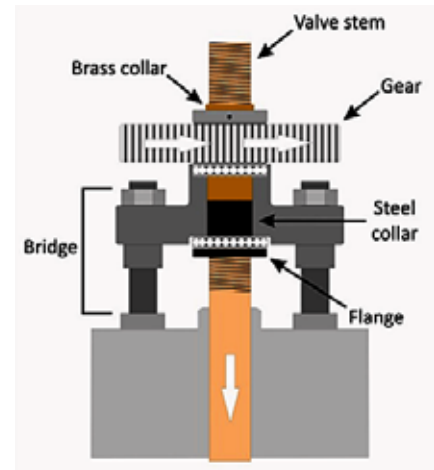
Figure 1. Valve operating mechanism

On the *John I*, the low sea chest angle valve is opened and closed via a gear mechanism. Rotation of a large gear moves the valve stem up and down through 2 collars that are threaded together to form a single unit.<sup>18</sup> The upper collar is made of brass and the lower is made of steel (Figure 1). The brass collar has internal threading for the valve stem, while the steel collar does not. The valve stem and collars are held in place by a bridge (secured to the valve body). The steel collar has a flange that holds the valve operating mechanism in place when an upward force is exerted on the valve disc.

Post-occurrence, the brass and steel collars were found to have separated. Reassembly of the collars demonstrated that they did not fit together well.

The brass threads did not engage with the steel threads until the brass collar had been well inserted in the steel collar, and the threads on the bottom end of the brass collar were in poor condition; however, neither collar showed signs of thread stripping.<sup>19</sup>

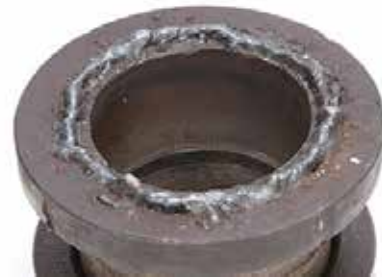
Thread locking compound<sup>20</sup> residue was found on both collars; this compound was the only means of preventing disengagement of the collars. The underside of the flange on the steel collar was found to have a pre-existing weld (Photo 4).

Photo 4. Weld repair on steel collar

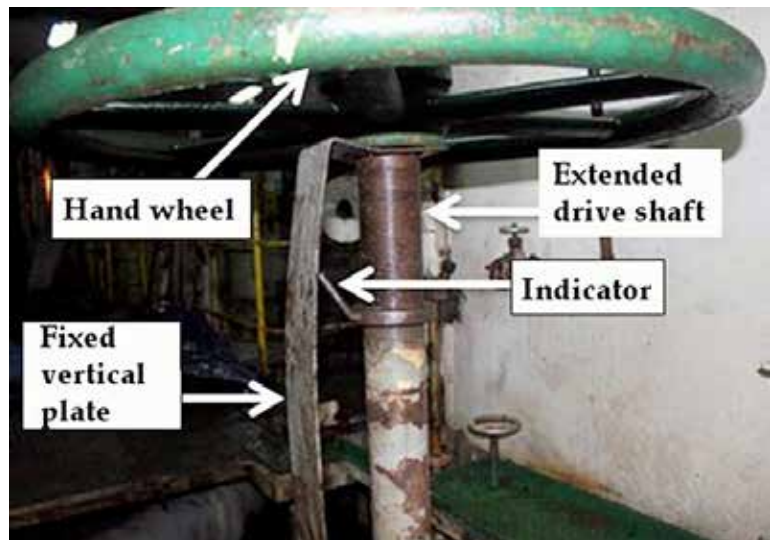
Each valve position indicator consisted of a fixed vertical plate marked at the top, open, and at the bottom, closed. The plate had a vertical slot, within which an indicator affixed to threads on the valve extended drive shaft would move up or down indicating the position of the valve disc as the extended drive shaft was turned (Figure 2). The post-occurrence inspection found that the vertical plate of the valve position indicator located at the grating deck was bowed outwards and its indicator was bent upwards and therefore no longer fitted within the slot in the fixed vertical plate (Photo 5).

Photo 5. Hand wheel and bent valve position indicator no longer within the bowed fixed vertical plate at grating deck level

In this condition, the indicator could turn freely within the valve extended drive shaft and not be moved up or down by the effect of the threads on the shaft, preventing the indication of the position of the valve disc when in operation. The valve position indicators for the high and low sea chest valves at 5 other locations were found in various states of disrepair, rendering them unreliable (Photo 6 and Photo 7).

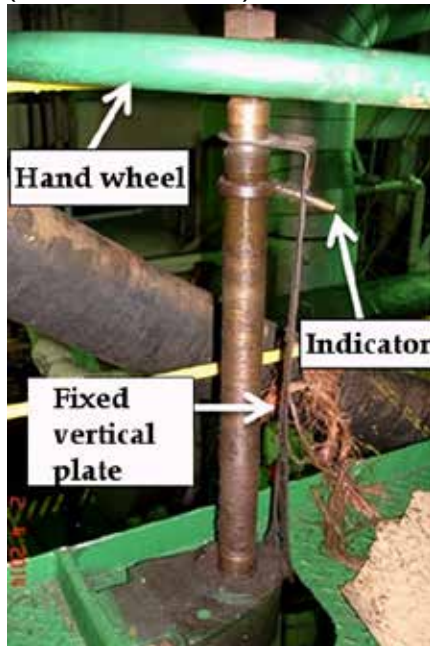
Photo 6. Hand wheel with a deformed fixed vertical plate and bent indicator (on second deck level)

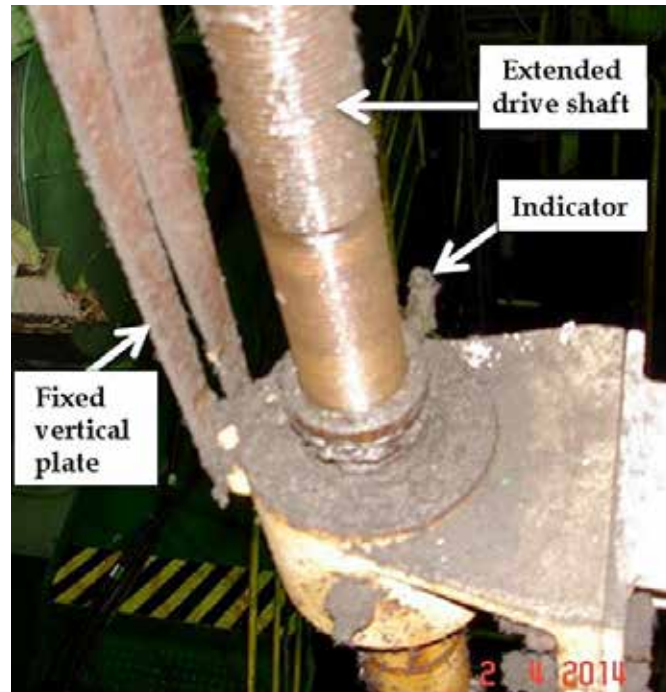
Photo 7. Indicator no longer within the fixed vertical plate (on the third deck level)

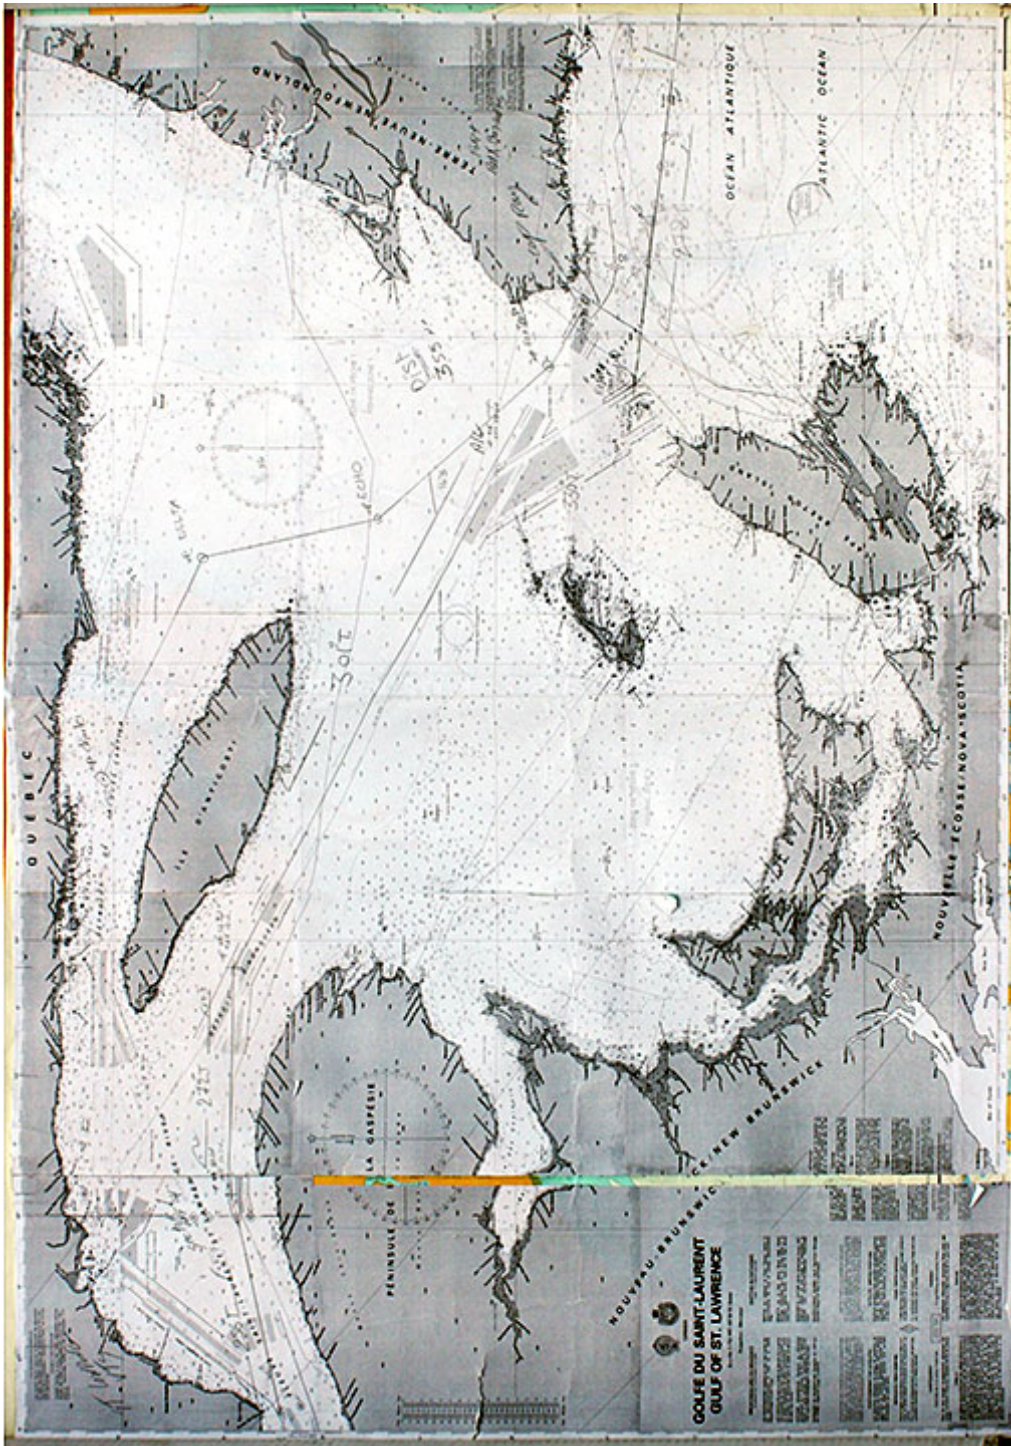
### Appendix A – Photograph of the chart carried on board the John I

As the *John I* drifted, the master was plotting the vessel's position; however, the on-board small-scale photocopied chart provided little detail of the hazards along the shoreline. With no other navigational information, the master was unaware of the steep rise of the sea bed and the presence of shoals along the coastline where the vessel was drifting.

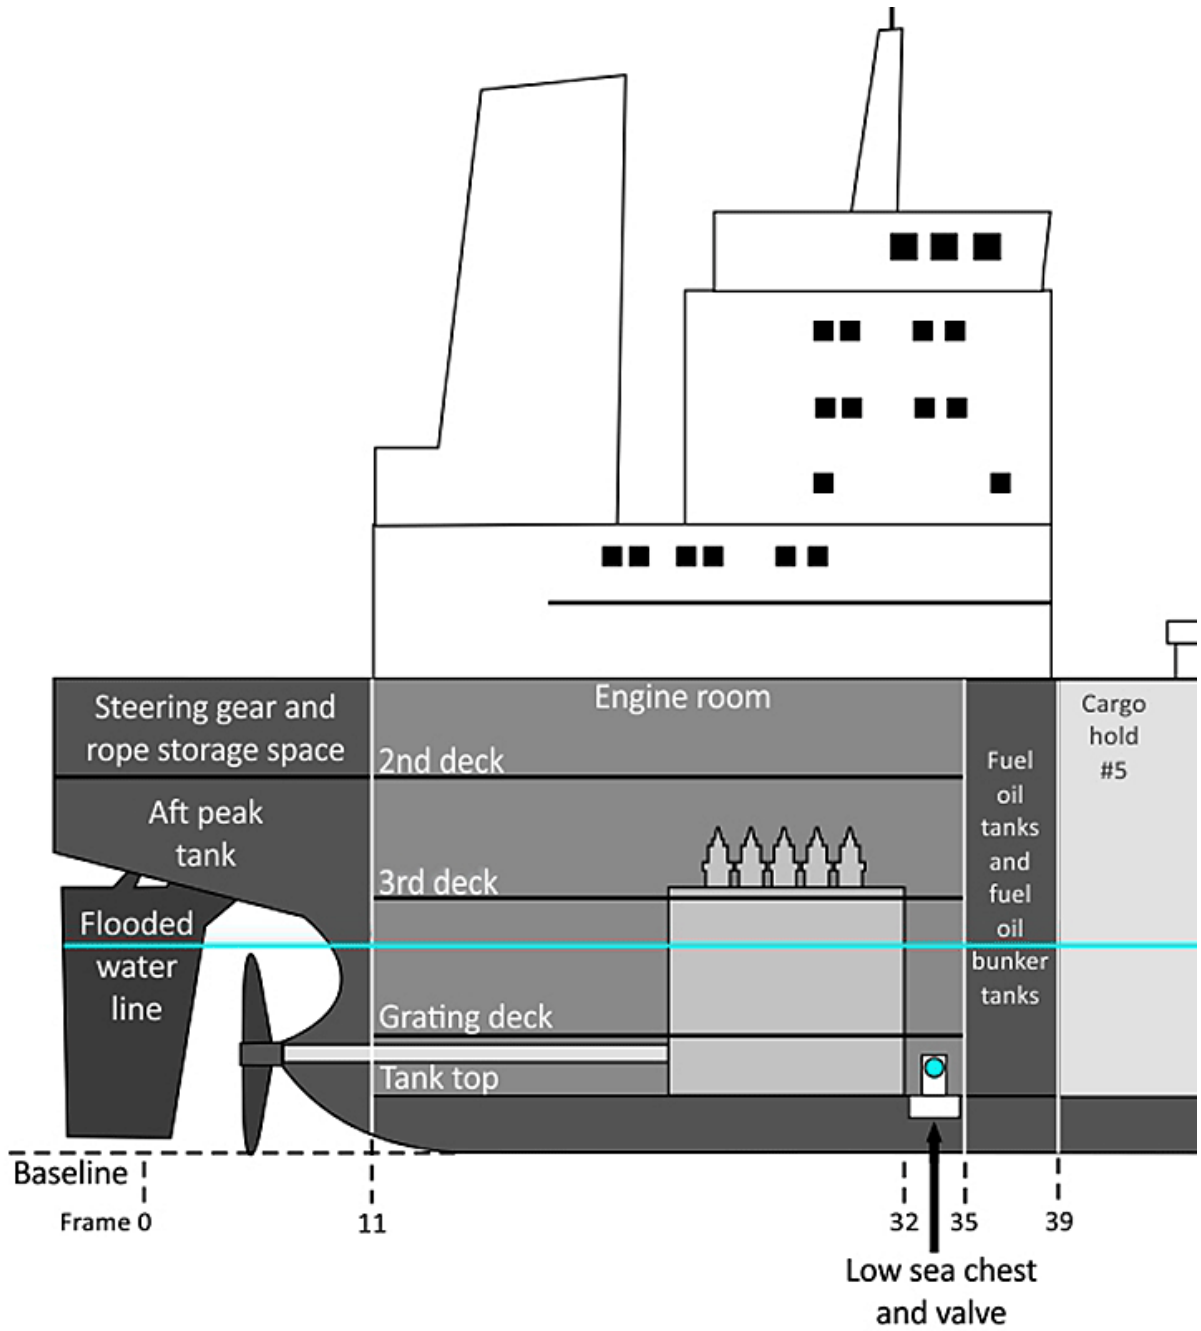
*Appendix D – John I profile up to frame 39*

The hull sustained tears, punctures, and dents. The damage was mainly concentrated on the port side of the vessel, approximately from midships to frame 32, which is located 5.6 metres aft of the engine room forward bulkhead (Appendix D). The engine room machinery and electrical components located below the flooded waterline<sup>12</sup> were rendered inoperable.

Note: "Flooded waterline" indicates the level of water ingress in the engine room after the flooding.
