**MARINE INVESTIGATION REPORT
M14C0045**

GROUNDING

**CHEMICAL/PRODUCTS TANKER *HALIT BEY*
GRONDINES, QUEBEC
22 APRIL 2014**

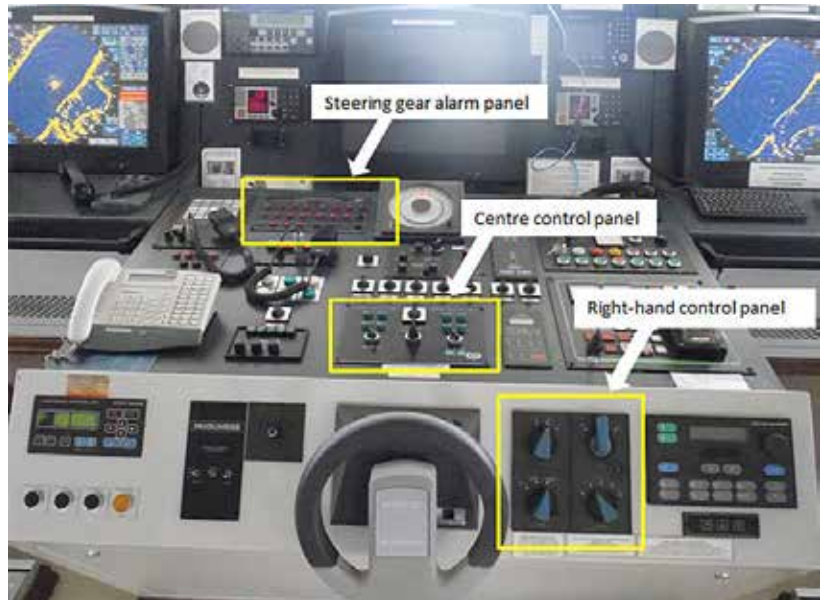
Photo 2. *Halit Bey's* bridge main console

At the time of the *Halit Bey's* construction, the shipbuilder installed 2 different steering gear control panels on the bridge main console: the centre control panel and the right-hand control panel (Photo 2). These 2 control panels had been manufactured by different companies.

On the centre control panel, in addition to the starter switches for the 2 steering gear pumps, there is a single selector switch to toggle between 5 different steering gear system modes: (0) OFF, (1) NON-FOLLOW UP, (2) FOLLOW UP, (3) AUTOPILOT, and (4) WINGS (Photo 3).

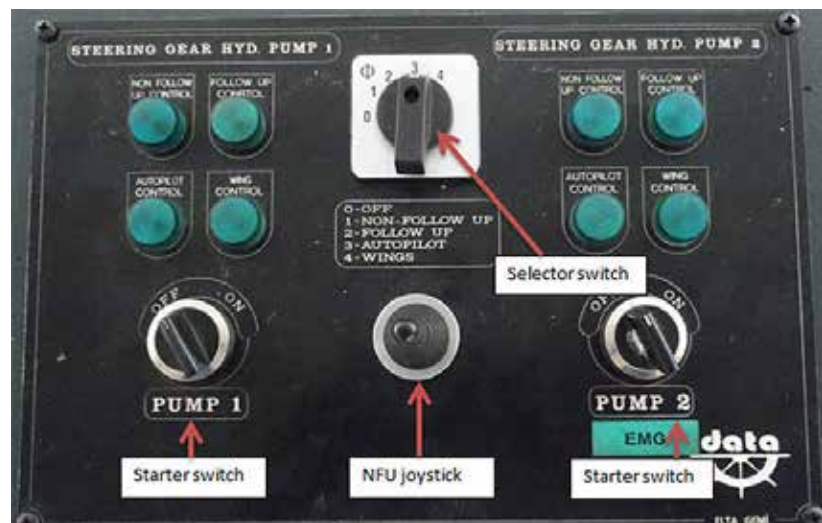
Photo 3. Close-up view of centre control panel

There is also a short black joystick that can be used to steer the vessel when it is operating in NFU mode; however, on the *Halit Bey*, it was not the practice to use this joystick. The joystick is positioned in the middle of the centre control panel and does not have an identification label, nor does it have a protective covering or any other locking feature to prevent accidental activation.

On the *Halit Bey*, there are 7 NFU steering controls; one is the short black joystick located on the centre control panel (Photo 3), one is the blue tiller switch located on the right-hand control panel (Photo 4), and one is an identical blue tiller switch located at the far right end of the bridge main console, between the voyage data recorder repeater display and the shipboard internal telephone. Each wing console also has 1 tiller joystick and 1 tiller switch. None of the NFU steering controls are fitted with protective safeguards.

- Although position 3 on the centre control panel does not engage the autopilot, the associated autopilot override can still be activated by touching the black NFU joystick located on the centre control panel. Only a light touch of the joystick is necessary to activate the autopilot override. The autopilot override can be activated not only when the vessel is operating in autopilot, but also when it is operating in follow-up or NFU mode.

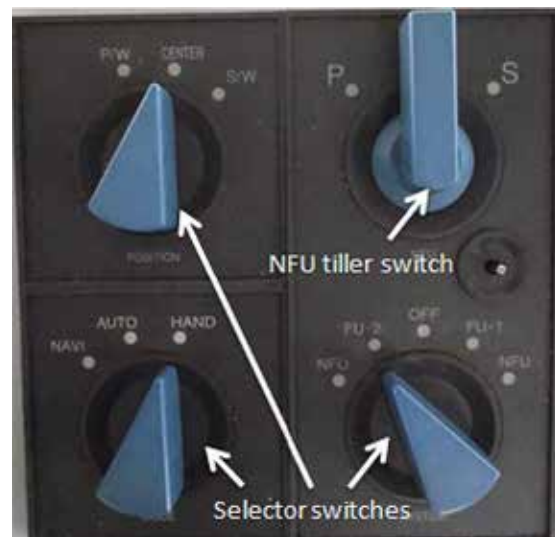
Photo 4. Close-up view of right-hand control panel

As indicated in Photo 4, the right-hand control panel comprises 3 selector switches and an NFU tiller switch. The top-left selector switch, labelled “POSITION,” allows the operator to toggle the steering controls between the port wing (P/W), centre, and starboard wing (S/W) consoles. The bottom-left selector switch, labelled “MODE,” allows the operator to control the steering by means of the ECDIS (NAVI),⁶ the autopilot, or by hand.⁷ The bottom-right selector switch, labelled “SYSTEM,” allows the operator to toggle between the follow-up (FU) and NFU modes, and to select which steering gear pump starter panel⁸ is powering the steering control system. Whenever NFU mode is selected on either of the 2 power supplies, the NFU tiller switch in the top-right corner can be used to

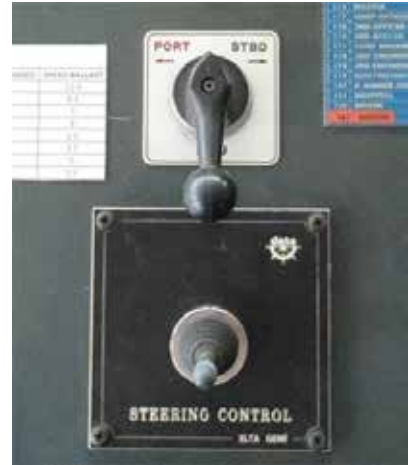
Photo 5. Wing console steering controls

The *Halit Bey* was fitted with port and starboard wing consoles that each had 2 NFU steering controls (Photo 5). The top tiller switch, labelled "NFU," could be activated from the right-hand control panel, while the lower joystick, labelled "STEERING CONTROL," could be activated from the centre control panel. There were no labels to indicate which steering control was connected to which control panel.

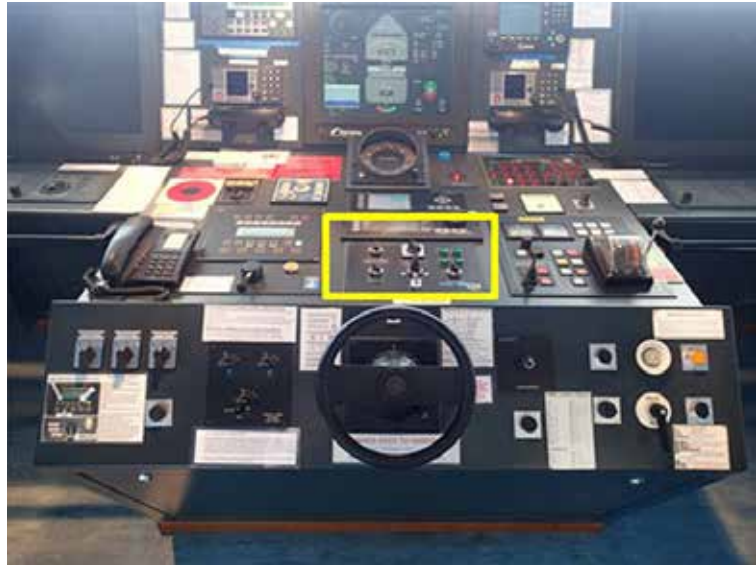
Photo 6. *Manas* bridge centre console (steering control panel indicated by yellow box)

Following the occurrence, TSB investigators boarded a chemical/products tanker similar to the *Halit Bey* in order to compare steering gear control systems. The comparison vessel, the *Manas* (IMO 9447055), is fitted with a steering control and alarm system supplied by the same manufacturer as the one installed on the *Halit Bey*. The general bridge arrangement and equipment on board the *Manas* is similar to the *Halit Bey*, except that there is a single steering control selector switch panel located in front of the steering wheel (Photo 6), and the port and starboard wing consoles are fitted with single NFU control sticks.

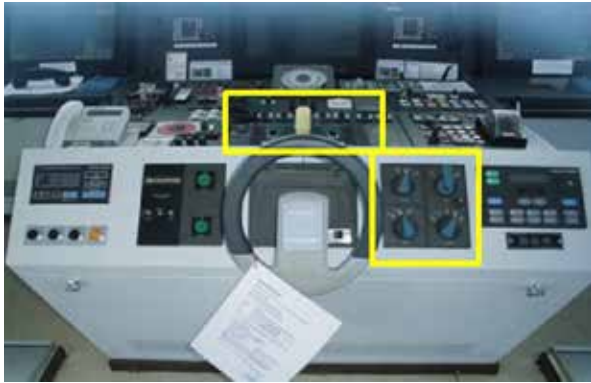
Photo 7. *Nilufer Sultan* bridge main console (steering control panels indicated by yellow boxes)

The *Halit Bey* has 2 sister vessels: the *Nilufer Sultan* (IMO 9410131), built in 2008, and the *Mehmet A* (IMO 9418822), built in 2011. The 2 vessels are fitted with steering gear control arrangements similar to the *Halit Bey*, combining 2 separate steering control panels, one

installed in front of the steering wheel and the other located to the right of the steering wheel (Photo 7 and Photo 8).
