**MARINE INVESTIGATION REPORT
M14C0106**

GROUNDING

**SELF-DISCHARGING BULK CARRIER ATLANTIC ERIE
PORT COLBORNE, ONTARIO
12 JUNE 2014**

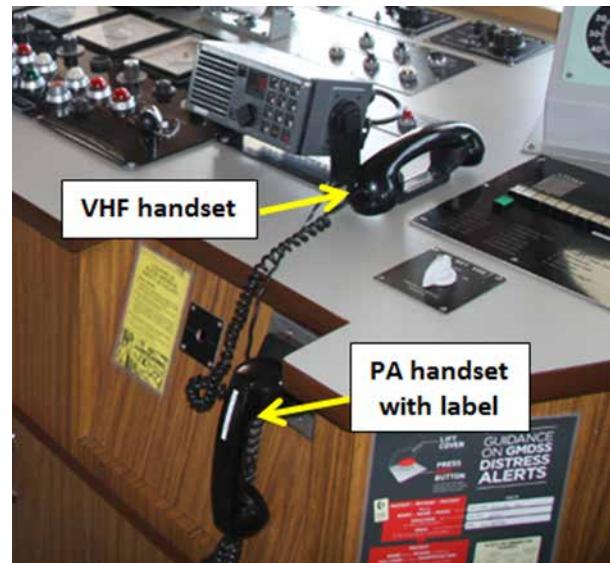
Photo 2. Public address system and VHF handsets

The PA handset is near one of the VHF handsets and is similar in appearance (Photo 2). The PA handset has a white label identifying it as the PA system. The VHF handset does not have a label.¹⁰

1. The checklist to follow in the event of a gyrocompass failure (Checklist 3.5.11) had been removed from the vessel's safety management system with the intent to add it to the shipboard contingency plan; however, this had not been done at the time of the occurrence.
2. The public address and the very high frequency handsets on the bridge central console are similar in appearance, are located close together, and had been mistaken for one another in the past.

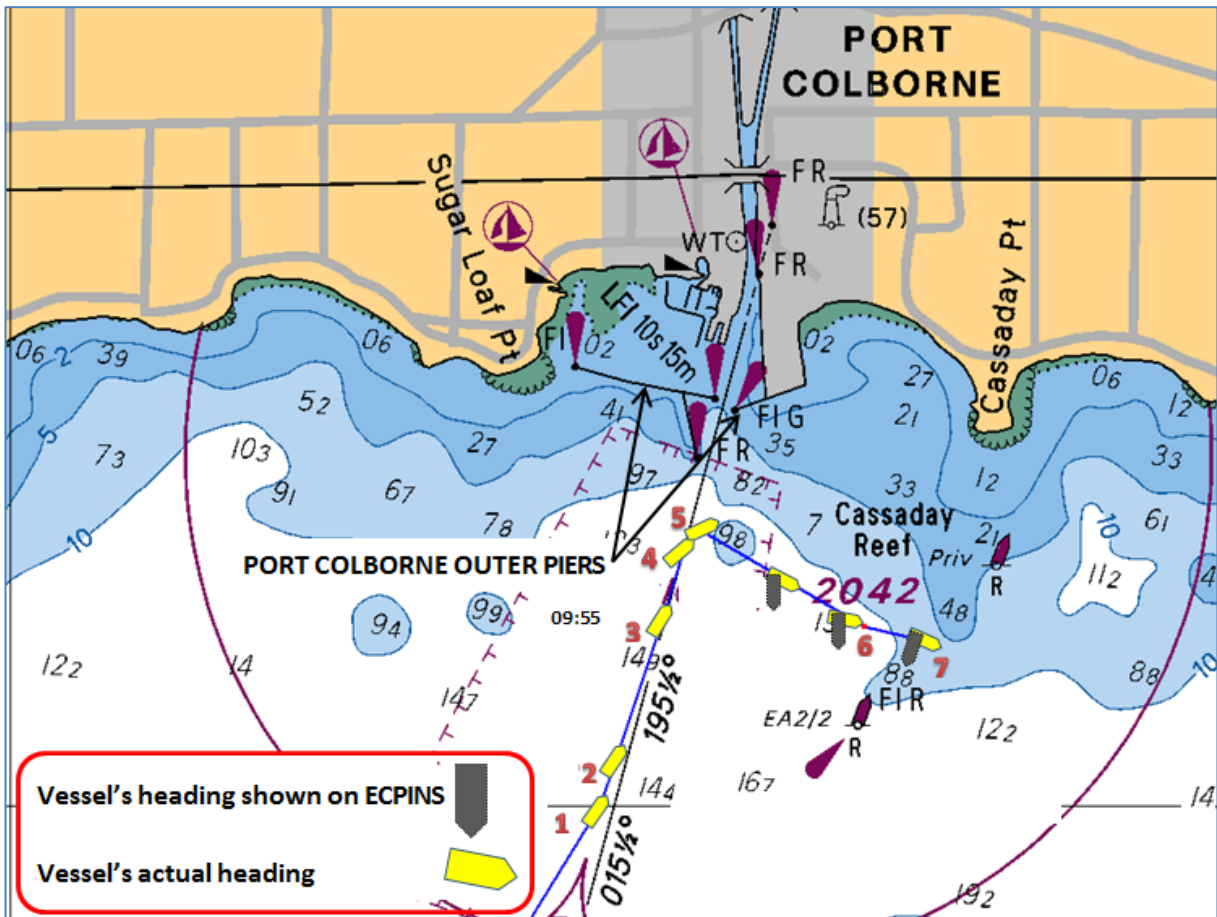
Appendix E – Course made good versus gyrocompass heading

³⁷ Between 1006 and 1017, the misalignment caused the difference between the gyro heading and the CMG to increase from 15° to 111°.

The following image has been compiled by the TSB to show the difference between the vessel’s course made good (CMG) and the gyrocompass heading as it was being displayed on the Electronic Chart Precise Integrated Navigation System (ECPINS) at the time of the occurrence. The grey (dark) vessel-shaped markers show what the master would have been seeing on the ECPINS, whereas the yellow (light) markers show the actual CMG.

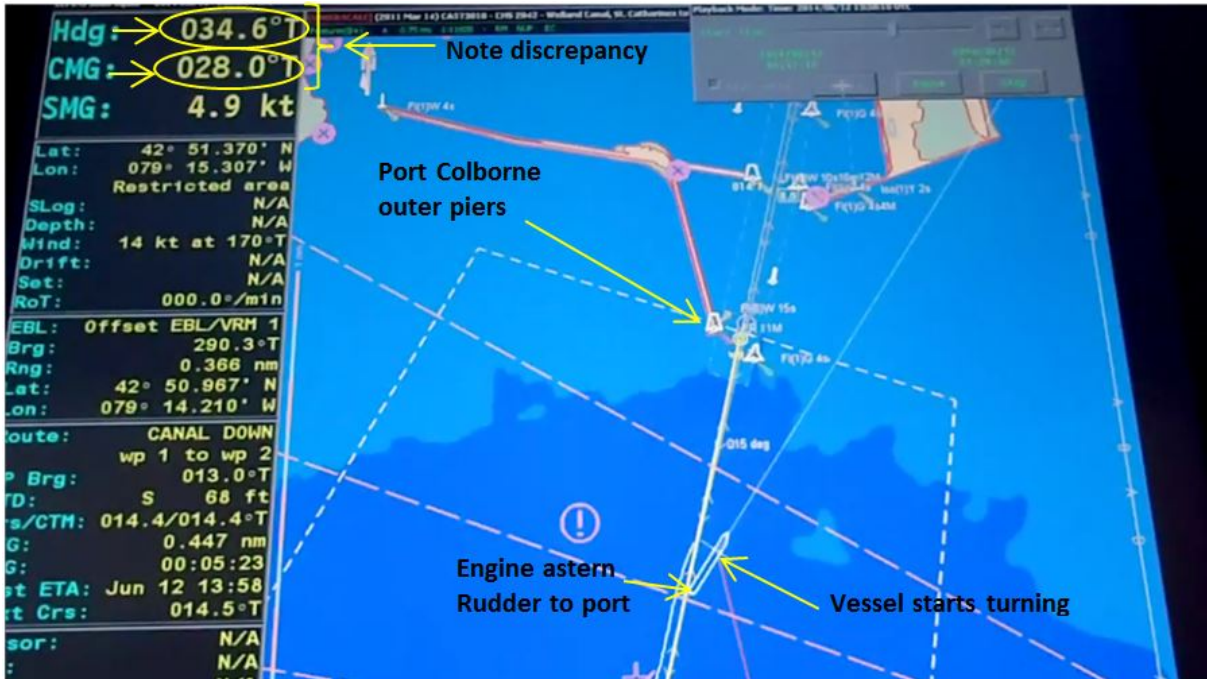
Screenshot 1: As the vessel begins turning to starboard and away from the entrance to the canal, the difference between the vessel's heading and the course made good (CMG) starts to increase, as per usual.

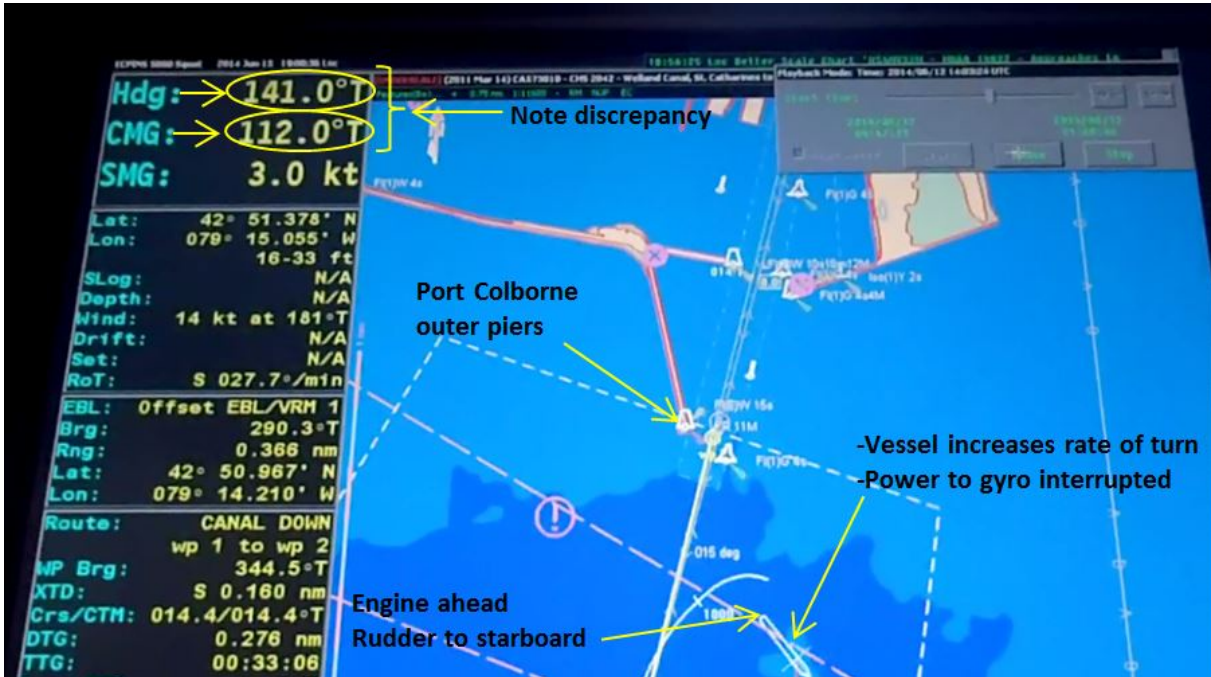
Screenshot 2: As the vessel is turning, the difference between the vessel's heading and the CMG continues to increase, which is also normal.

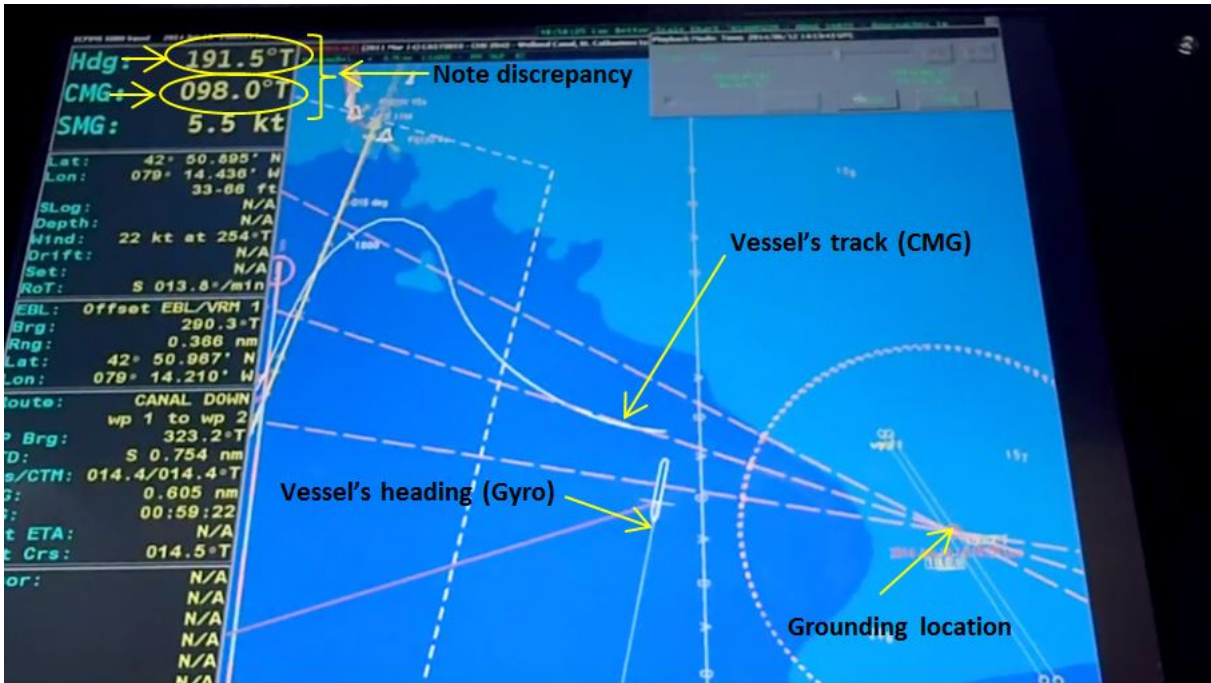
Screenshot 3: The vessel has completed the turn and has been proceeding on 180°G for approximately half a minute. At this point, the difference between the CMG and the heading is increasing, when it would normally decrease. In addition, the vessel-shaped marker is pointing southerly, even though the vessel is proceeding easterly.

Note: It could not be determined why the vessel-shaped marker is not overlaid on the vessel's track, which is normally the case.

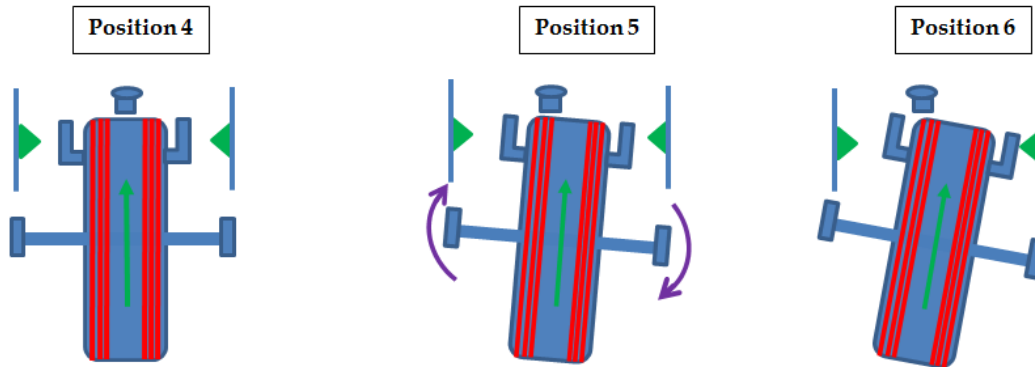
AT TIME OF OCCURRENCE

Position 4 = The rotor is in a vertical position, there is no magnetic field induced.

Position 5 = As the vessel turns, a tilting effect is produced, which interrupts power to the pick-up. The pick-up does not induce correcting voltage.

Position 6 = The rotor continues to tilt until it rests on the bumpers, causing the gyrocompass to be unreliable.
