**MARINE INVESTIGATION REPORT
M14P0023**

LOSS OF PROPULSION

TUG JOSE NARVAEZ
WITH BARGE TCT 8000
SOUTH ARM FRASER RIVER, BRITISH COLUMBIA
11 FEBRUARY 2014

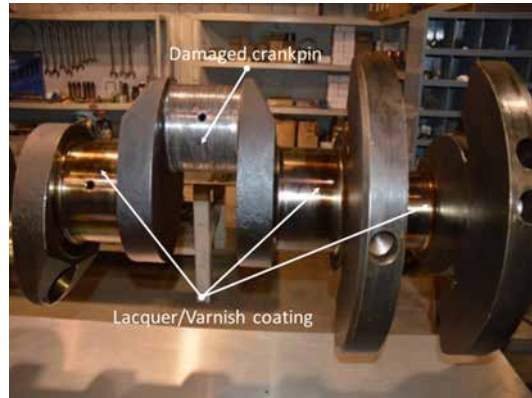
Photo 2. Crankshaft section

- Units 3 and 7 crankpin and bearings were damaged, and power packs had seized (Photo 2 and Photo 4).
- Piston skirts and pins, and cylinder liners showed evidence of scuffing and overheating, indicative of a lack of lubrication; piston skirt showed signs of blow-by of combustion gases.

- Lacquer formation on the crankpins and inside the piston cooling spaces (Photo 2).
- Loss of cylinder cooling water from all units above the joint between the cylinder heads and the liners, due to gasket damage (Photo 3).

The contamination of the oil also resulted in loss of lubrication and piston cooling, and cylinder units 3 and 7 overheated. This overheating damaged the rubber seal between the cylinder head and cylinder liner, causing the cylinder cooling water to leak into the main engine crankcase. This leakage, in turn, depleted the water level from the other cylinders, which exacerbated the overheating of the rest of the engine, eventually leading to its seizure and the loss of propulsion.

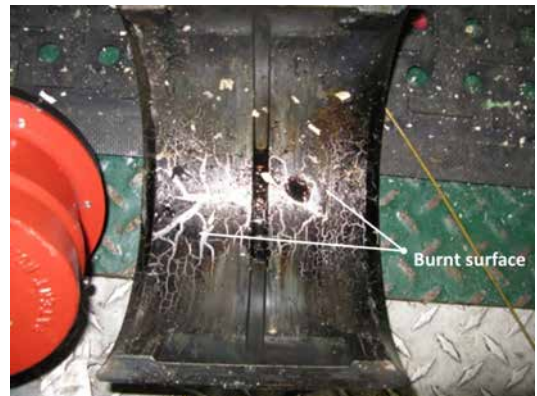
Photo 4. Unit 3 crankpin bearing shell

- Both cylinder cooling fresh water pumps and main cooling water pipes were contaminated with lubricating oil.
- Sump lubricating oil had emulsified and also showed signs of oxidation, as indicated by the burnt surface of the bearing shell (Photo 4).

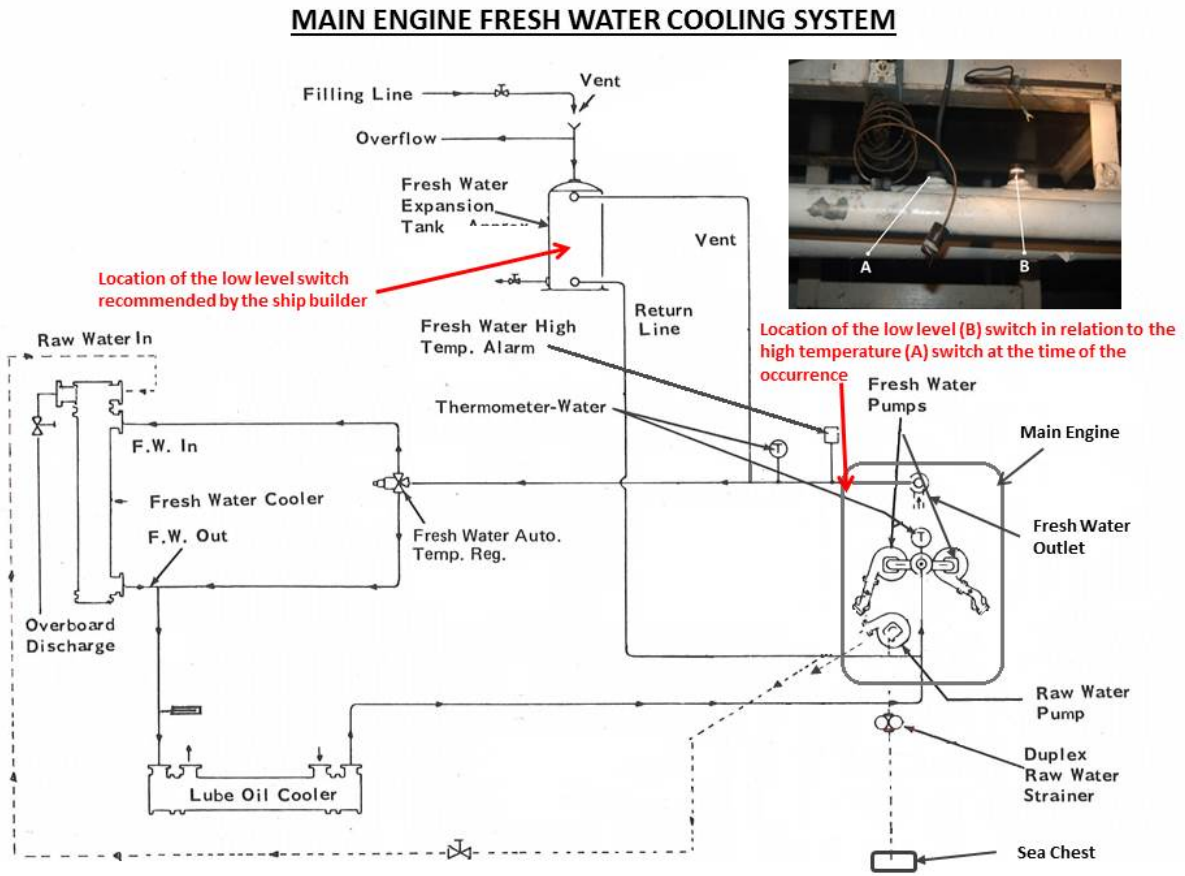
Appendix D – Fresh water cooling system

In this occurrence, the low level alarm switch was fitted to the cylinder cooling water outlet piping. It was not fitted to the fresh water expansion tank (Appendix D), as was recommended by the vessel builder. As its position on the outlet piping was lower than the fresh water expansion tank, an alarm would not sound if the tank level dropped completely. In this case, the tank emptied out and the alarm did not sound. If it had sounded, the vessel crew could have been alerted to the significant loss of water, and would have had an earlier opportunity to take action.
