# MARINE INVESTIGATION REPORT

## M16C0036

### **Capsizing and sinking**

*Tug Ocean Uannaq*

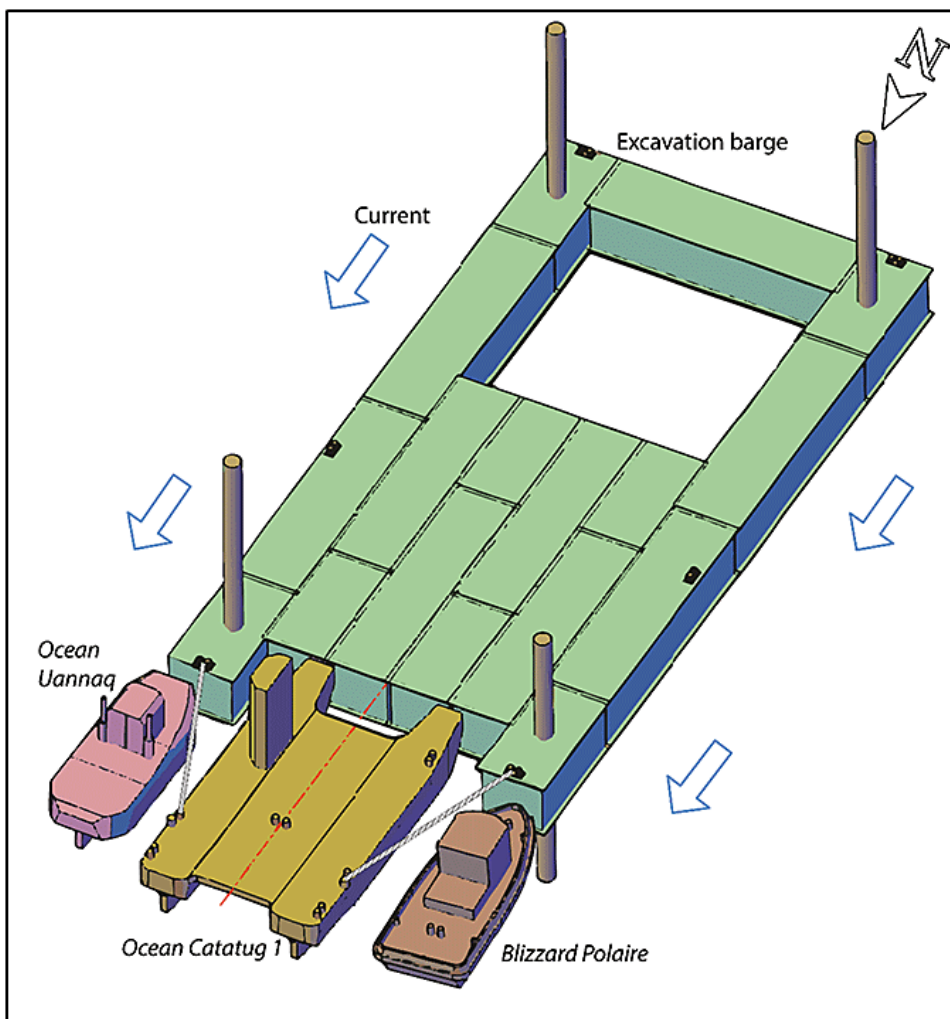
Figure 5. Barge with 3 spuds raised at the moment when the starboard aft spud jammed. The entire operation is oriented toward the south. The construction wharf is on the right, i.e., to the west. (Source: Signature sur le Saint-Laurent, Incident Report 6853, with TSB modifications)

The TSB investigation determined that the barge's spuds would occasionally jam in their housing because of the strong current. In this occurrence, no mechanical issues were discovered that would cause the spuds to jam. These jams were reported as temporary and were easily resolved by using the tugs to push on the barge to relieve the pressure around the housing.

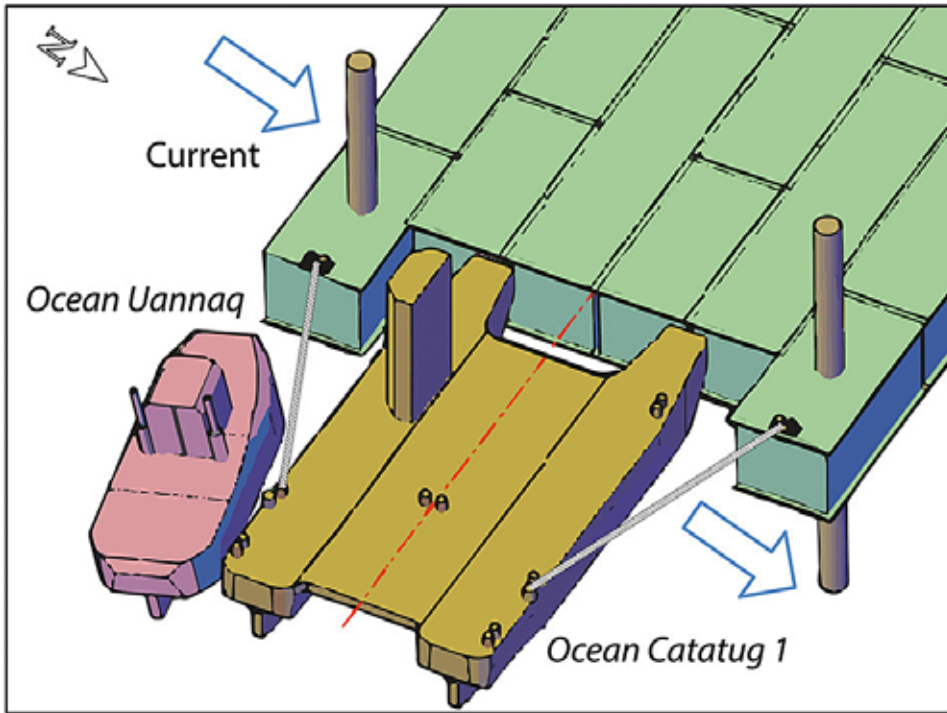
same time, he requested that the *Blizzard Polaire* push harder on the starboard aft corner of the barge. The orientation of the barge and the 3 tugs at this point was across the current and westward. The port side of the *Ocean Uannaq* was exposed to the 6-knot current, which had pushed the tug away from the stern of the barge so that the tug was no longer pushing on the stern (Figure 7).

Figure 7. *Ocean Uannaq's* position when across the current (Source: Signature sur le Saint-Laurent, Incident Report 6853, with TSB modifications)

The port wire<sup>7</sup> securing the *Ocean Catatug 1* to the barge was pushing against the starboard exhaust stack of the *Ocean Uannaq*. The master of the *Ocean Uannaq* put the throttles to full ahead<sup>8</sup> to get away. The master of the *Ocean Catatug 1* requested that the *Blizzard Polaire* move to the starboard forward side of the barge to push from there, and that the port aft spud be lowered (Figure 8). At the same time, the *Ocean Uannaq* heeled to port and water began flowing onto the vessel's port quarter.

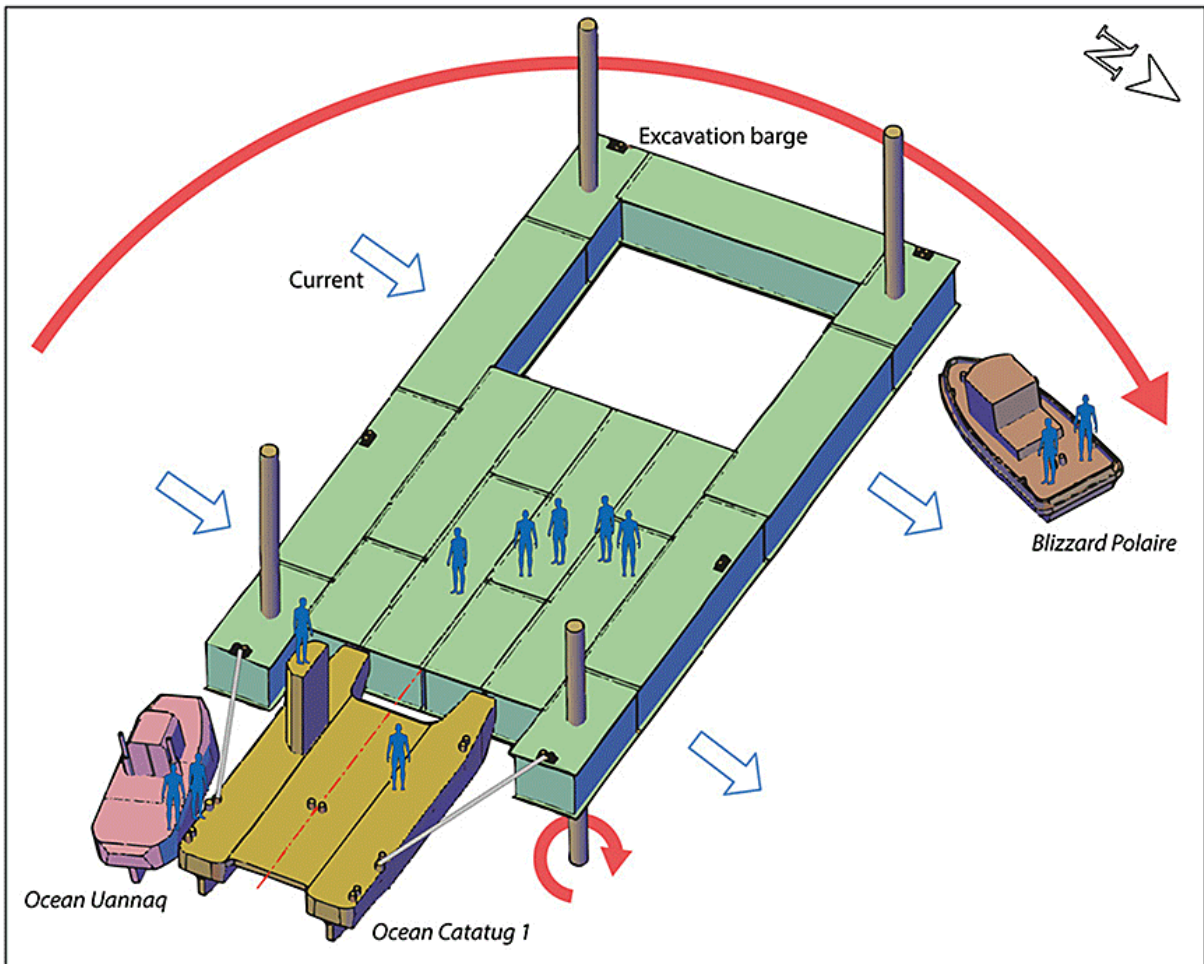
Figure 8. Bird's-eye view of the moment of capsizing, showing the clockwise rotation of the barge and the locations of personnel (Source: Signature sur le Saint-Laurent, Incident Report 6853, with TSB modifications)

At approximately 1623, less than 1 minute after the starboard aft spud jammed, the *Ocean Uannaq* capsized to port just as both of the masters on the *Ocean Uannaq* scrambled onto the *Ocean Catatug 1*. At the time of the capsizing, all of the barge spuds had been lowered, the barge's pivot had been stopped, and the *Blizzard Polaire* was in position to push on the side of the barge, near the starboard forward spud.

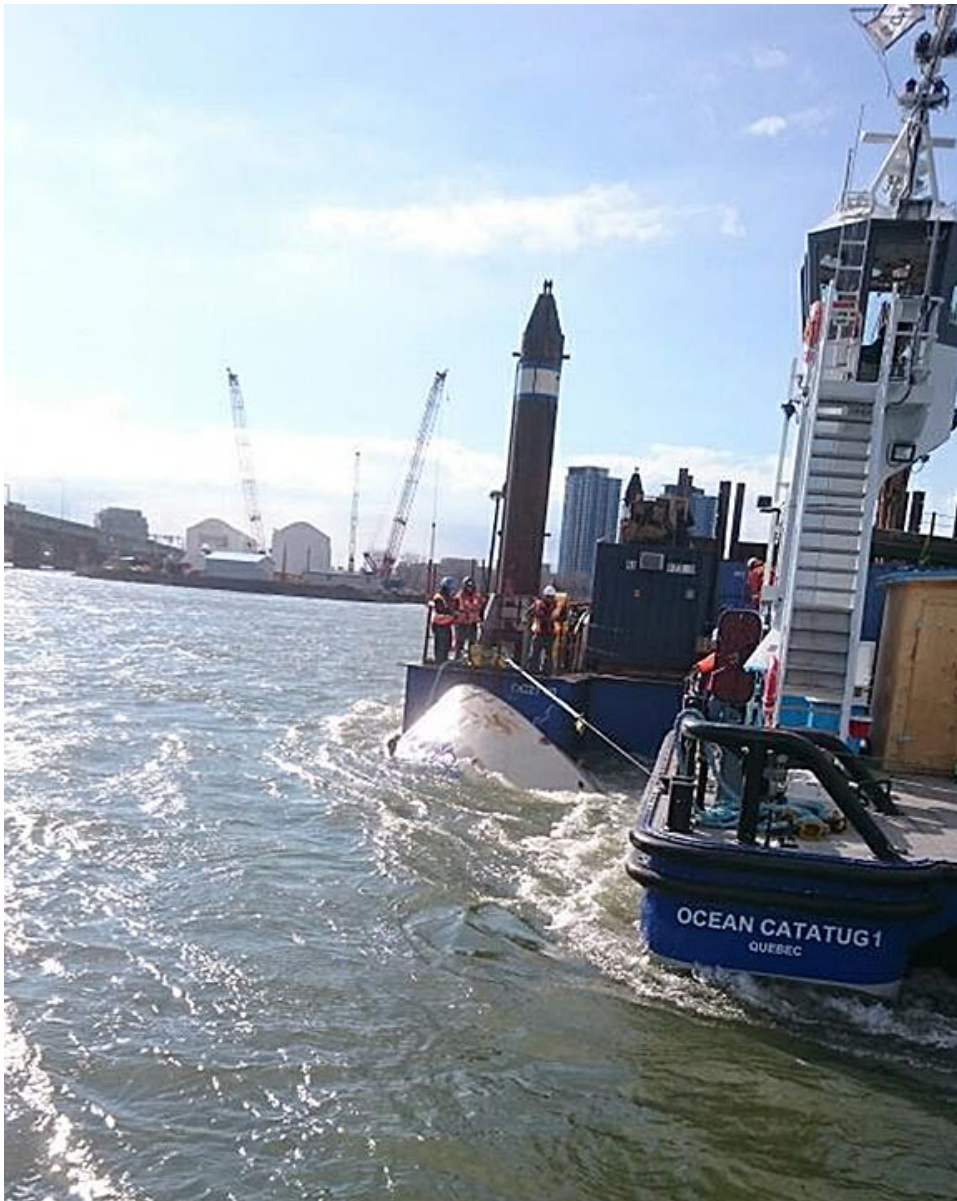
At approximately 1630, the master of the *Ocean Catatug 1* reported to shore-based personnel that the *Ocean Uannaq* had capsized (Figure 9) and that all tug and barge crew were safe. Personnel from the companies involved were transported to the barge on board another vessel. Together, they decided that the capsized tug would be towed to shore, approximately 0.5 nm away. The crew welded a steel lug onto the keel of the *Ocean Uannaq* and secured the capsized tug to the barge with ropes.

Figure 9. Photo taken from astern of the *Ocean Catatug 1* showing the *Ocean Uannaq* following capsizing. The entire operation is now oriented to the west, having rotated approximately 90° clockwise from the original orientation, which was to the south. (Source: Signature sur le Saint-Laurent)

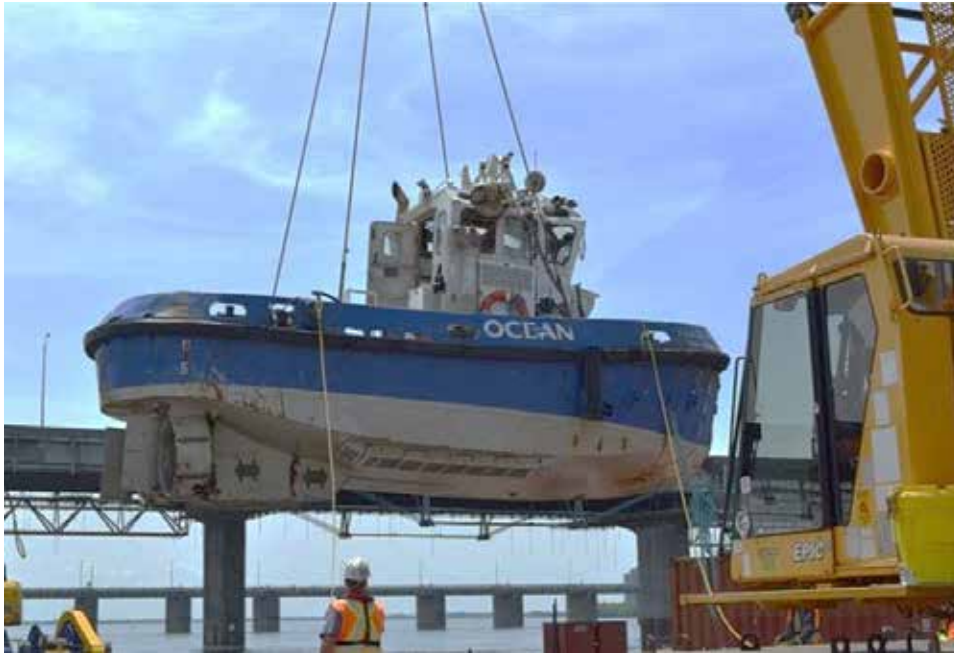
On 27 May 2016, the *Ocean Uannaq* was examined by divers, who observed that the ventilation flaps and gooseneck vents for all of the tanks and compartments were open. The following day, the *Ocean Uannaq* was righted on the riverbed, refloated at the construction site, and examined by TSB investigators (Figure 10).

Figure 10. *Ocean Uannaq* being raised from the riverbed

- The hull was intact, based on a visual examination.
- The 4 hatches were closed.
- The entry door to the wheelhouse was open.
- As the vessel was being raised out of the water, it was observed that the life raft had remained in its cradle and the hydrostatic release was attached to the lanyard. When the on-site investigator handled the hydrostatic release, the lanyard fell free. The investigator was then able to lift the life raft out of the cradle.
- The throttles of the *Ocean Uannaq* were at half ahead on the port engine and at three-quarters ahead on the starboard engine.

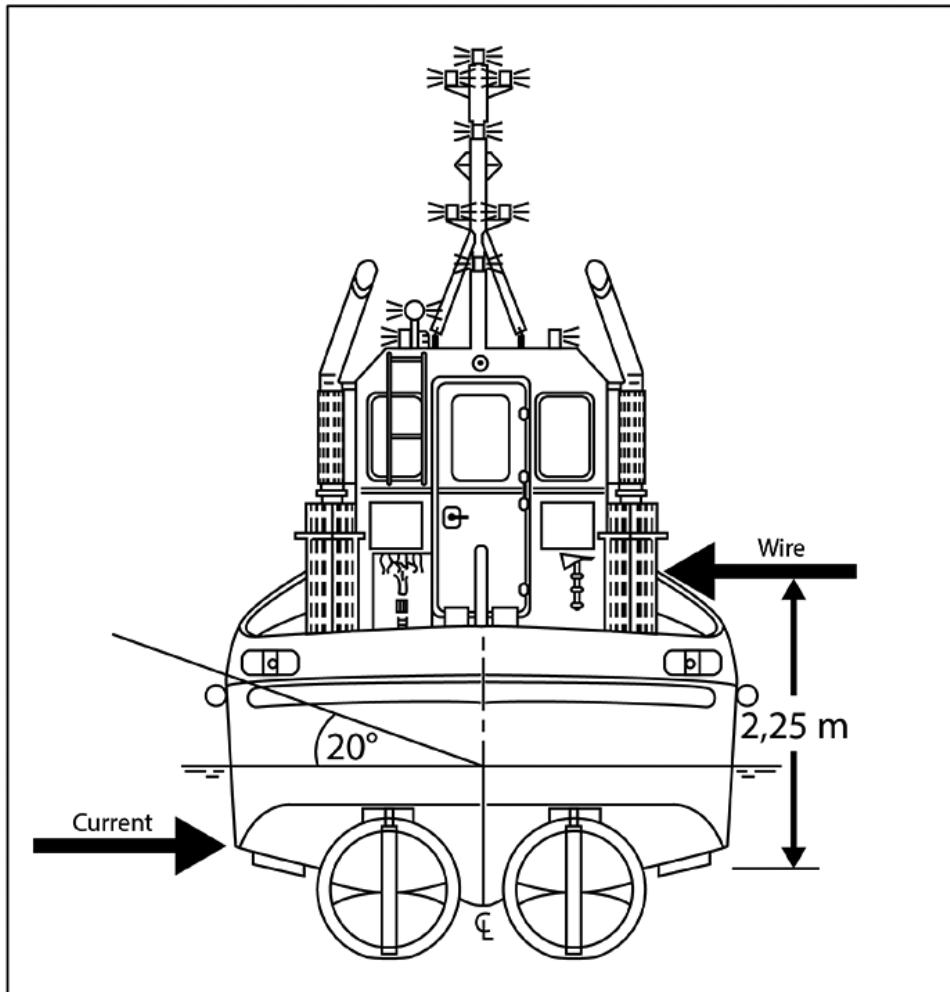
The investigation determined that the vessel's intact stability was not causal to the capsizing; rather, the combination of the wire and the current acting in opposite directions caused the capsizing.

Figure 12. Forces on the *Ocean Uannaq* (seen from astern) causal to capsizing. The wire on the starboard side was approximately 2.25 m above the centre of buoyancy of the tug. (Source: Based on a drawing by Concept Naval)

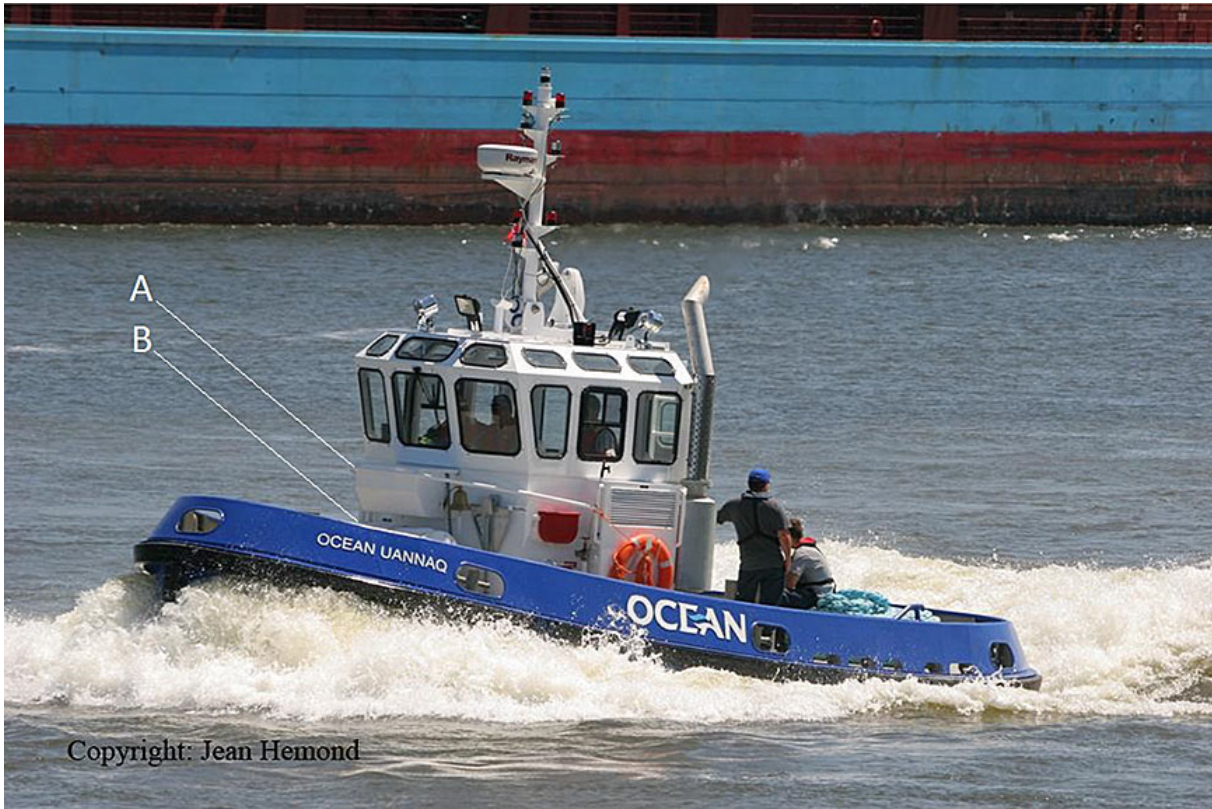
The *Ocean Uannaq* carried a 6-person life raft that was secured in a welded cradle and located beneath a storage container on the main deck, just forward of the wheelhouse (Figure 13). The Hammar H-20 hydrostatic release unit (HRU) on the *Ocean Uannaq* had a water pressure-activated automatic release mechanism. When submerged to a depth of 1.5 to 4 m, water pressure activates a sharp spring-loaded knife within an HRU's casing. The knife cuts the rope that secures the strap holding the life raft in its cradle, allowing the life raft case to float free because of its buoyancy. The HRU fitted on board the *Ocean Uannaq* did not require annual service, maintenance, or spare parts. The unit had a 2-year mandatory replacement frequency. The occurrence unit was due for replacement in April 2016.

Figure 13. Photo of the *Ocean Uannaq* showing the position of the storage container and railing (A), and the life raft (B) (Source: Jean Hemond, with TSB annotations)

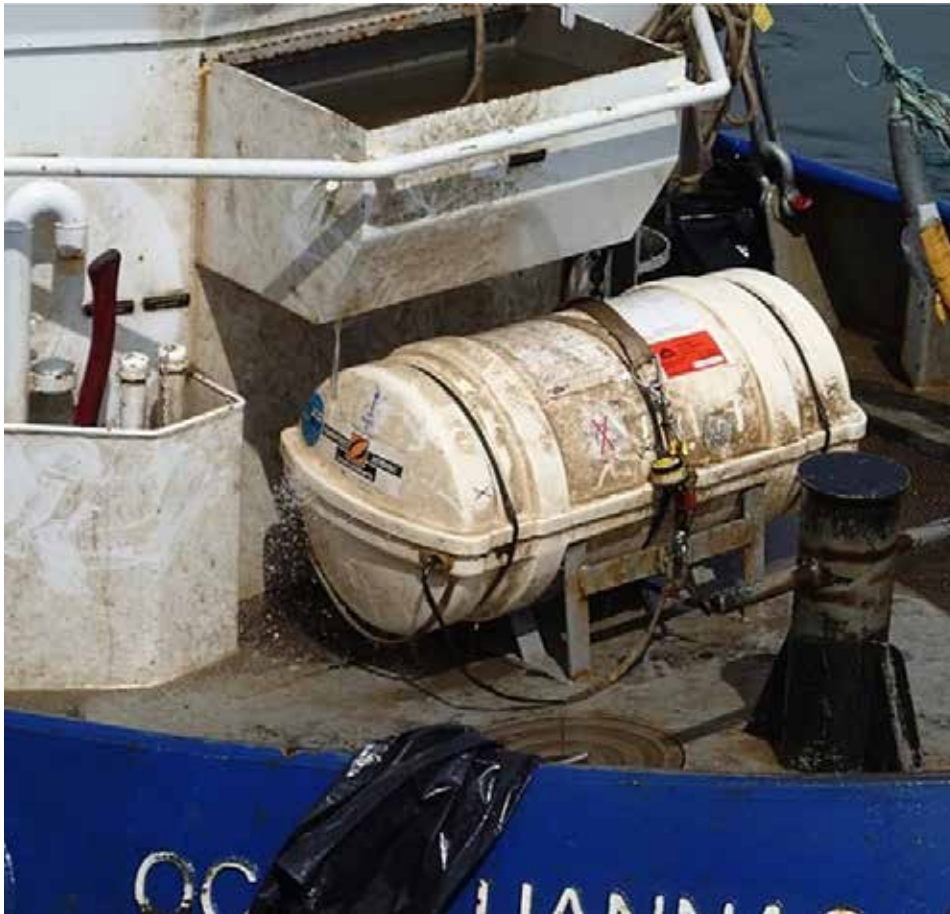
On 28 May, the *Ocean Uannaq* was righted and raised. The life raft remained in its cradle during the raising, with the HRU appearing intact (Figure 14). This indicated that the life raft remained in its cradle while submerged. Upon closer examination, it was noted that the attachment rope was inside the HRU; however, when a TSB investigator touched it to verify the expiry date, the whole unit fell into the investigator's hand. A TSB investigator then lifted the life raft, and it was found to be free in the cradle. Therefore, it did not appear that the arms of the cradle had impeded the release of the life raft, given the position in which it was installed.

Figure 14. Post-occurrence photo showing position of unreleased life raft and apparently intact hydrostatic release unit

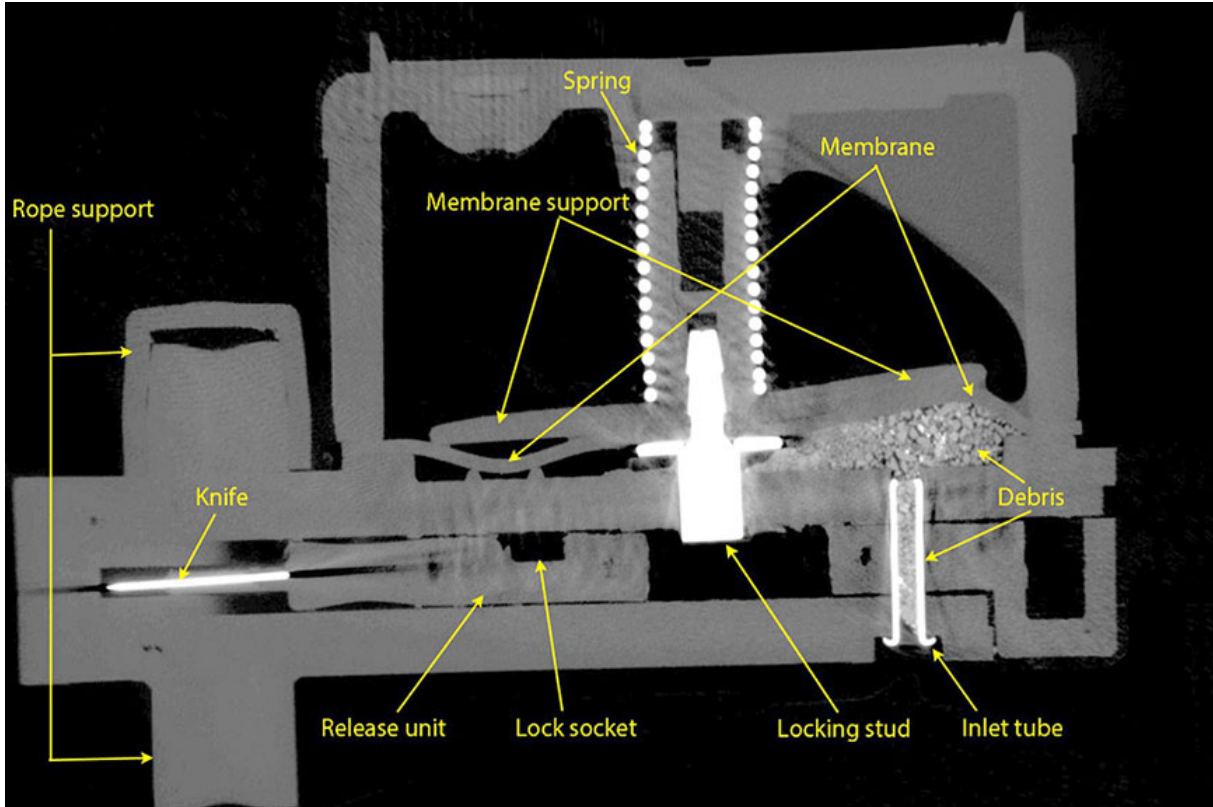
Following the occurrence, the HRU was examined at the TSB Engineering Laboratory. The membrane/support and locking stud assembly, which, in the non-activated condition, keeps back the spring-loaded knife holder, had been lifted to the height of the buildup of debris beneath the membrane. It was determined that the debris buildup would not have been possible unless the membrane/support and locking stud assembly had been lifted by water pressure. This height corresponds to the membrane/support assembly at its uppermost

position. Movement to this position pulls the locking stud from the lock socket and activates the release unit. Although it was not possible to determine the exact depth of activation, it was determined that the unit had operated as intended while submerged (Figure 15).

Figure 15. Computed tomography (CT) image of the hydrostatic release unit showing the internal configuration prior to disassembly. Note the knife position and the debris below the membrane.

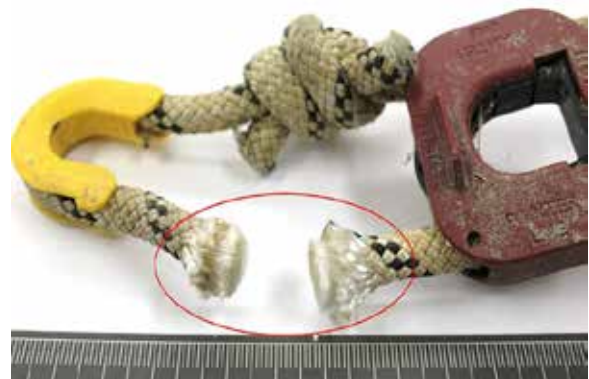
The knife blade was observed in the extended position, and the rope was severed from the unit. The cut ends of the rope were consistent with a clean cut that extended through all strands of the rope (Figure 16). The HRU had operated as intended, but it could not be determined why the life raft had not floated free from its cradle.

Figure 16. Photo showing the clean cut of the hydrostatic release unit's life raft rope

1. The life raft's hydrostatic release unit operated as intended, but the investigation could not determine why it did not float free from its cradle when the *Ocean Uannaq* sank.
2. The emergency position indicating radio beacon carried on board the *Ocean Uannaq* was not registered. Therefore, the Canadian Coast Guard did not know which vessel was transmitting a distress signal.
3. Communications for the tug and barge operations were conducted on 4 separate radio frequencies.

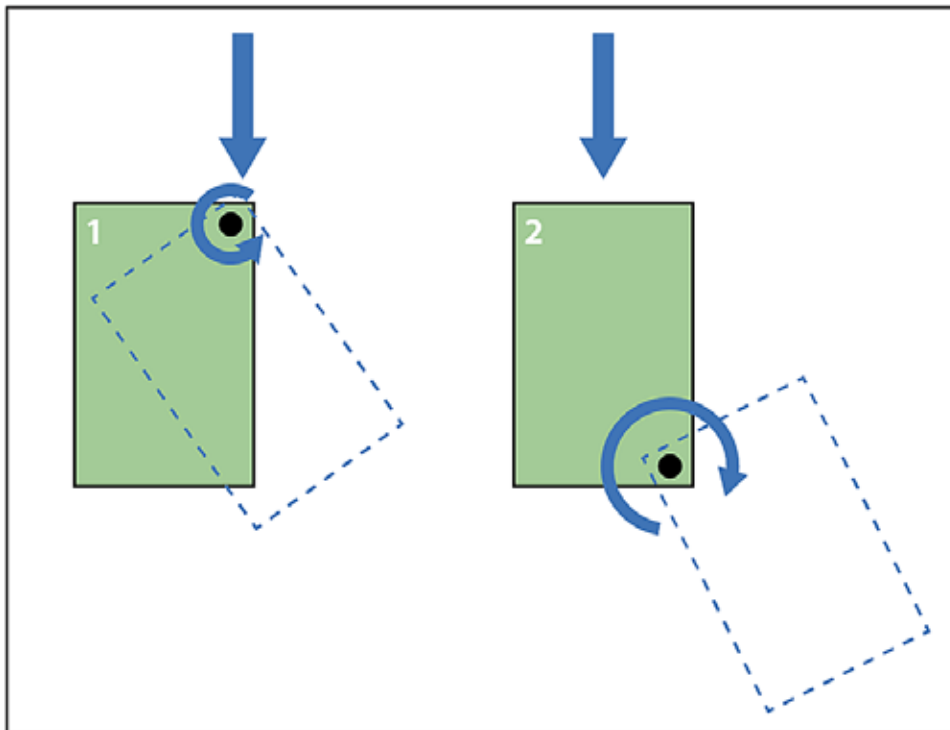
In this occurrence, the barge's upstream spuds were raised first; therefore, when the starboard downstream spud jammed temporarily, the degree to which the barge was able to rotate was greater than if an upstream spud had jammed (Figure 17).

Figure 17. Illustration showing the difference in the extent of rotation between an upstream spud jam and a downstream spud jam. Note that the barge's rotation about the starboard aft jammed spud was checked at approximately 90° in this occurrence because the remaining 3 spuds were lowered and the *Blizzard Polaire* was pushing on the starboard side of the barge.

The force of the *Ocean Uannaq* pushing on the barge's stern, directly aft of the port spud when the starboard spud jammed, initiated a turning moment clockwise around the jammed spud. This caused the barge to begin rotating clockwise. The spud acted as a pivot and the barge rotated around it in the strong current. The rotation from an upstream spud jam could have been counteracted by a tug that was already stationed on the side of the barge;
