MARINE INVESTIGATION REPORT M16P0162

Collision and sinking

*Tugs *Albern* and *C.T. Titan**

Northumberland Channel, British Columbia

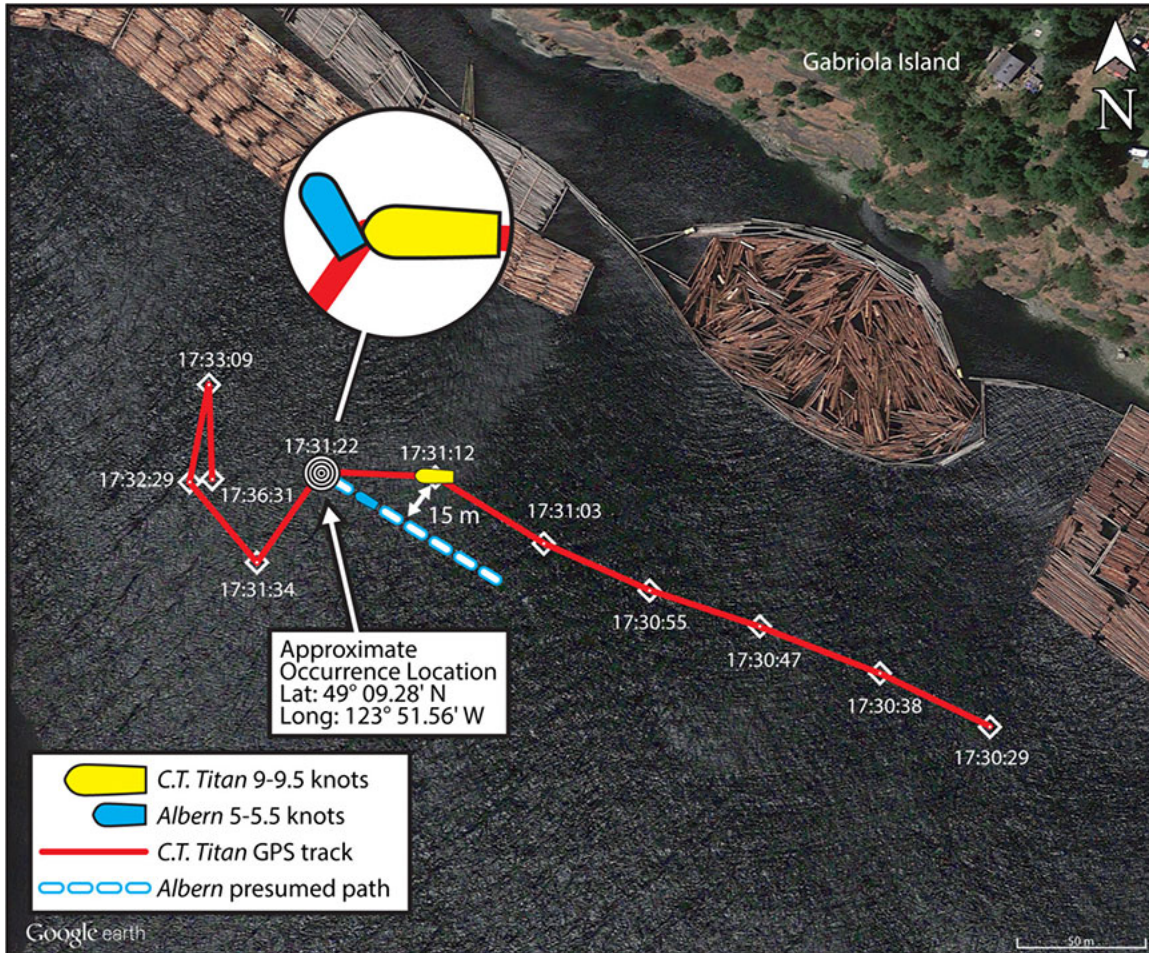
Figure 4. Satellite photo with overlay showing tracks and collision of the *C.T. Titan* (yellow) with the *Albern* (Source: Google Earth with TSB annotations)

Upon striking the *Albern*, the *C.T. Titan* veered approximately 90° to port (heading 215°T) and then ran up onto the hull of the capsized *Albern*. Soon after, the *C.T. Titan's* master regained propulsion control and backed the vessel away from the *Albern*. The *C.T. Titan* sustained damage to its keel cooler.⁷

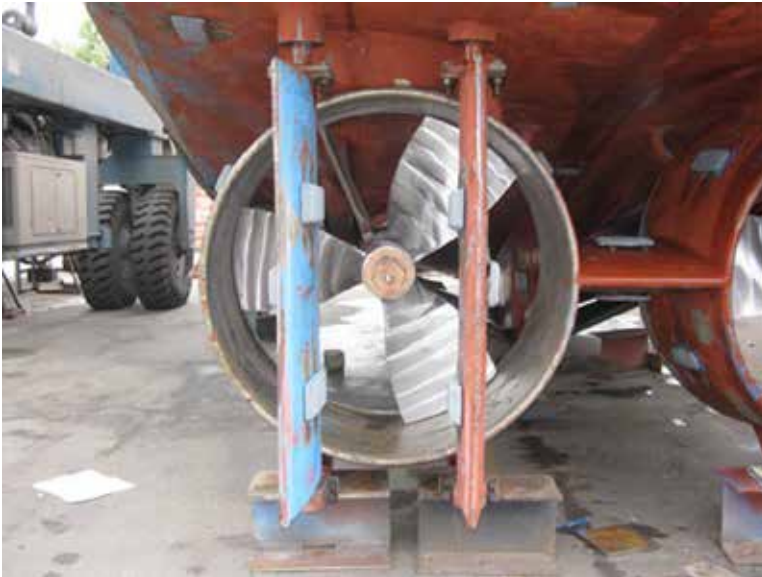
Figure 8. *C.T. Titan* port rudder alignment

- Both port and starboard rudders were undamaged, and the port outer (blue) rudder and the starboard inner rudder were misaligned towards the port side. These misalignments were visually estimated to be approximately 3° (Figure 8).
- The rudder angle indicators at the flying bridge and winch control stations were not consistent with the rudder angle indicator in the wheelhouse. There was a 1.5° to 2° error on the indicator at the flying bridge and about a 0.5° error on the indicator at the winch station.

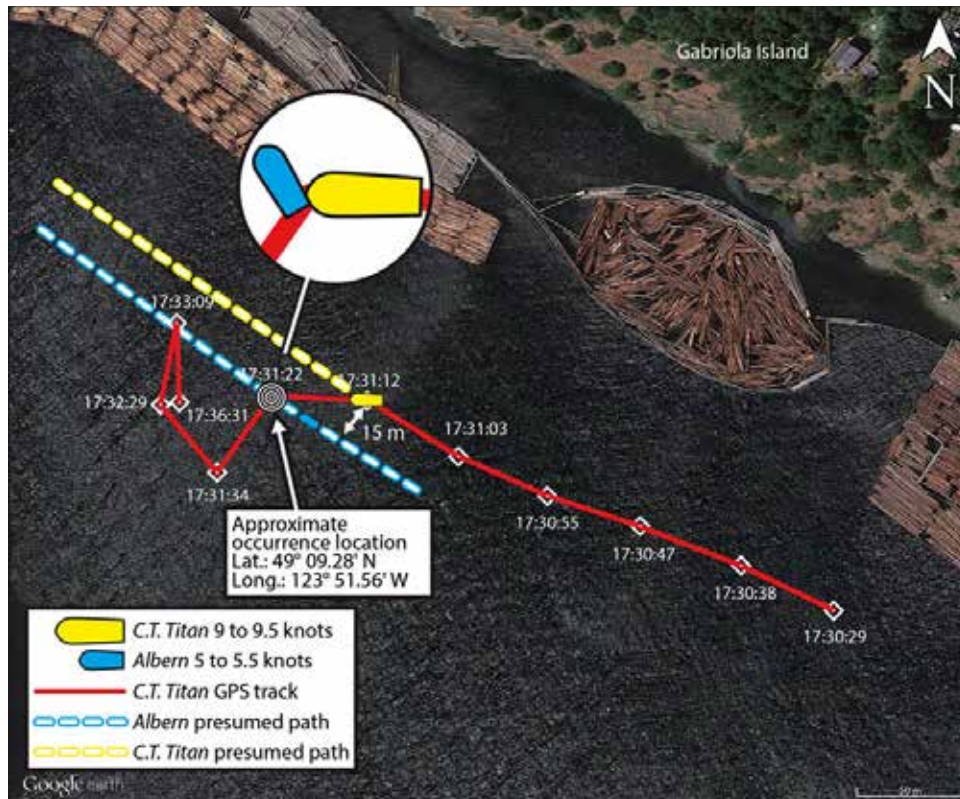
Appendix C – C.T. Titan’s track data

Time	Position	Leg	Heading	Distance covered	Time	Speed
17:30:29	49°09.2356' N, 123°51.3568' W	17:30:29 to 17:30:38	296°	47.3 m	9 seconds	5.26 m/s 10.22 knots
17:30:38	49°09.2468' N, 123°51.3918' W	17:30:38 to 17:30:47	291°	49.6 m	9 seconds	5.51 m/s 10.71 knots
17:30:47	49°09.2566' N, 123°51.4301' W	17:30:47 to 17:30:55	288°	44.5 m	8 seconds	5.56 m/s 10.88 knots
17:30:55	49°09.2643' N, 123°51.4648' W	17:30:55 to 17:31:03	294°	44.5 m	8 seconds	5.56 m/s 10.81 knots
17:31:03	49°09.2643' N, 123°51.4982' W	17:31:03 to 17:31:12	301°	49.2 m	9 seconds	5.47 m/s 10.62 knots
17:31:12	49°09.2882' N, 123°51.5326' W	17:31:12 to 17:31:22	273°	44.4 m	9 seconds	4.94 m/s 9.60 knots
17:31:22	49°09.2895' N, 123°51.5691' W	17:31:22 to 17:31:34	215°	49.6 m	12 seconds	4.13 m/s 8.03 knots
17:31:34	49°09.2705' N, 123°51.5897' W	17:31:34 to 17:32:29	320°	40.4 m	55 seconds	0.73 m/s 1.419 knots
