MARINE INVESTIGATION REPORT M17P0098

Partial sinking with loss of life

Commercial sport fishing vessel BC1329967
(*Catatonic*)

30 April 2017

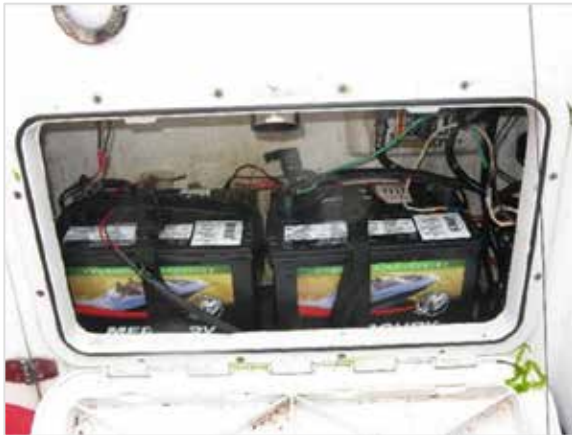
Figure 3. Modified, non-standard arrangement of battery banks in the port battery compartment

The operator purchased the vessel in January 2015. The following month, he contracted a local company to repower the *Catatonic* with 2 Mercury 225 hp outboard engines. At the same time, the contractor replaced the vessel's batteries with new ones, installed them inside the port battery compartment (Figure 3), and connected them to a single 4-way selector switch located inside the starboard battery compartment.

The 4-way selector switch could be set to 1, 2, ALL, or OFF. For convenience, the operator typically chose to keep the selector switch set to the ALL position, causing both batteries to act as a single unit. At the time of the occurrence, the selector switch was set to the ALL position.

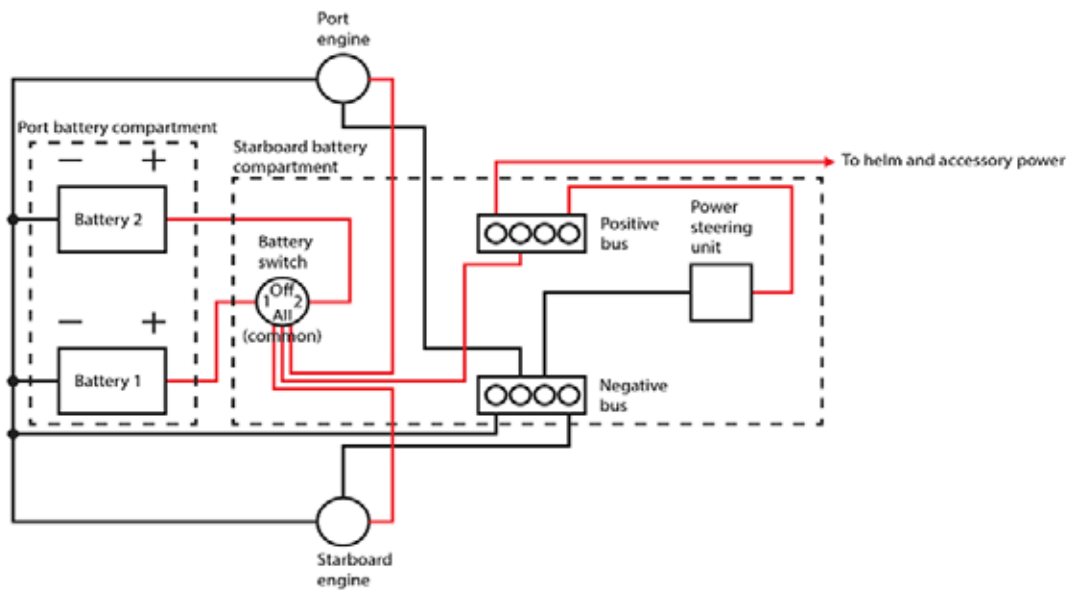
Figure 4. The vessel's battery power distribution arrangement at the time of the occurrence

When acting as a single unit, both batteries are charged and drained simultaneously, and act as the only power source for the entire vessel (Figure 4).

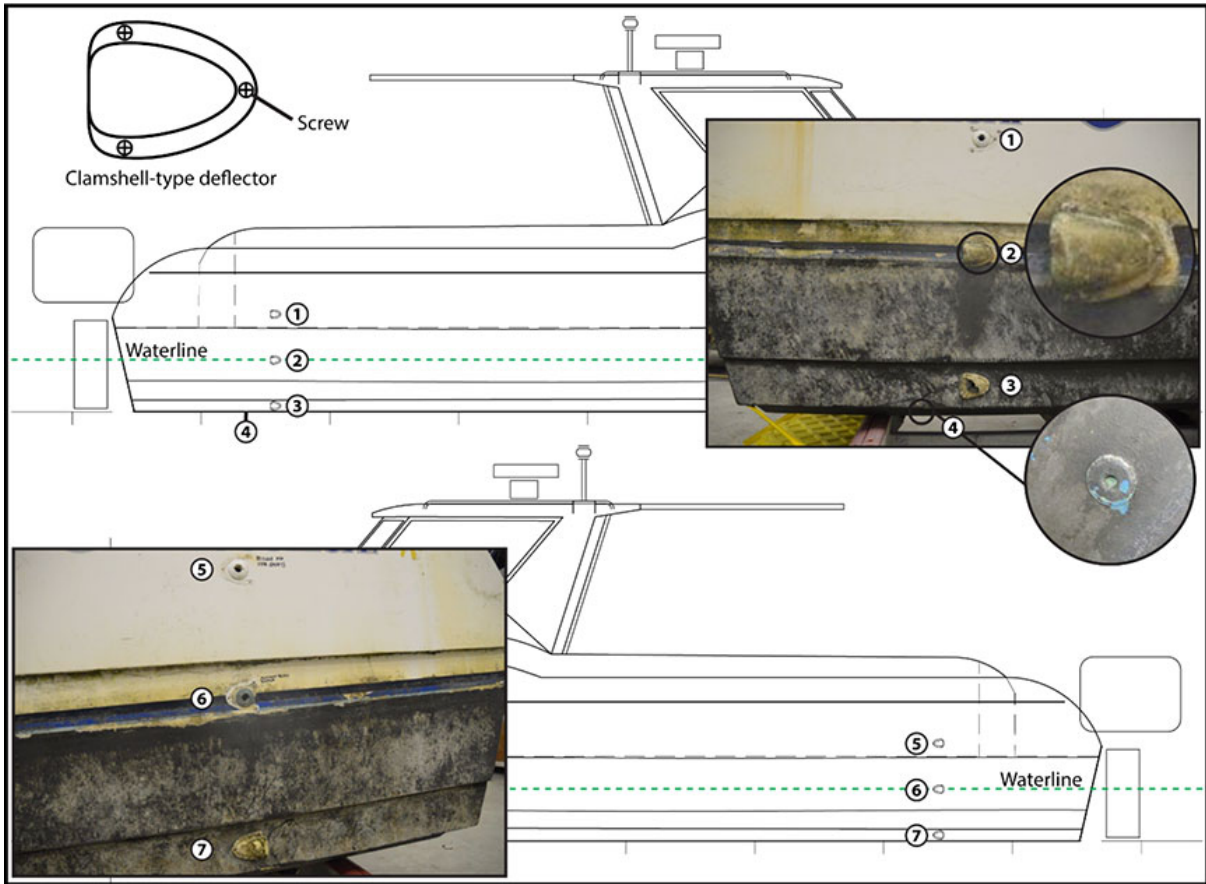
Appendix B – Location of clamshell-type deflectors

- The clamshell-type deflector located at the stern port section of the vessel's outer hull around the waterline was missing. Three screws, about 3 mm in diameter, which originally secured the deflector, were also missing. The 3 screws had been installed 4 cm, 7 cm, and 10 cm, respectively, below the main deck level around the waterline. The waterline was observed to be about 7 cm below the deck level.³⁴

When the 3 deflector securing screws on the port pontoon hatch cover drain went missing, the watertight integrity of the hull was compromised, and seawater was allowed to ingress into the vessel's port pontoon. The TSB determined that seawater ingressed through one of the 3 mm holes where the securing screws would normally have been installed. The ingress occurred at an approximate rate of 1 L per minute, and this rate increased as time progressed. Furthermore, the removal of the fish box drain hoses to make it easier to take out the boxes and inspect the pontoon bilges created a point of ingress for seawater that had washed on deck due to shipping seas. The water thus entered the starboard and port fish boxes through the pontoon hatch covers, eventually draining into both pontoons through the open fish box drain holes. Because the bilge pumps were run intermittently to keep the water in the bilges at a low level, the hull breach and the resulting water ingress went undetected.

At some point in time, 6 clamshell-type deflectors were fitted over 5 outlets and 1 inlet on the stern quarter of the outer hull of the vessel. Each deflector had 3 securing screws. All securing screws penetrated the hull. The deflector and securing screws for the port pontoon cover channel drain outlet were missing. Because the deflector was in line with the outriggers, it is likely that, over time, the fishing lines snagged the deflector, ripping it off.

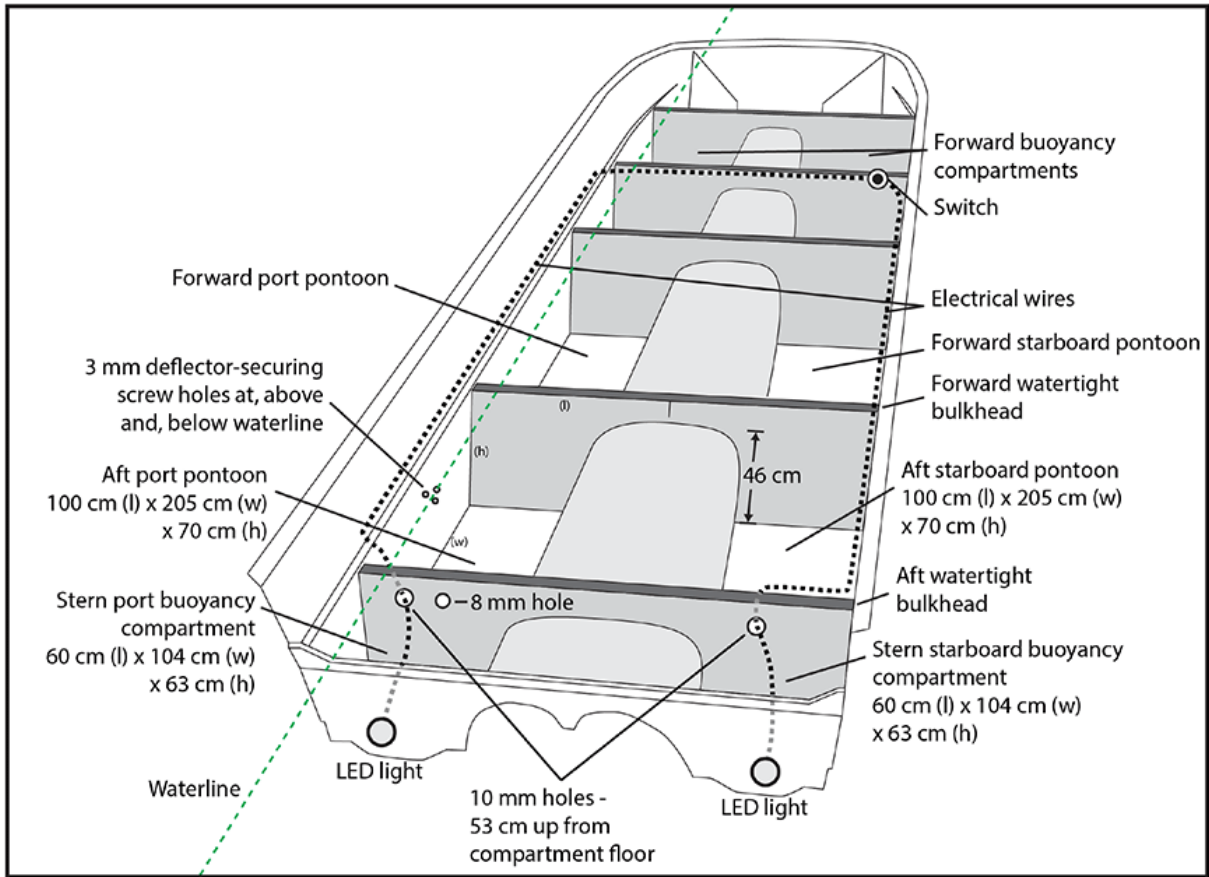
Appendix C – Position of holes and compartments below main deck

Two electric cables run through holes in the watertight bulkhead of the stern buoyancy compartments. These cables are connected to light-emitting diode (LED) lights fitted to the stern's outer underwater hull, one on each side of the vessel (Appendix C).

- Three holes were observed on the aft watertight bulkhead separating the stern buoyancy compartment and aft pontoons: 2 holes (10 mm and 8 mm in diameter) were on the port side of the vessel, and 1 hole (10 mm in diameter) was on the starboard side. All 3 holes were located about 53 cm in height from the keel.

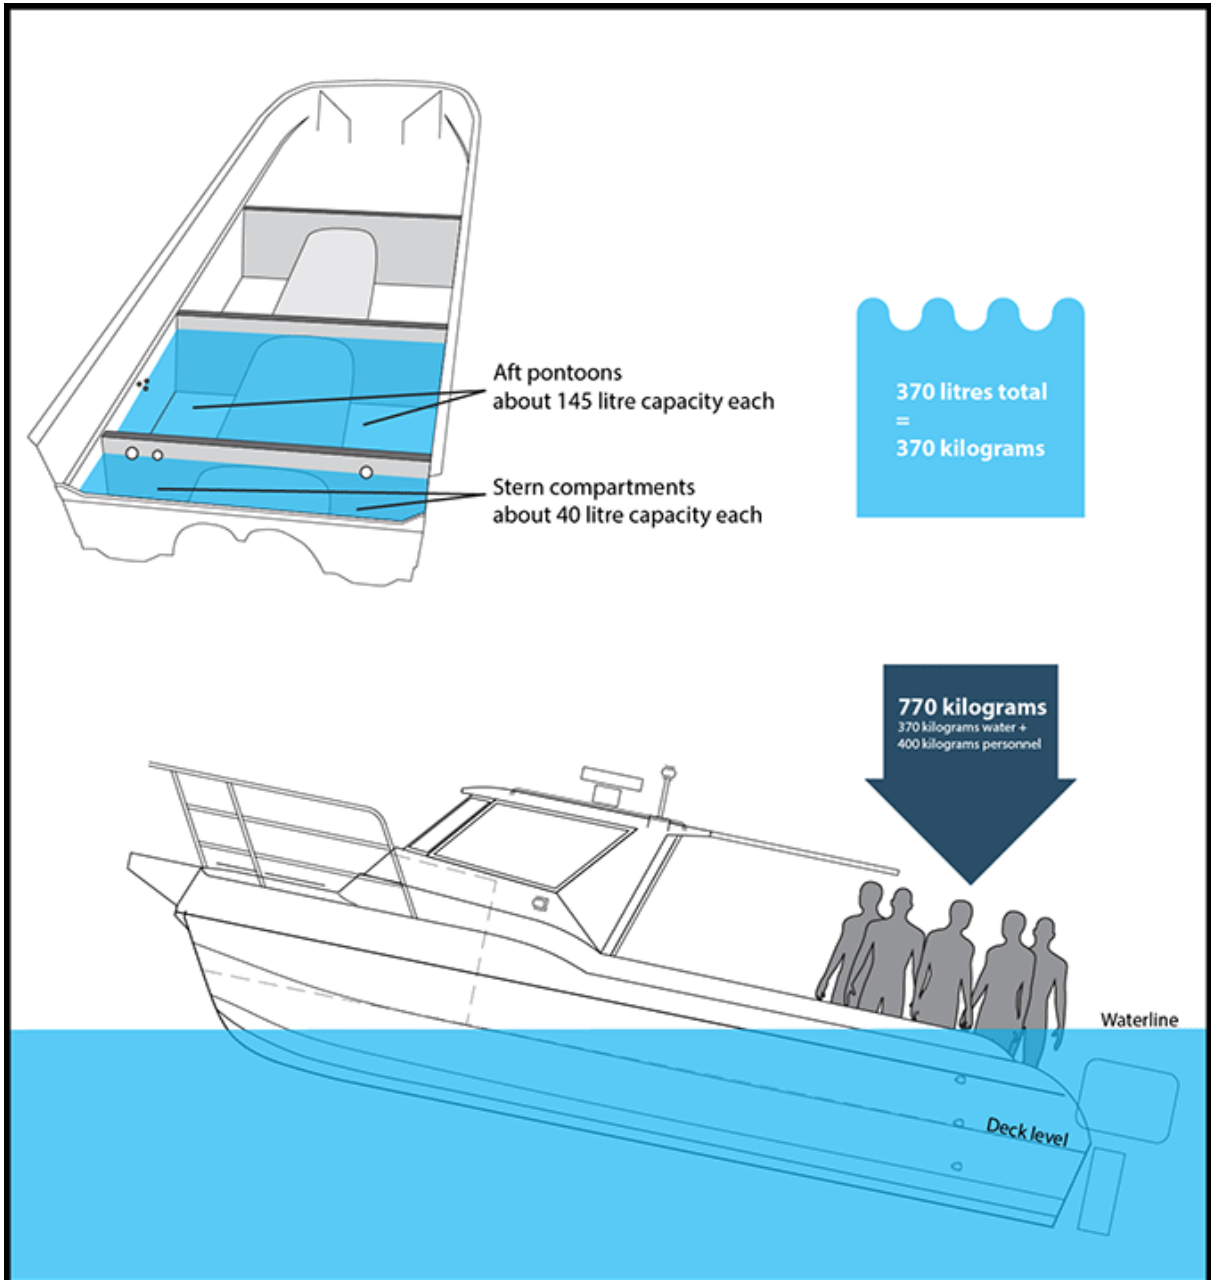
Appendix H – Effect of water ingress and weight of people standing at the stern of the vessel

with the shipping seas, this caused the deck to fill with water and contributed to the stern's sinking (Appendix H). Eventually, the vessel could not maintain its upright aspect, and everyone on board abandoned the vessel into the water.

4. The water from the port pontoon progressed into the starboard pontoon through the hull's middle arc structure. Once the water level equalized, it rose simultaneously in both pontoons and caused the vessel's stern to sit low in the water.
