MARINE TRANSPORTATION SAFETY INVESTIGATION REPORT M18A0454

DOWNFLOODING AND SINKING

Fishing vessel *Atlantic Sapphire*
Georges Bank, Nova Scotia
13 December 2018

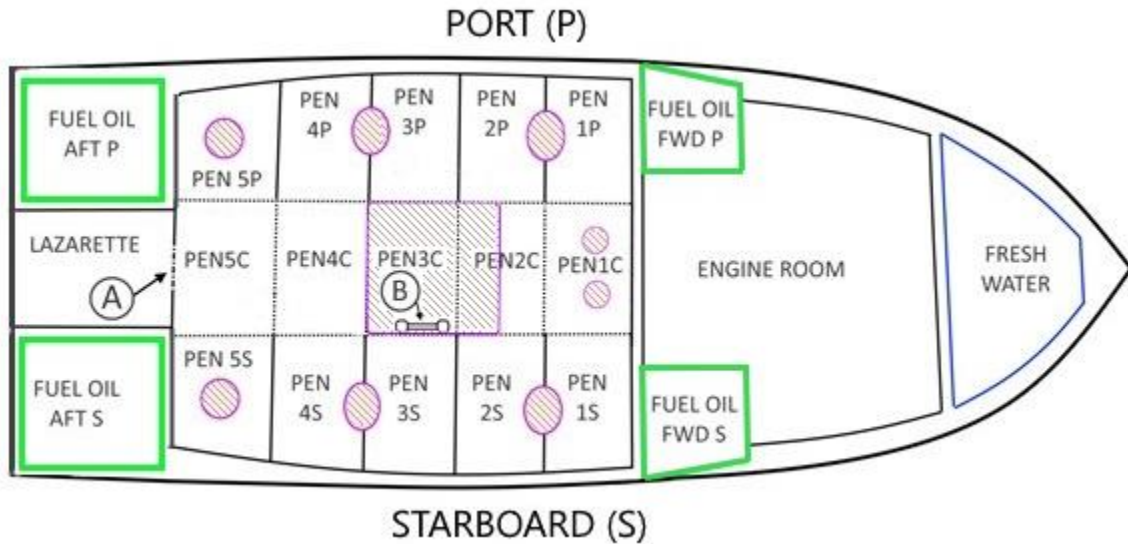
Figure 3. Layout of the fish hold on the *Atlantic Sapphire*, showing the locations of the non-watertight access panel (A), the access ladder (B), the penboards (dotted lines), and hatches (circles between the pens) (Source: TSB)

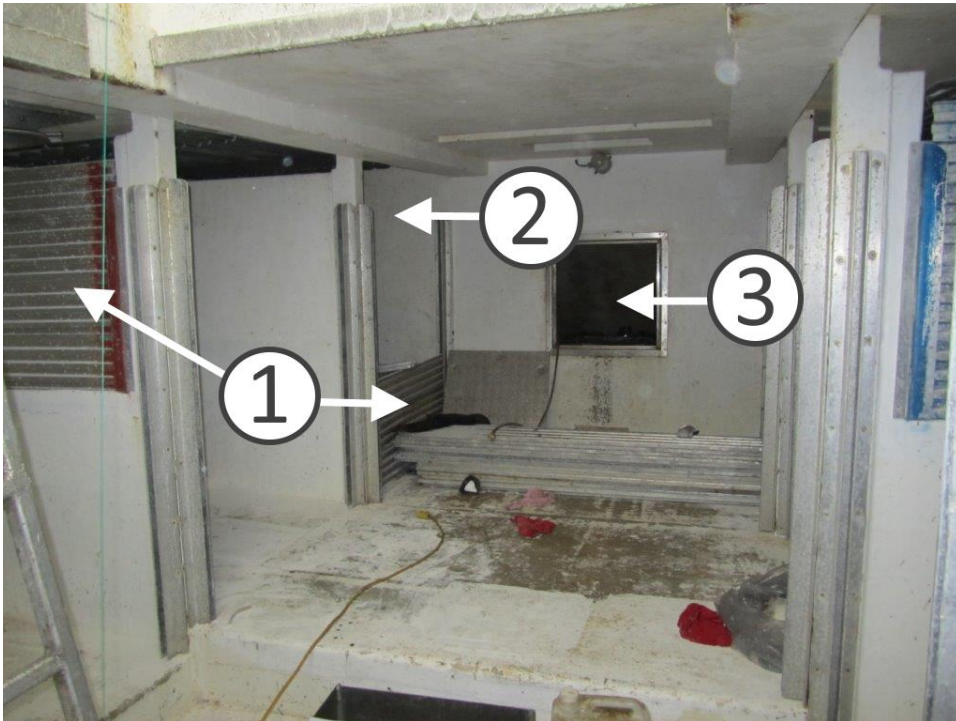
Figure 4. Fish hold, looking aft, showing access to the steering gear compartment (Source: Third party, with permission, with TSB annotations)

3. Non-watertight access to steering gear compartment

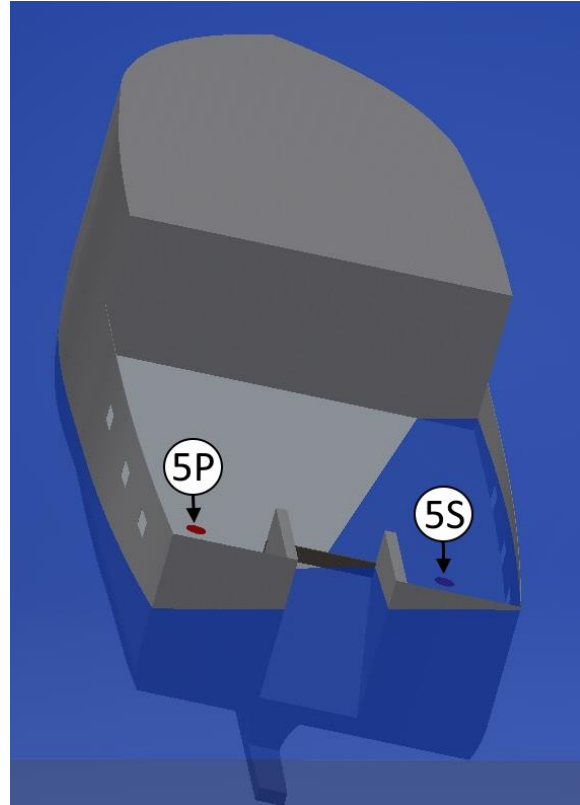
Figure 6. Model of *Atlantic Sapphire* condition when fishing operations stopped. The dots indicate the location of the hatches over pens 5P and 5S (Source: TSB)

With the final catch on board, the vessel's stability was further compromised; the rolling motion due to the sea condition was enough to immerse the deck edge and allow seawater onto the main deck. The water then downflooded into the fish hold through the open hatch.

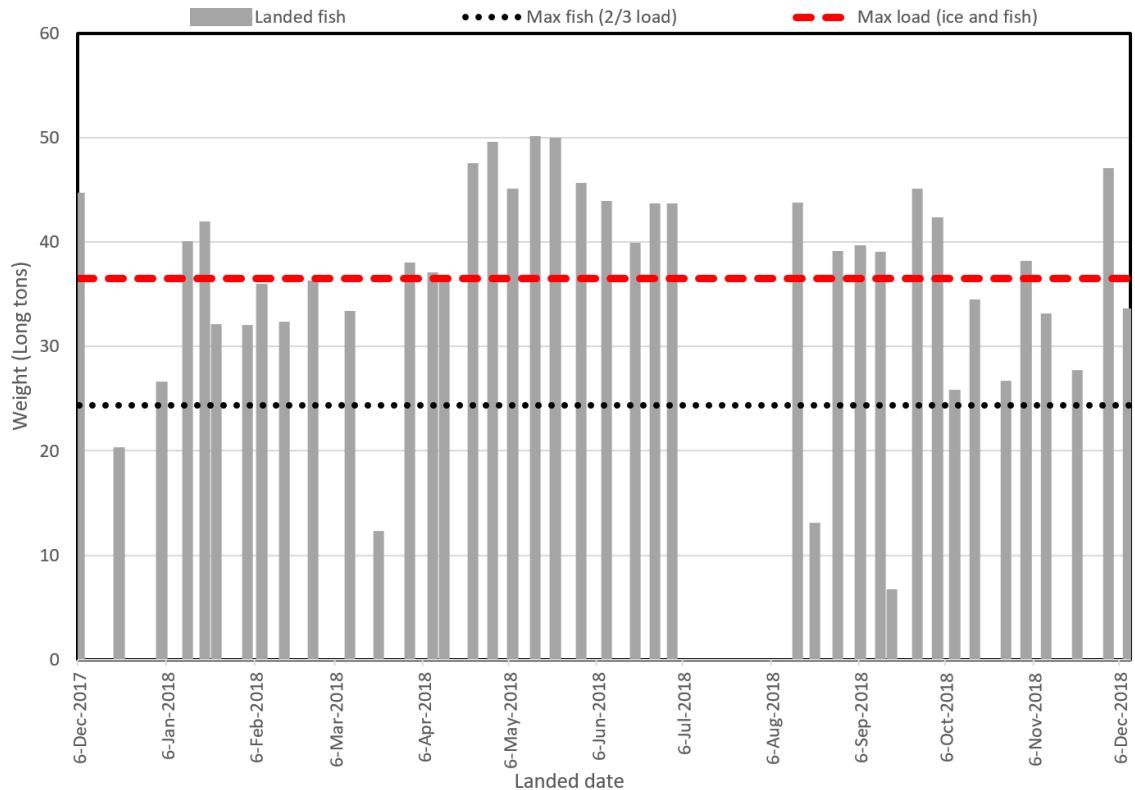
¹⁸ The vessel's stability booklet before 2013 had indicated a maximum loaded condition of 51.2 long tons of fish, and a previous owner had landed over 60 long tons of fish in the past. The vessel underwent modifications in 2013 that necessitated a new stability booklet, which indicated a lower maximum loaded condition of 36.51 long tons of fish. The vessel's landing history dating back to 2013 shows that the vessel was routinely loaded above its maximum loaded condition for fish.

Figure 7. Weight of fish landed* by the *Atlantic Sapphire* from December 2017 to December 2018
(Source: TSB)

* The additional weight of the ice on board that remained in the hold after the fish were landed is not shown on this figure.

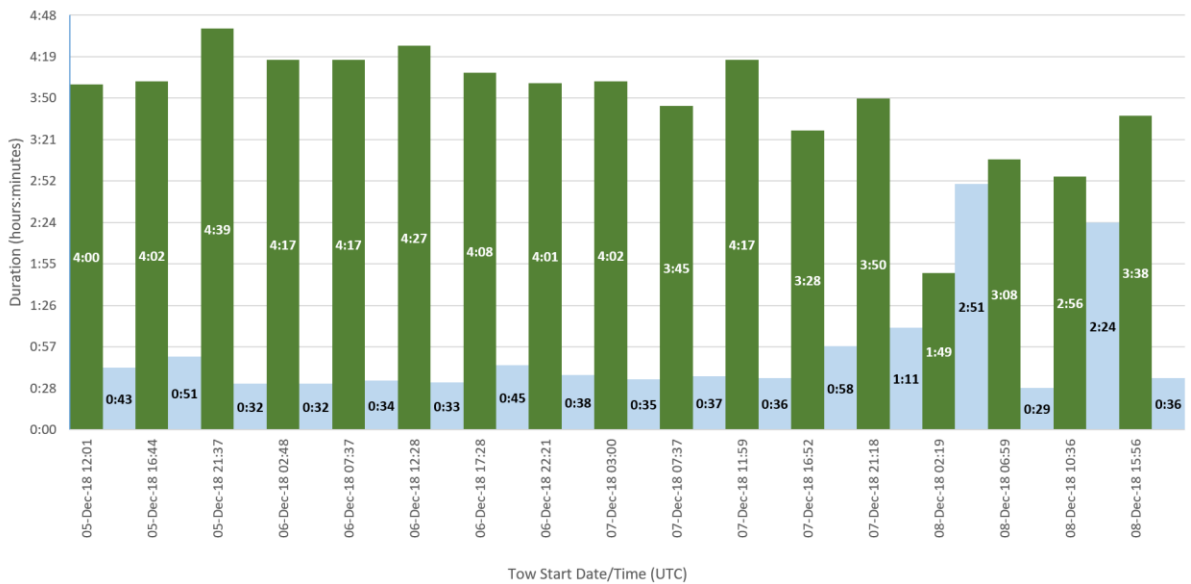
For the fishing trip from 05 to 09 December 2018, the vessel fished for 3 consecutive days. During those 3 days, the longest period of rest possible was 4 hours 39 minutes, with an average tow time of 3 hours 49 minutes (Figure A1). This does not take into account the time required to complete deck duties, clean up, eat, and change before actually resting.

Figure A1. Time towing and time between tows for the *Atlantic Sapphire's* trip with a 3-person crew on the fishing trip that ended on 09 December 2018 (Source: TSB, based on data provided by a third-party on-board monitoring company)
