Marine Transportation Safety Investigation Report M18P0073

SINKING AND LOSS OF LIFE

Fishing vessel *Western Commander*
Triple Islands, Dixon Entrance, British Columbia
09 April 2018

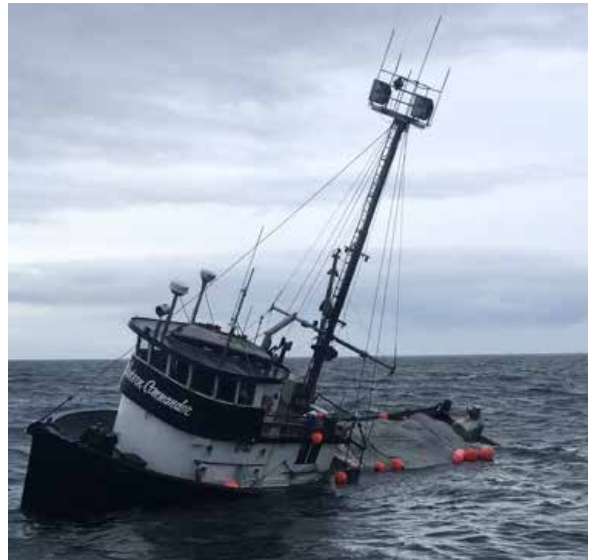
Figure 2. The *Western Commander* listing to port

Around 0900⁴ on 09 April, the mate, who was on watch, noticed that the vessel was not fully returning upright when it was heeled over by the swell. Water was coming over the port railing and remaining on deck, and the vessel developed a port list. At some point, water had entered the port forward fish

hold. In an attempt to reduce the list, the master started pumping the port forward fish hold and repositioned the boom as far as possible to starboard; however, the list continued to increase.

At 1051, the first CCG vessel, the *Cape Dauphin*, arrived on scene as the *Western Commander* continued to list to port (Figure 2). The CCG crew stabilized the mate and transferred him to the RCM-SAR 64 vessel, which evacuated him to Prince Rupert at 1120. At 1212, the RCM-SAR 64 vessel arrived in Prince Rupert and transferred the mate to emergency health services. The mate was pronounced dead on arrival at the hospital.

During loading, each of the 11 harvesters that delivered urchins to the *Western Commander* provided bags of different sizes and shapes at various times over the 2-day period. Some of the bags delivered near the end of this period did not fit through the vessel hatches and were therefore stacked about 1 m high on the hatch covers. Stacking the bags on the hatches blocked access to the holds and the lazarette and eliminated the possibility of identifying points of water ingress or adding portable pumps to these areas. Stacking bags on top of the hatches also raised the vessel's centre of gravity and created an opportunity for the cargo to shift, which could adversely affect stability.

It could not be determined how water entered the port forward fish hold or whether the loading practices adversely affected the vessel's stability to the extent that they contributed to its sinking.

Loading and securing catch (e.g., sea urchins and herring) should be done in accordance with current vessel-specific stability information to avoid hazards such as uneven weight distribution, cargo shifts, or blocked access to critical areas of the vessel.
