Marine Transportation Safety Investigation Report M19A0090

CAPSIZING AND LOSS OF LIFE

Unregistered fishing vessel
Mackenna Point, Nova Scotia
08 April 2019

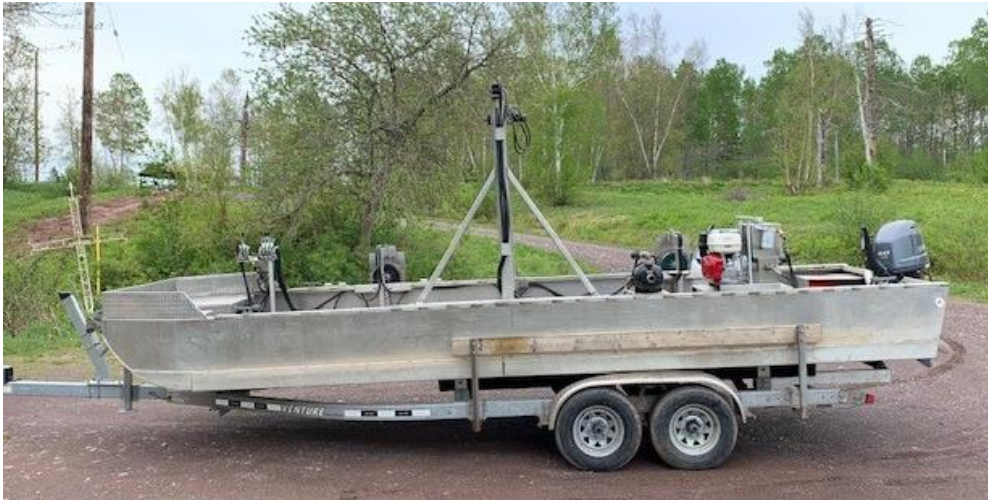
Figure 2. The fishing vessel (Source: Paqtnkek Mi'kmaw Nation)

The vessel was not built to any standard;³ it was constructed without a lines plan or engineering drawings, its stability was not assessed, and its stability limits were not known.⁴ The 2018 bill of sale included a disclaimer indicating that the purchaser was responsible for understanding the limitations of the vessel's custom design.

There were no freeing ports on the main deck, but the main deck was fitted with a drain plug. The vessel was equipped with an automatic bilge pump for the main deck and a small gasoline engine driving a hydraulic-power pack, which powered an oyster cage hauler and a deck hose. The vessel was also equipped with a 60 hp outboard motor and was capable of reaching speeds of approximately 25 knots (Figure 2).

- Nova Scotia Community College, the Nova Scotia Fisheries Sector Council, and a safety consultant developed a voluntary training course to address gaps in training for small aquaculture vessel operators. The training focuses on vessel maintenance and operations, and creates awareness about regulatory requirements and the benefits of conducting drills and safety procedures. Participants review vessel stability and safe working practices for loading and handling the traps and cages used in the aquaculture industry.
- TC conducted outreach to local First Nations aquaculture operations.
- The AR arranged to have the vessel's stability assessed.
