MARINE TRANSPORTATION SAFETY INVESTIGATION REPORT M20A0160

SINKING AND SUBSEQUENT LOSS OF LIFE

Fishing vessel *Sarah Anne*
Placentia Bay, Newfoundland and Labrador
25 May 2020

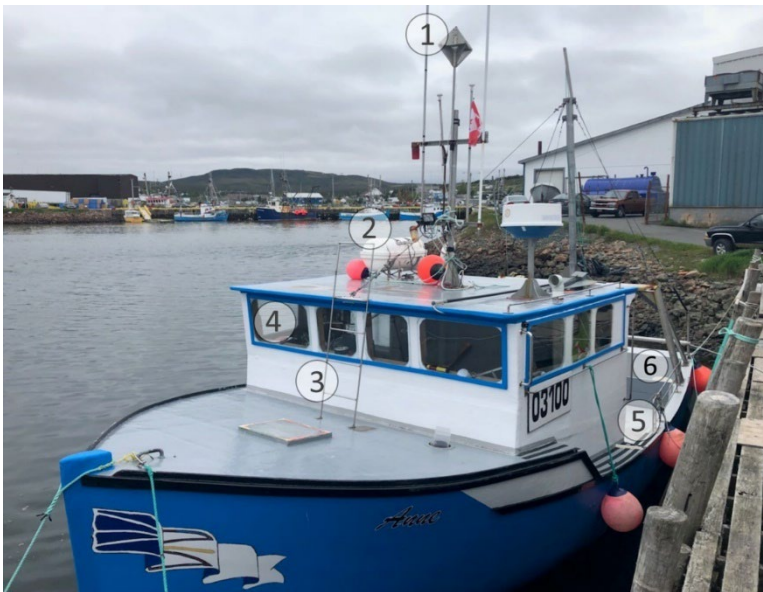
There was a 6-person inflatable life raft in a cradle on top of the wheelhouse. The life raft was typically secured to the cradle with straps. The vessel's mast held radio and GPS antennas and a radar reflector (Figure 1).

Figure 1. Photo of the *Sarah Anne* before the occurrence, showing the radar reflector (1), life raft (2), access ladder to life raft (3), wheelhouse conning station (4), forward section of the main working deck (5) and aft storage area (6) (Source: Third party, with permission)

The *Sarah Anne's* life raft was secured on the top of the wheelhouse without a hydrostatic release unit; it was typical to use straps to secure the life raft to its cradle and the life raft would therefore have required manual deployment. Because the *Sarah Anne* likely lost stability and capsized quickly, the crew may not have had the opportunity to manually deploy a life raft. The life raft was not found during the SAR efforts; it likely sank with the vessel.
