MARINE TRANSPORTATION SAFETY INVESTIGATION REPORT M20C0101

CREW FALL OVERBOARD AFTER WORKBOAT STRUCK BY MOORING LINE

Unregistered workboat belonging to the bulk carrier *Manitoulin*
St. Clair River, near Sombra, Ontario
12 May 2020

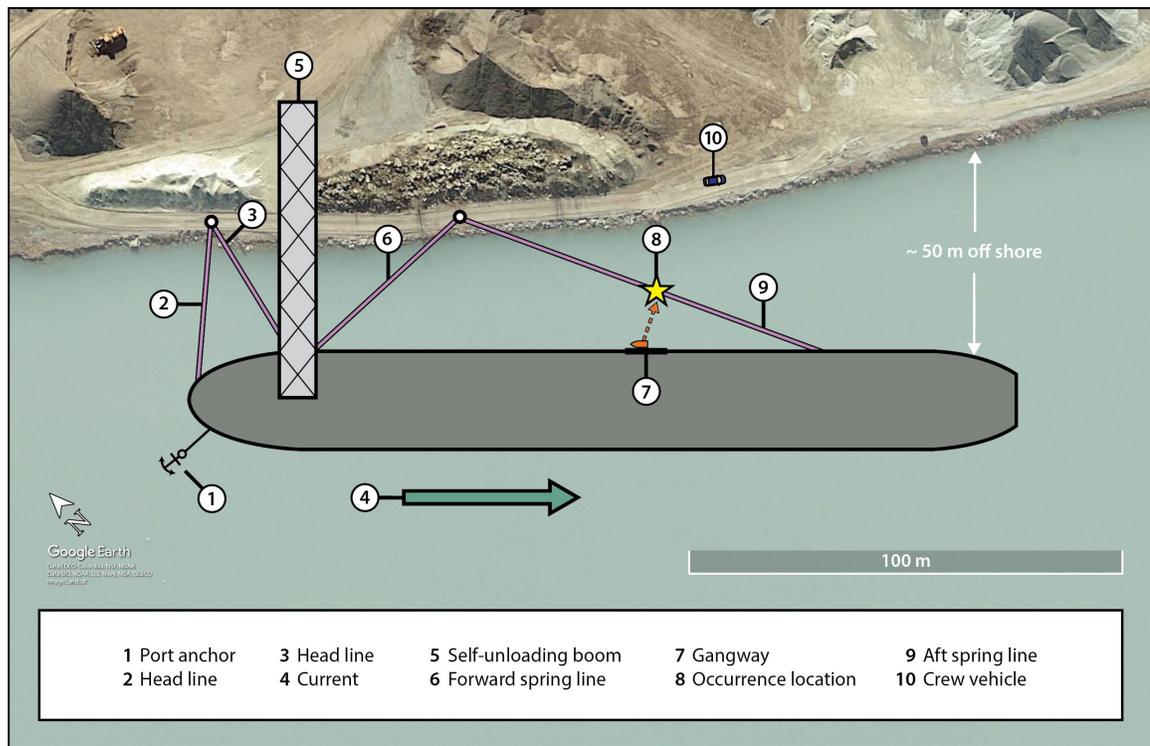
Figure 3. The *Manitoulin's* mooring arrangement at the time of the occurrence (Source: Google Earth, with TSB annotations)

By 1530, the port anchor had been deployed, and 4 of the vessel's mooring lines had been secured to shore (Figure 3, items 1, 2, 3, 6, and 9). The aft spring line was secured to shore but kept slack for emergency use in the event that the other mooring lines parted or detached from shore. The line had approximately 9 to 12 m of slack on it. Keeping the aft spring line slack for emergency use was common practice at this location.

At 1536, unloading operations using the vessel's self-unloading system (Figure 3, item 5) began. The chief officer was supervising these operations from the starboard side of the main deck. The second officer was assisting from one of the 2 unloading control rooms that are located forward.
