MARINE TRANSPORTATION SAFETY INVESTIGATION REPORT M20P0229

SINKING WITH LOSS OF LIFE

Fishing vessel *Arctic Fox II*

11 August 2020

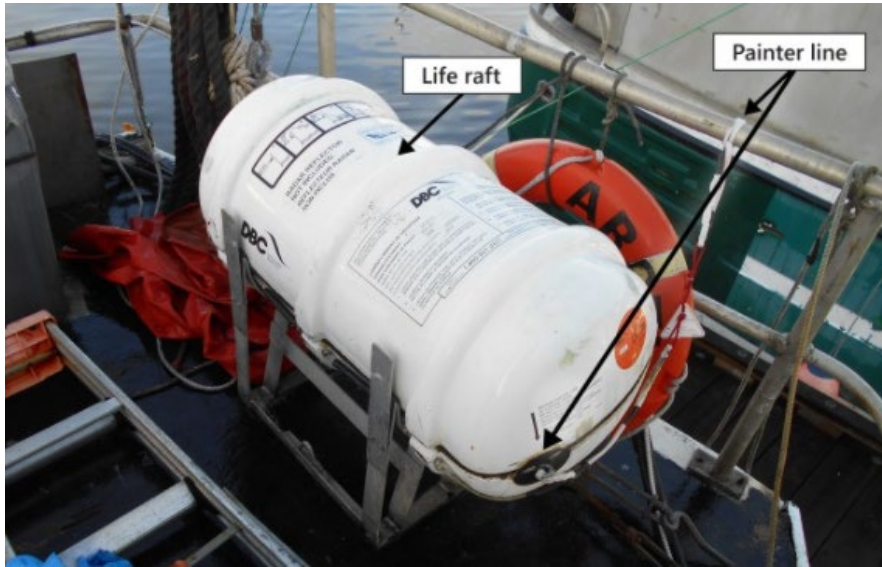
Figure 3. Stowage of the life raft on the Arctic Fox II (Source: Owner)

The instructions for manual deployment written on the life raft read:

1. Check painter line is secured to strong point.
2. Launch life raft container.
3. Heave on painter line until life raft inflates.
