Marine Occurrence Report

Collision

between the "AMELIA DESGAGNES"
and the "6E7221"

Report Number M92L3008

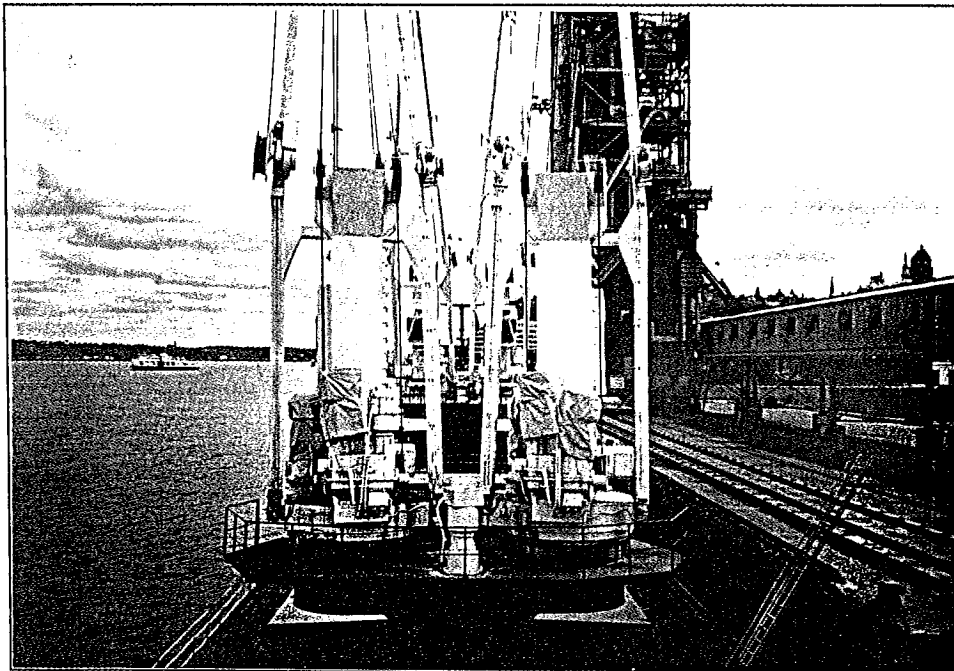
On the "AMELIA DESGAGNES", as on most commercial vessels, there is an area ahead in which the vision of an observer on the bridge is restricted. The situation was aggravated on the "AMELIA DESGAGNES" by the presence of two sets of two deck cranes. Although the booms were lowered, the cabs of the cranes restricted the field of view forward.

For a person at the centre-line conning position, the vertical blind sector between the two sets of cranes extended approximately 190 m beyond the bow, taking into consideration the vessel's trim

View forward with cranes raised.

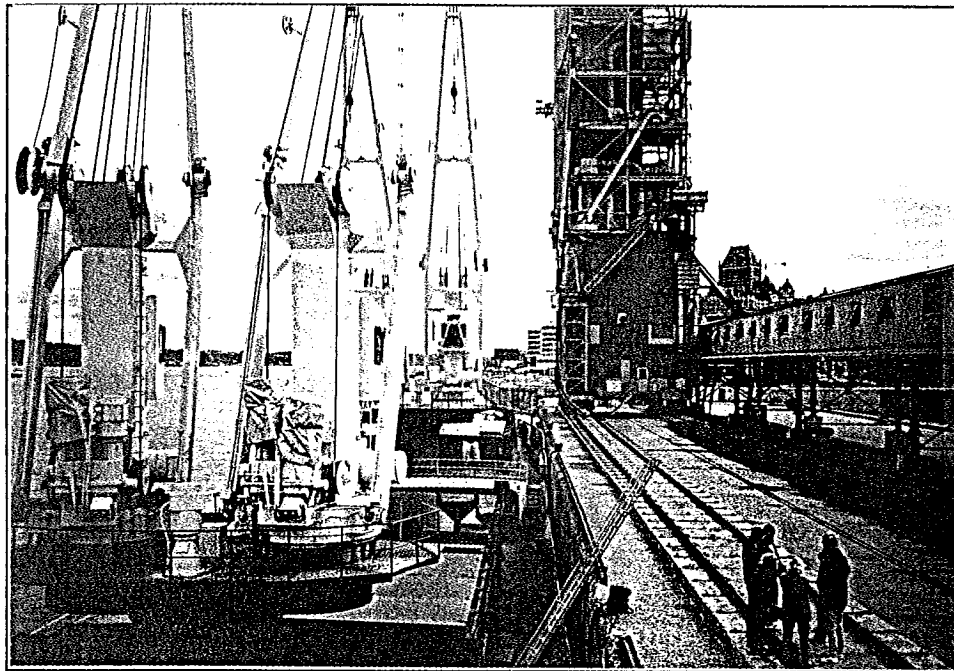
at the time of the occurrence. Because of this restricted field of vision, the navigating personnel adopted conning and look-out positions on either side of the bridge. The cranes also caused horizontal blind sectors totalling approximately eight degrees. As the "AMELIA DESGAGNES" was an "existing ship" on 02 January 1992, Canadian Coast Guard (CCG) Ship Safety Bulletin No. 3/93 regarding navigation bridge visibility did not strictly apply to her. However, to all intents and purposes, the vessel met the guidelines.

Showing improved view forward from side windows.

View forward from a starboard wheel-house window.

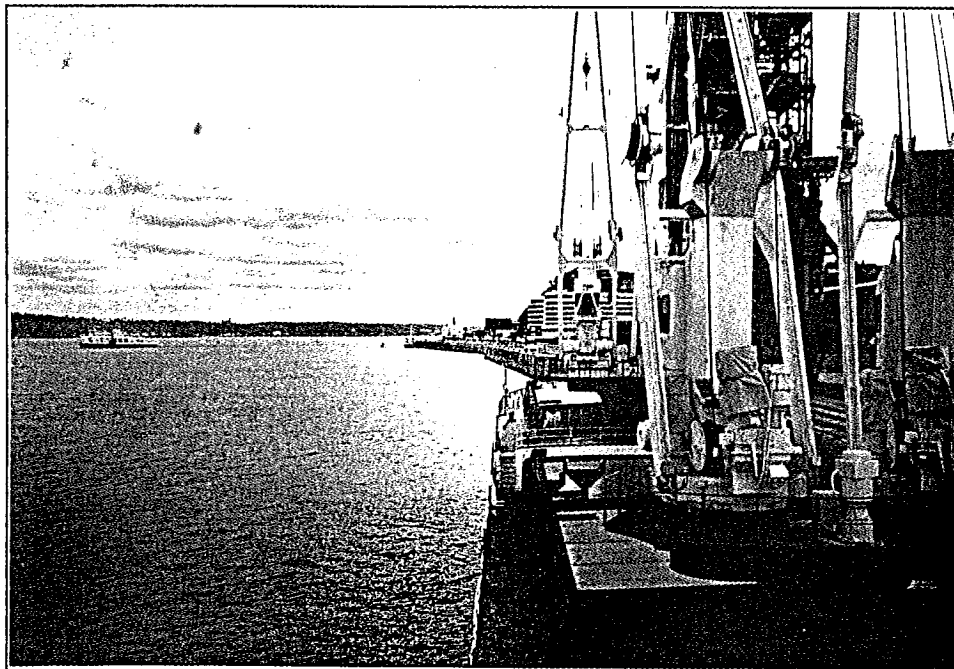
View forward from a port wheel-house window.

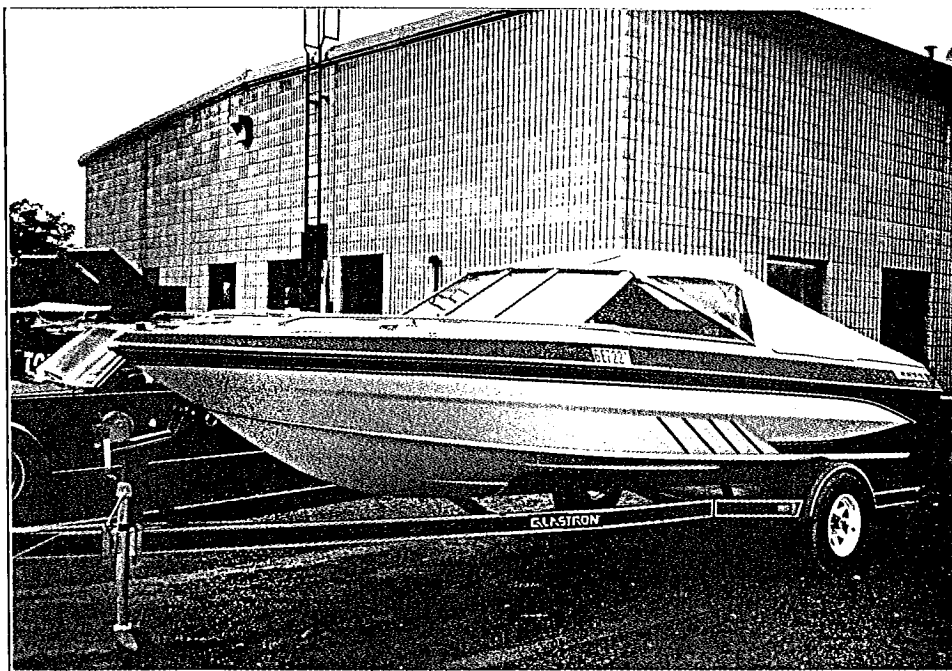
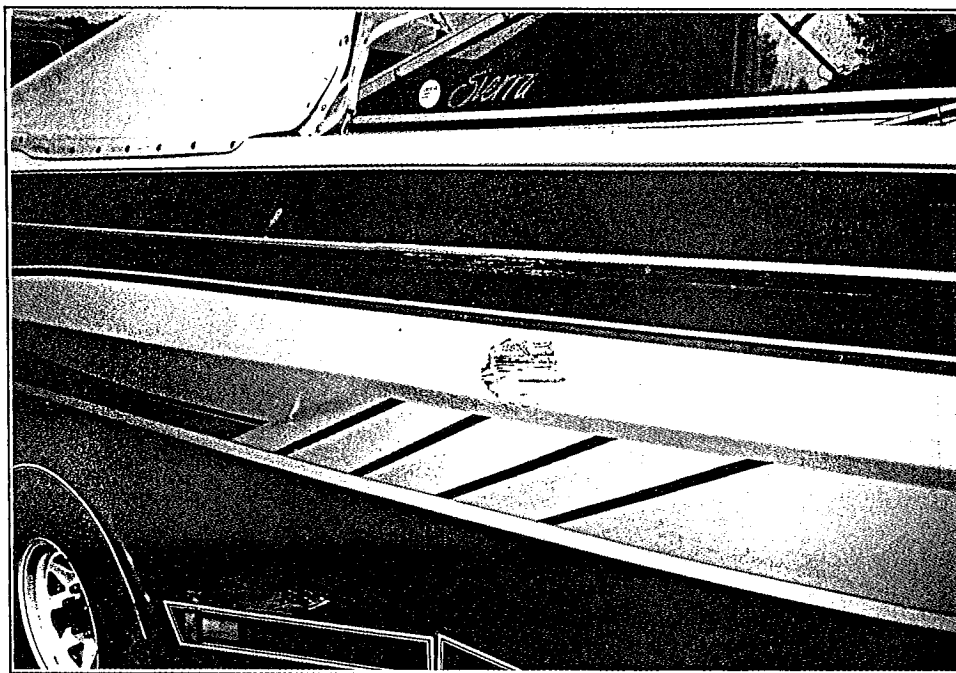
"6E7221"

At the deck edge of the "6E7221", a rubber rubbing strip on the starboard side of the hull was abraded over a length of one metre. Immediately below this damage, there was a 125 mm x 125 mm perforation in the boat's white fibreglass hull, in the middle of a 170 mm x 170 mm area of black abrasions. A sample of the black paint in these abrasions and a sample of paint from the bow of the "AMELIA DESGAGNES" were examined at the TSB Engineering Laboratory. It was considered that the similarity found in the analysis "would confirm the presence of the ["AMELIA DESGAGNES"] in an area of contact on the smaller craft and be consistent with collision of the two vessels."

Showing damage to hull of pleasure craft.
