Marine Occurrence Report

Striking

by the Bulk Carrier "NIRJA"
of the Tanker "HAMILTON ENERGY"
Hamilton, Ontario
11 December 1993

Report Number M93C0003

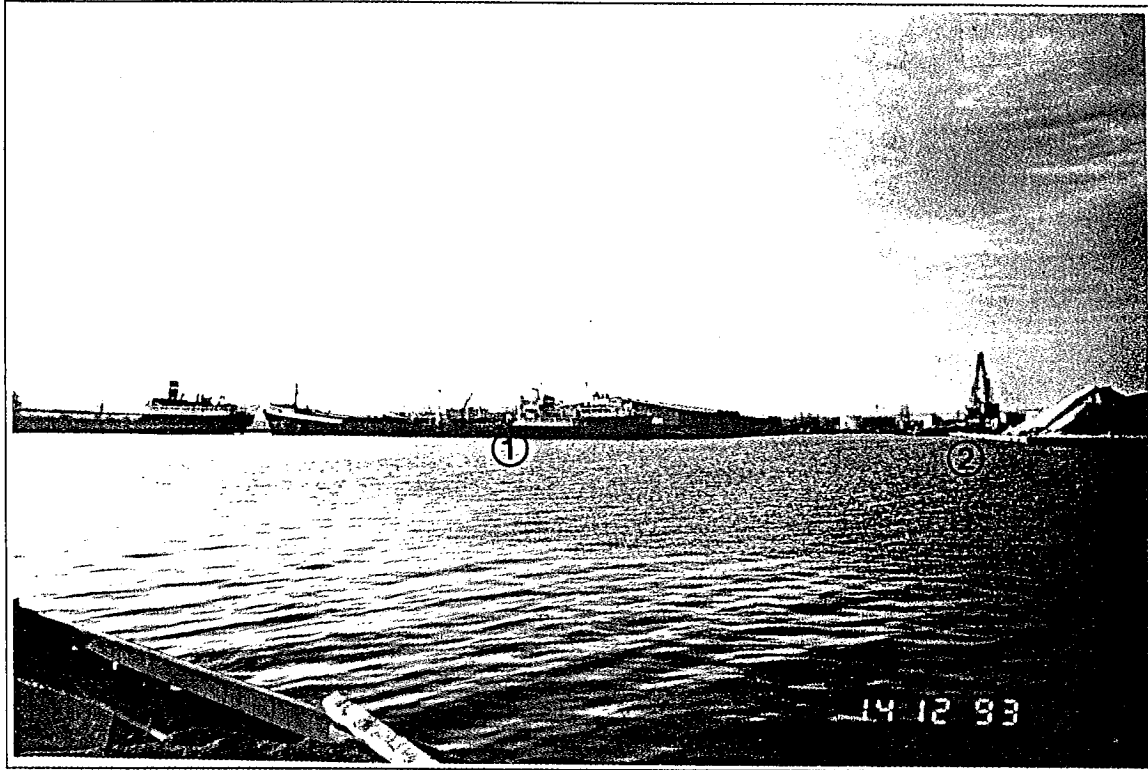
1. The "HAMILTON ENERGY" alongside the "PROVMAR TERMINAL I".
2. Crane at the right side of the slipway shows berthing location for the "NIRJA" (at Pier 23).
