MARINE OCCURRENCE REPORT

FIRE ON BOARD

THE RO/RO CONTAINER SHIP "ASL SANDERLING"
ST. JOHN'S, NEWFOUNDLAND
15 SEPTEMBER 1997

REPORT NUMBER M97N0129

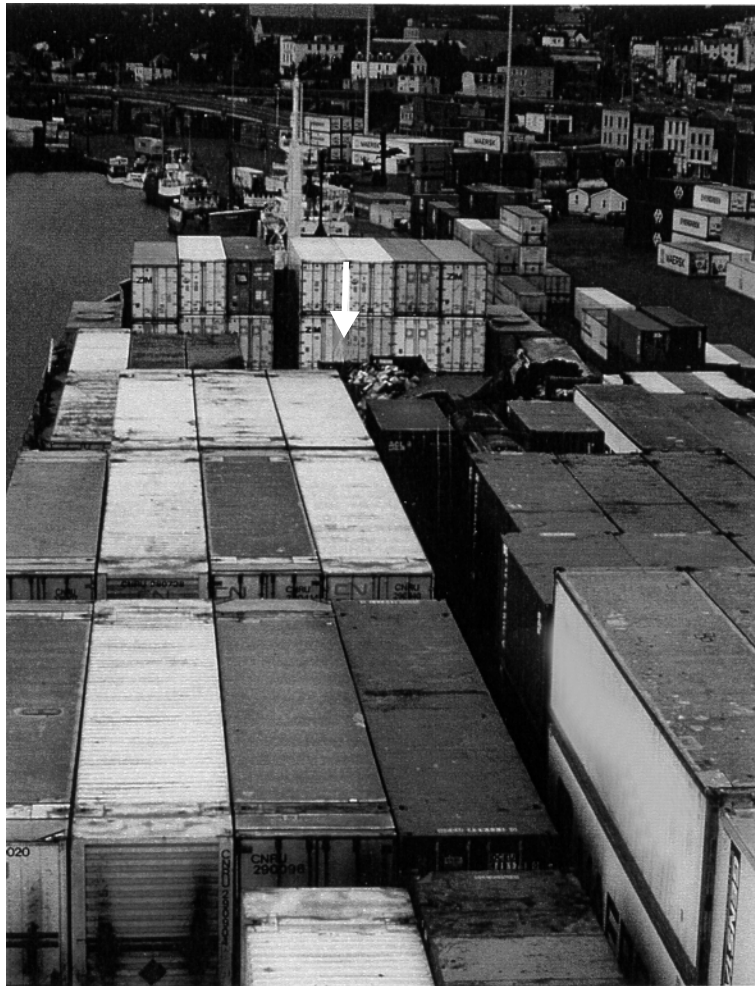
Appendix A - Photographs

The generator/container frame assembly was placed on the weather deck in position “315,” i.e., the 3rd bay from forward, on the 1st or bottom level and at the 5th position from the port side of the ship. It was overstowed in position “325” by an empty, steel-sided 20-foot container with a 3/4-inch plywood floor. (See Appendix A showing photographs of the fore deck and partial deck cargo.)

It was evident that the area of most intense heat was concentrated at the generator set, the empty container located directly above it and the two refrigerated containers located immediately to the starboard side of the generator set. The intensity of the fire and the difficulty in bringing it under control indicated that it was fuel fed.

- The fire originated on the portable generator platform located on the forward deck.

- The probable cause of ignition was the direct impingement of hot exhaust gases onto the wooden floor located 13 inches above the exhaust stack outlet.
- The reported presence of the two plastic drums of diesel fuel contributed to the propagation of the fire.
- The Caterpillar portable generator, model 3306B, was not marine rated.
