MARINE INVESTIGATION REPORT

M98L0165

GROUNDING

OIL AND CHEMICAL TANKER "JADE STAR"

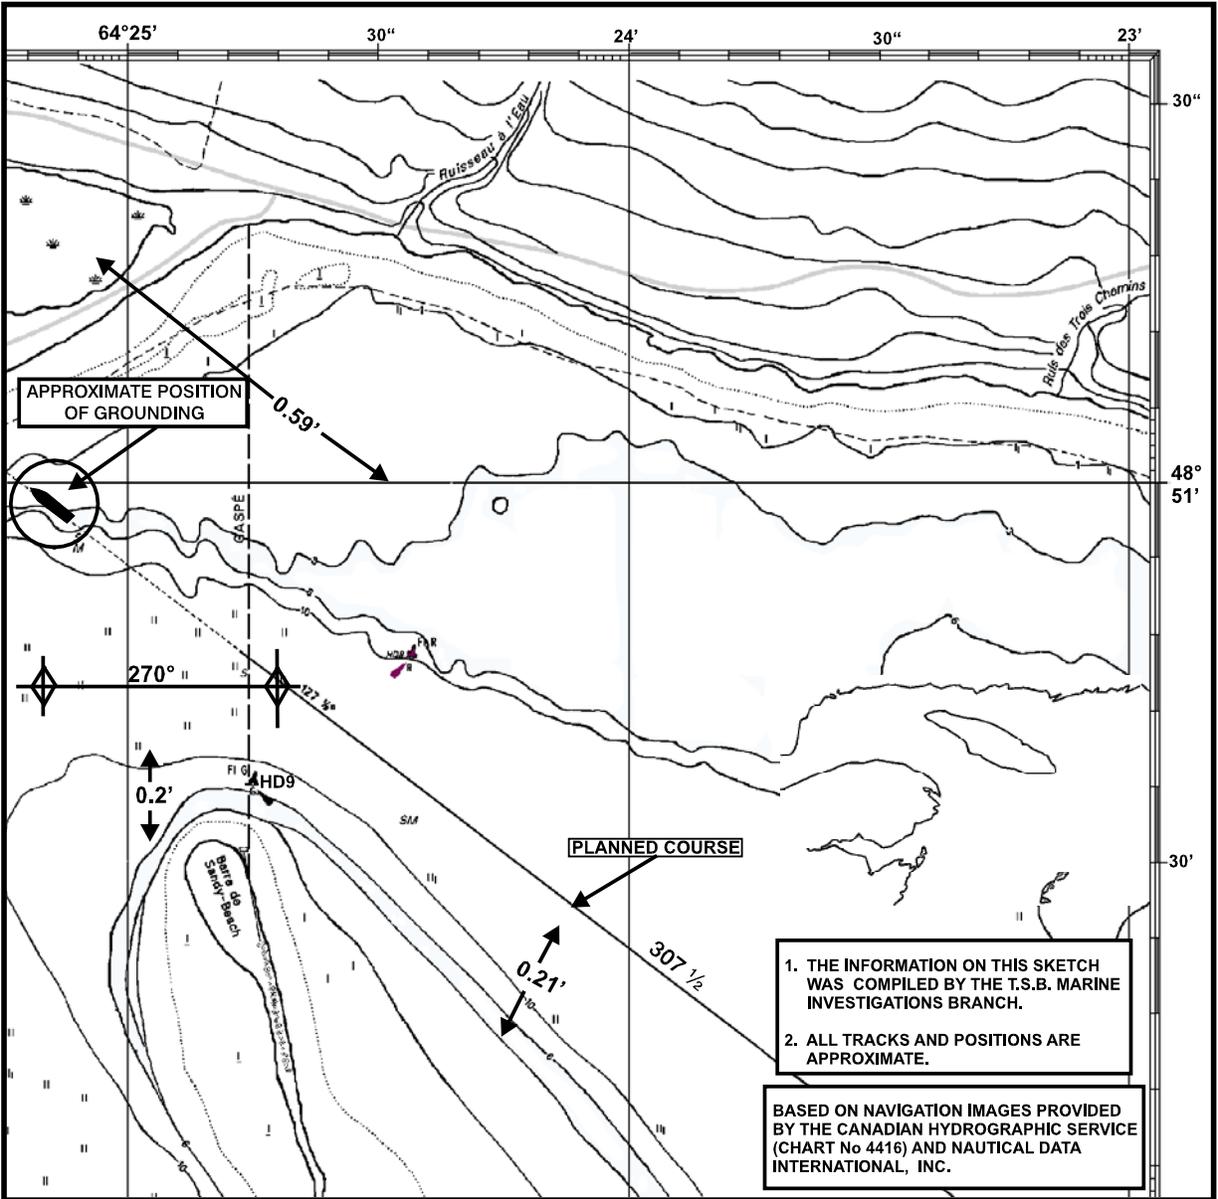
Appendix A - Sketch of the Occurrence Area

At approximately 0440, 50 minutes before high water, the "JADE STAR" grounded in sand in approximately 5.5 m of water, 1.8 cables south-east of Presqu'île de Penouille, still on the ranges and with the engine at half ahead. At this time the master reversed the pitch to give 100 per cent reverse thrust, but the vessel did not move.

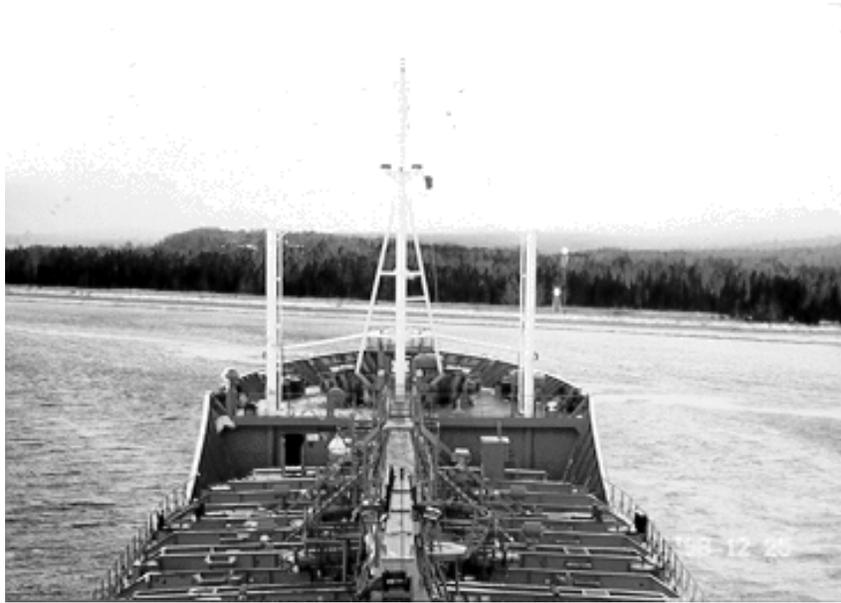
WHEEL-HOUSE VIEW AMIDSHIPS

Both the OOW and the master reported that the range lights were very bright. Their night vision was further affected by the illumination of the deck lights some minutes before arrival in the narrows.

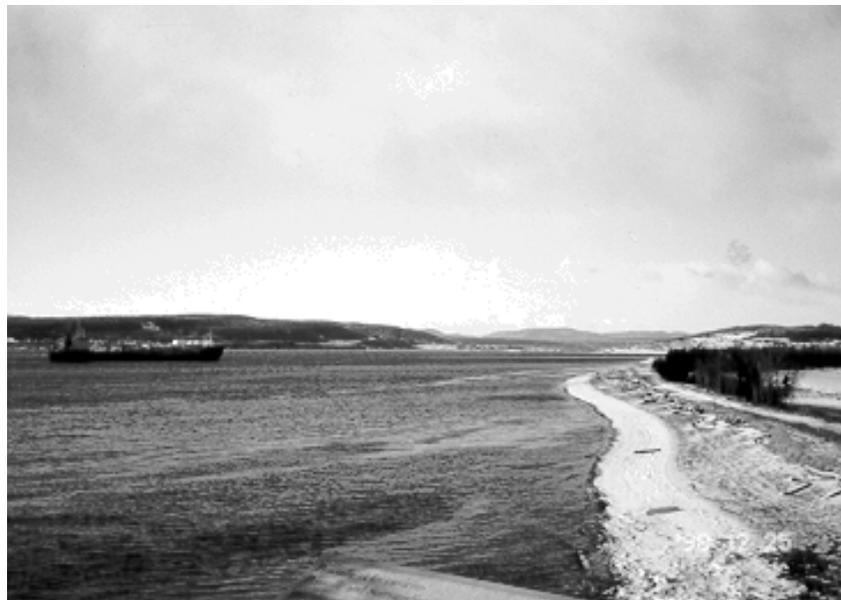
The "JADE STAR" ran aground when, on scanty and erroneous information, a critical course alteration was delayed.

THE "JADE STAR" AGROUND ON SHORE OF PRESQU'ÎLE DE PENOUILLE
48°50.97'N, 064°25.15'W HEADING 302° (G)
