MARINE INVESTIGATION REPORT

M99C0019

GROUNDING

OF THE BULK CARRIER "HOPE I"

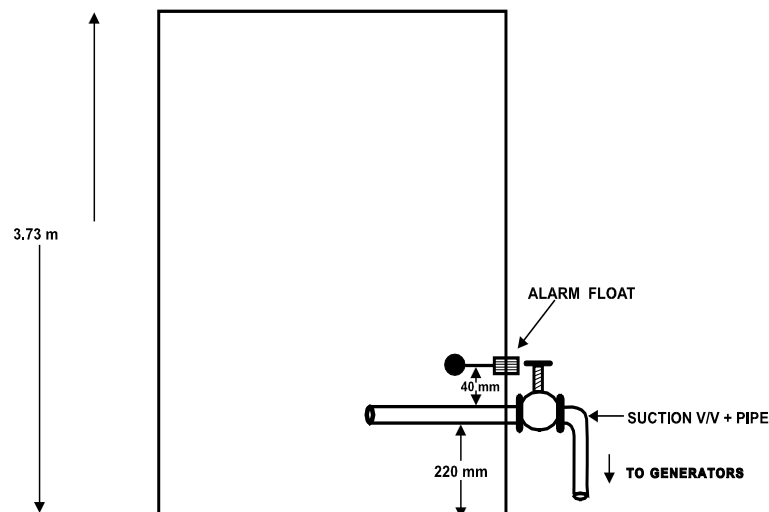
The engine-room staff were unaware that the generator fuel suction pipe arrangement in the service tank was such that the pipe extended straight into the tank on a horizontal plane, 220 mm from the bottom of the tank. Because of this arrangement, the last 1.8 tonnes of fuel in the tank was unusable. The float for the low level alarm was located 40 mm above the fuel suction pipe.

The engine-room staff was not aware that the internal arrangement of the generator service tank was such that the fuel below the suction pipe was unusable, the tank sounding tables did not indicate that this was the case, and reliance was placed on soundings which showed that there were about two and a quarter tonnes of fuel remaining in the tank. These factors combined to influence the engineer’s decision to ignore the low level alarm. However, the combination of the known average fuel consumption and the low level alarm, reinforced by the 1000 sounding, should have provided ample warning that the level of fuel in the generator service tank was critically low.

Subsequent to the occurrence, a low fuel level notation was added to the Alternator Service Tank sounding tables on board the vessel.
