MARINE INVESTIGATION REPORT

M99F0023

ENGINE-ROOM FIRE

THE SELF-UNLOADING BULK CARRIER "NANTICOKE"
AT 39°20' N, 072°22' W, WESTERN NORTH ATLANTIC OCEAN

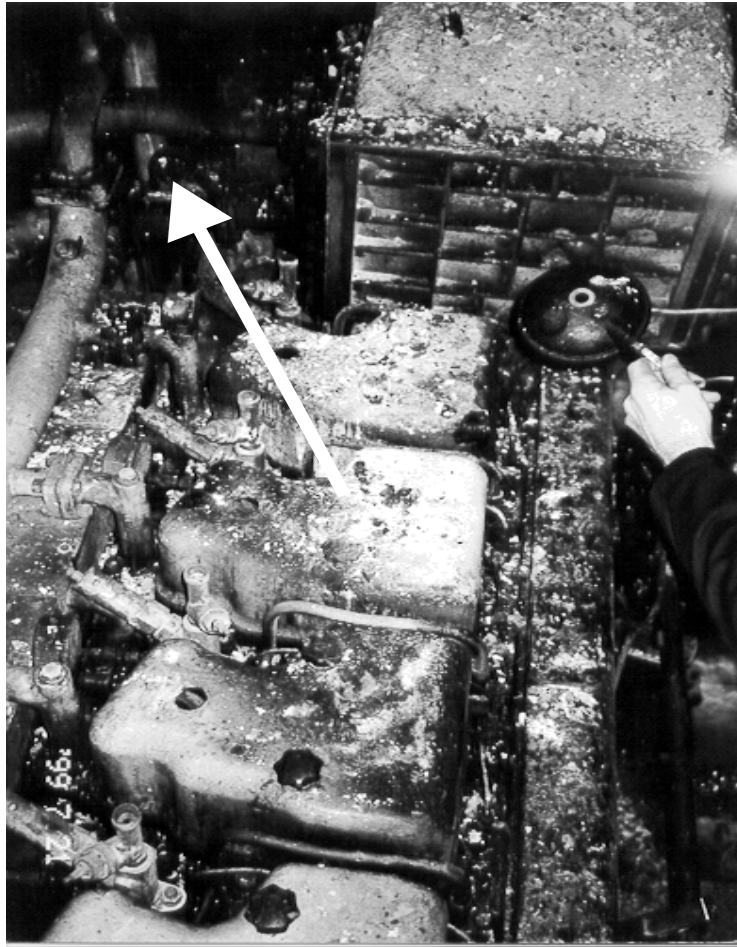
A vertical, V-shaped soot pattern was present on the port generator exhaust uptake as well as a horizontal soot pattern on valve covers 1, 2 and 3, both originating in the vicinity of the exhaust manifold/turbocharger inlet area. Aft surfaces of the valve covers had been "shadowed" from the fire even though their top surfaces were burned and sooted. An area of "clean burn" damage was present on the cable tray directly above the fuel filters.

The vertical soot patterns on the exhaust uptake, the horizontal patterns on top of valve covers 4, 5 and 6, and the shadowing on the aft surfaces of the same valve covers, indicate a fire origin at the engine’s port side, forward of cylinder head No. 1. The most probable high temperature ignition sources in this area are the indicator cock protruding from the cylinder head and the uncovered exhaust manifold connecting to the turbocharger.

**HORIZONTAL CHARRING PATTERN POINTING TOWARDS
THE SEAT OF THE FIRE AT THE EXPOSED EXHAUST PIPING**

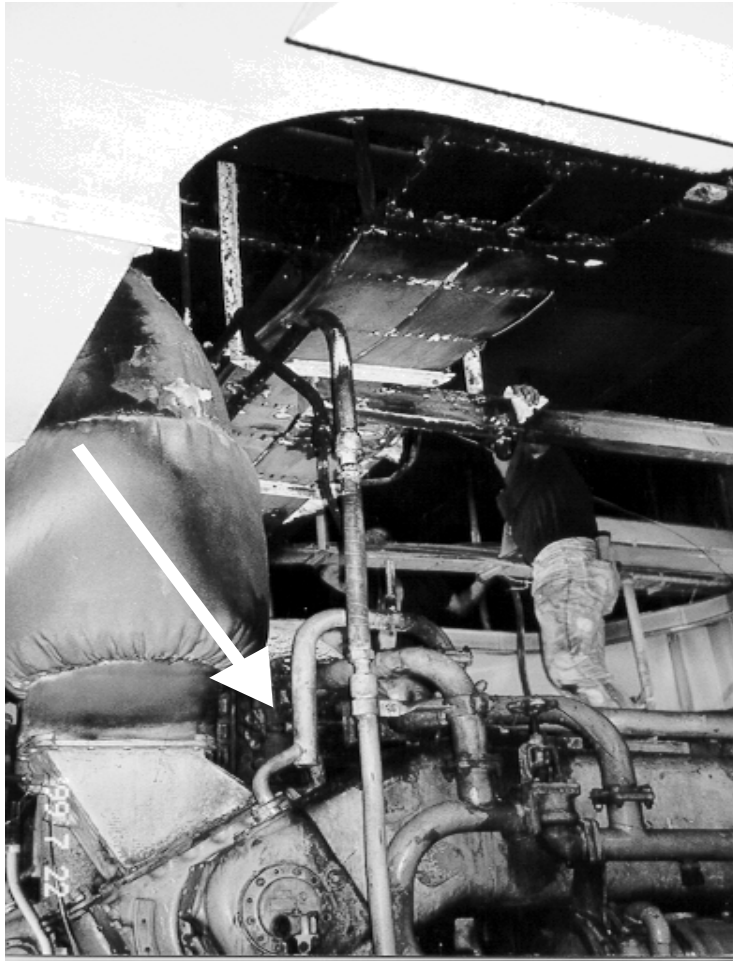
**VERTICAL SOOT PATTERN INDICATING THE SEAT OF FIRE
NEAR EXHAUST MANIFOLD AT INLET TO TURBO-CHARGER**

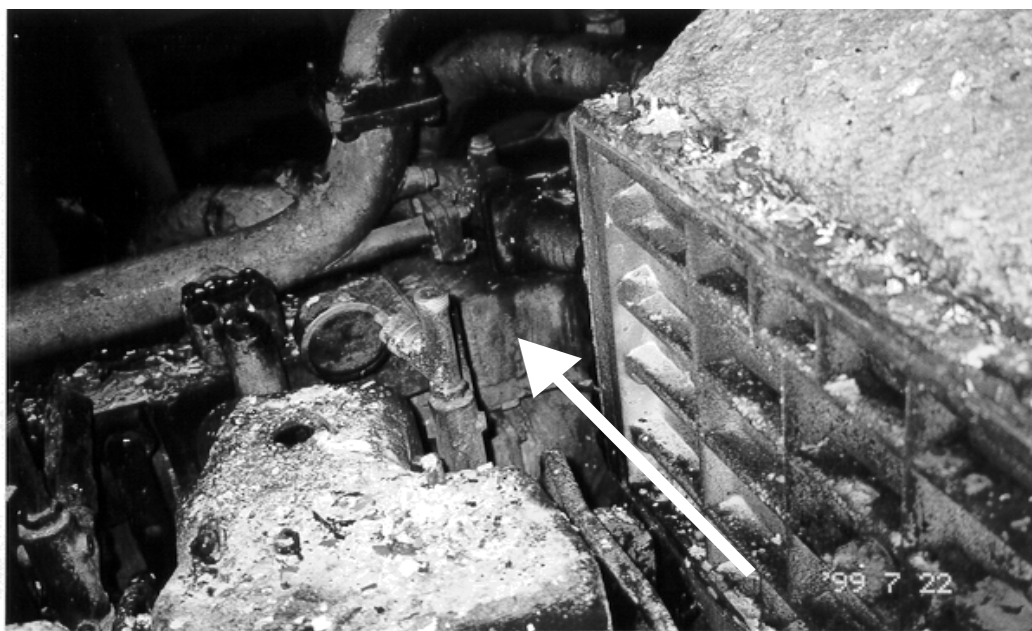
Outboard of cylinder No. 1 are the exhaust collector pipes which lead to the turbocharger mounted on the forward end of the engine. No lagging or shielding was present on the exhaust pipes where they connected to the turbocharger. An indicator cock protruded from each cylinder head just forward and outboard of the valve covers.

Under normal circumstances a liquid fuel would have to be above its flash point for vapours to form an ignitable mixture. However, in the case of spraying fuel, ignition can often occur at temperatures below the flash point provided a heat source above its ignition temperature is present. Therefore, the initial leak developed at the copper gasket and, due to the mounting position of the filter and lack of shielding between it and the engine, sprayed a fine mist of fuel onto the exposed indicator cock or exhaust manifold, both of which were

EXPOSED EXHAUST MANIFOLD ADJACENT NO. 1 CYLINDER HEAD

- New top covers have been installed on all generator fuel filters.
- Metal shields have been installed between filters and adjacent hot exhaust surfaces to prevent contact in the event of filter leakage.
- The steering control and power wiring have been re-routed so that they do not pass over the generators' forward ends.
- An internal safety bulletin has been circulated to the entire fleet apprising them of the occurrence.

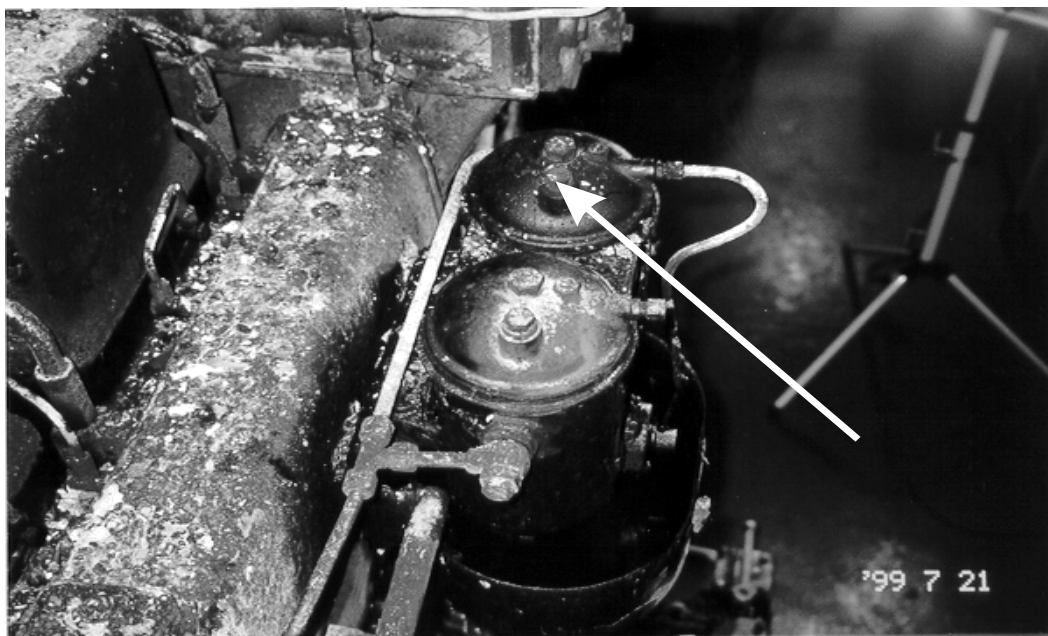
The port generator was examined by the TSB on the evening of July 21. The generator secondary fuel filters are located on the inboard forward end adjacent to valve cover No. 1. The generator secondary fuel filter selector cock was found in the forward filter position indicating that the forward fuel filter was in use at the time of the fire. Both the forward and aft filter bowls were extensively charred externally. The save-all under the fuel filters was full to within 3 cm of its upper edge with diesel oil. There was an indication that fuel had run down the starboard side of the engine under the filters.

The two fuel oil filters mounted on the starboard upper side of the engine contain fuel under pressure of approximately one bar and are mounted on the same plane as the exposed exhaust manifold and indicator cock. Examination of the fuel filters indicated that the aft filter was extensively damaged internally. This indicates that the aft filter was not cooled by fuel flow and thus not in service at the time of the occurrence. It can, therefore, be ruled out as a source of fuel to the fire. Furthermore, the position of the fuel selector cock indicated that the forward filter was in service at the time of the occurrence.

above the ignition temperature of the fuel. As the fire progressed, it melted the main cover rubber O-ring on the forward filter, which then provided a large volume of pressurized fuel until the fire was discovered and the engine was shut down.

**SECONDARY FUEL FILTERS ADJACENT NO.1 CYLINDER HEAD
ARROW POINTS TO INITIAL LEAKAGE POINT**

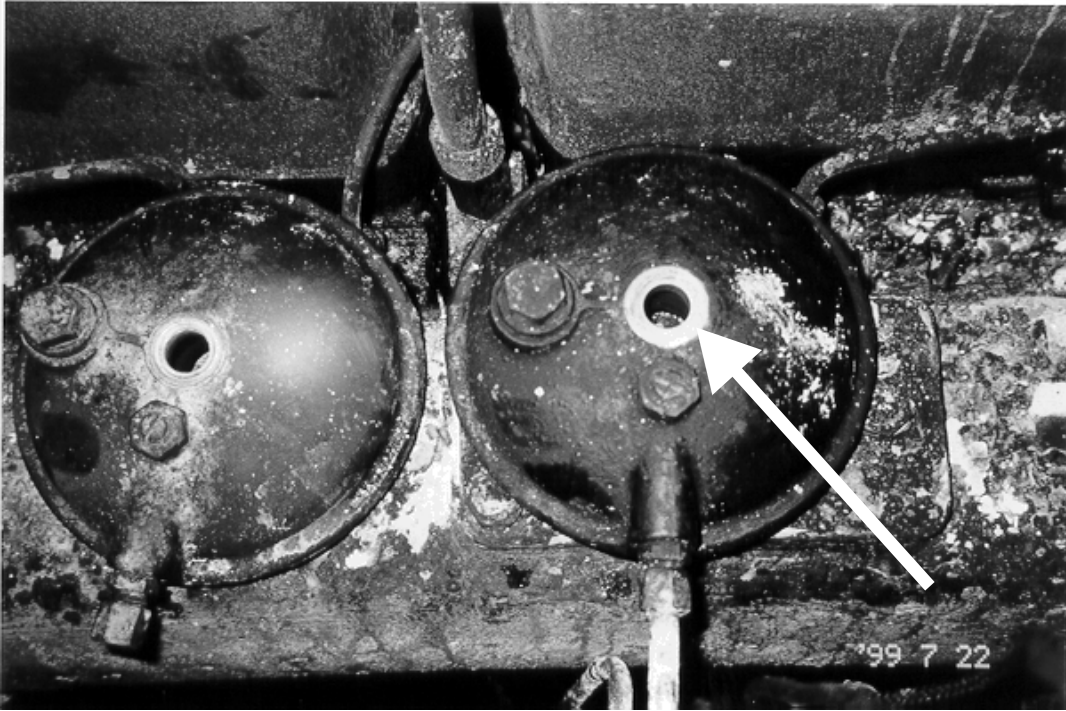
filter bowl was two-thirds full of diesel fuel. File marks were present on the cover/bolt sealing surface and, unlike the aft filter, the cover/bolt surface was flat, with no recess.

At an unknown time before the occurrence, modifications had been made to the forward filter cover/bolt sealing surface, which removed the seating groove for the copper washer and left the sealing surface uneven and grooved with file marks. As a result, the watchkeeping engineer had experienced a problem obtaining a fuel-tight joint at the copper gasket sealing the cover to its securing bolt when he serviced the filter one hour before the fire. No new copper gaskets were available on board, so the existing copper gasket was annealed and re-used. Once a copper gasket has been deformed by use, it is more difficult to obtain a tight seal for subsequent usage even if it has been annealed. The combination of the modified, uneven sealing surface and the re-use of the used gasket increased the risk of leakage once pressure was applied to the filter.

1. The bolt sealing surface on the forward fuel filter cover (port generator) had earlier been modified by removing the recess used to seat the copper washer. The surface was uneven and marred by file marks.
2. When the filter was serviced an hour before the fire, the copper washer was not renewed, as a spare was not available.
3. The port generator forward fuel filter was in service at the time of the fire.
4. The location of the forward fuel filter allowed leaking fuel to contact an adjacent, unshielded hot exhaust manifold and indicator cock.
5. No inspection rounds of the engine-room were made between 1515 and 1600, the time at which the fire was discovered.
6. Vessels built before 1 September 1984 were not required to have wiring for duplicated steering power and control systems in separated cable runs.

**COVER FROM FORWARD FUEL FILTER (RIGHT)
MODIFIED BY REMOVAL OF THE GASKET MOUNTING GROOVE**
